EPA R6 and ERT Dive Team Operations
SUMMARY REPORT
Cap Assessment and Sampling Activities
San Jacinto Waste Pits
Channelview, TX
September 6 to 15, 2017

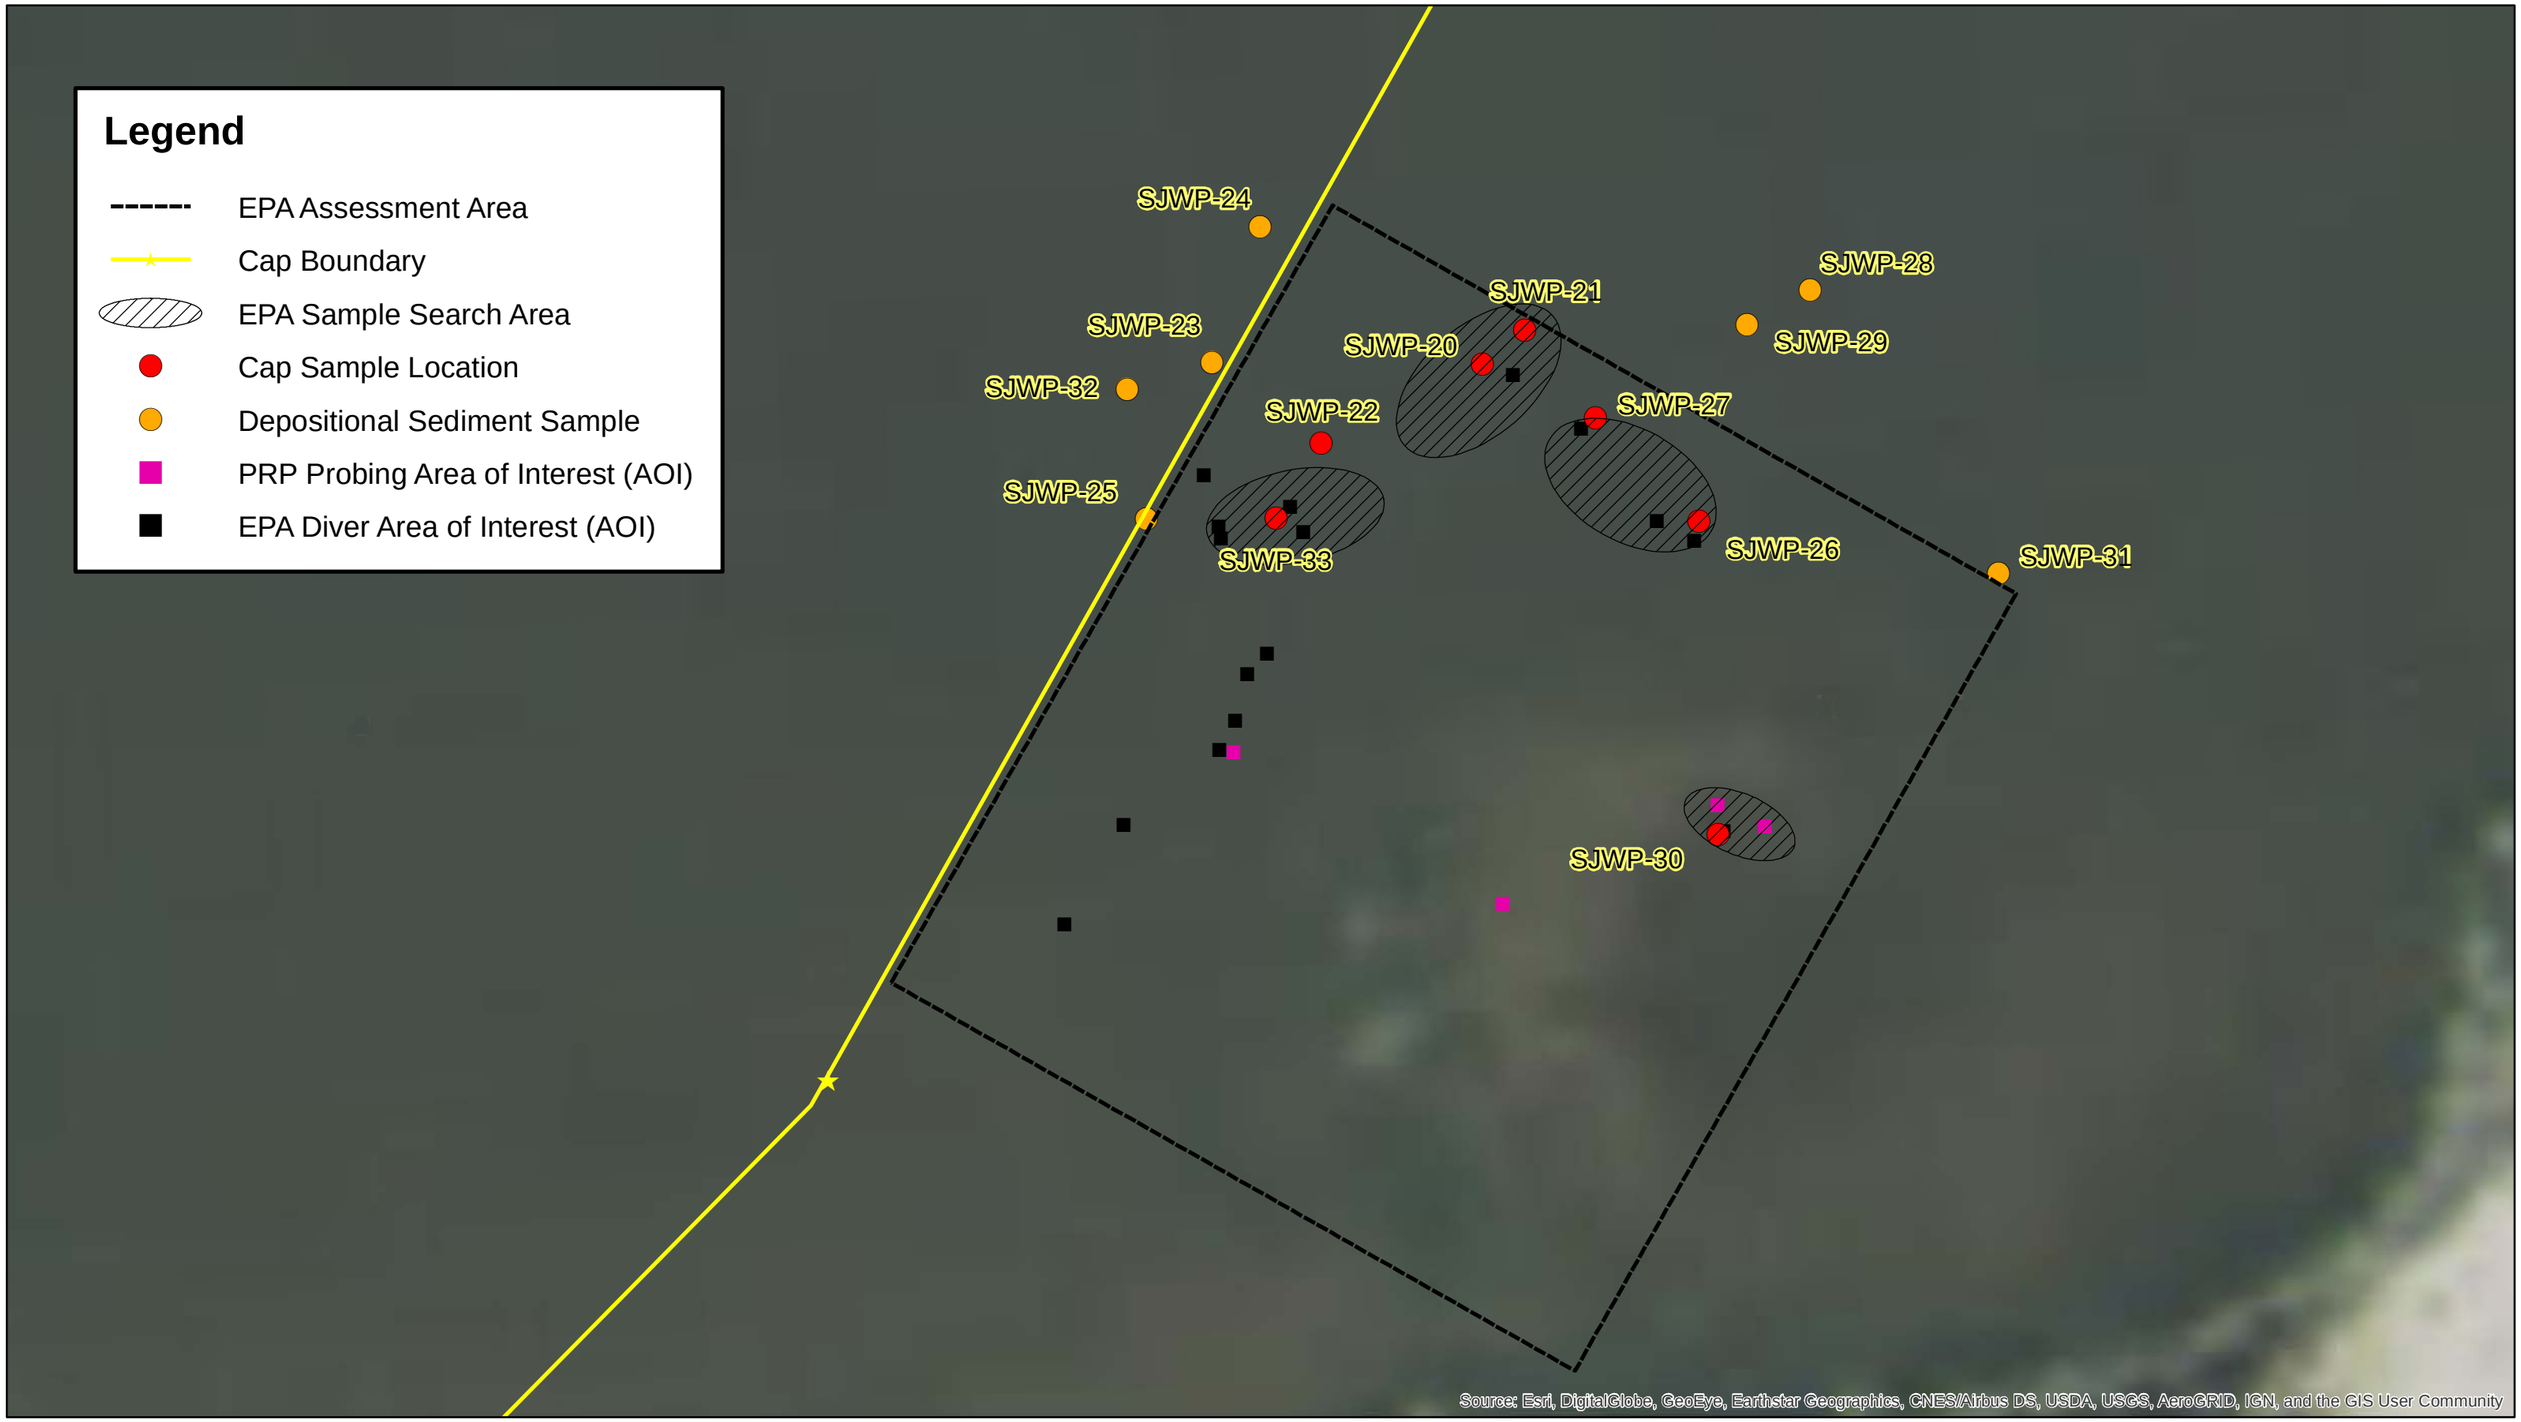
Figure 2
Probing and Diver Areas of Interest (AOI)
San Jacinto Waste Pits
Channelview, TX

For example, Sample #30 was taken from a larger area that had been identified several times throughout this project period. The PRP provided two Probing AOI points in this area, 146c and 146b, which were approximately 7 feet apart. On September 11th, a diver conducted a 10-foot circle search based on these Probing AOI and identified an area approximately 8 x 8 foot, which had intermittent areas of exposed sediment with no cap material underneath. Another diver, conducting a radial search through the same area on September 13th, also observed several gaps in the armor stone over a larger area. One of these gaps, a 2 x 2 foot area, was identified as an AOI for potential sampling as NE01. Based on the surface probing and diver observations made on September 11th and September 13th, the general area, as identified on Figure 2, became an EPA Sample Search Area. Areas, such as the one described above, with exposed or intermittently rock-covered sediments were targeted for sampling. EPA Diver AOIs and EPA Sample Search areas on summarized on Figure 2 and Table 3.

southeastern corner was on the shoreline and most of the water in that quadrant was very shallow, but the deeper sections of that quadrant were assessed during the dives made on the west and east corners. Figure 2 shows the EPA Assessment Areas along with the EPA Diver AOIs. Diver descriptions for these AOIs are summarized in Table 3. During this survey, the divers observed that both the top and slopes of the cap contained varying thicknesses and coverages (complete/intact, intermittent, none) of armor stone. If there were significant gaps in the cap, the diver chose a possible area for sampling and a GPS point was taken. If there were multiple gaps in a larger area, one GPS coordinate was taken to be a representative sample of that area. At the base of the slope and extending into the river, the armor stone was found to be intact with up to 4 feet of what assumed to be depositional material on top of it. The thickness of the overlying sediments tended to be the thinnest near the base of the slope and generally got thicker heading away from the slope.
