Facility Name ABANDONED
Building (B+W)

## ABANDONED BUILDING(B & W)

# B&W WELDING AND CONSTRUCTION
# SITE INVESTIGATION

Re: Site Inspection of B & W Welding and Construction
JN 117203
TWC 14-70020

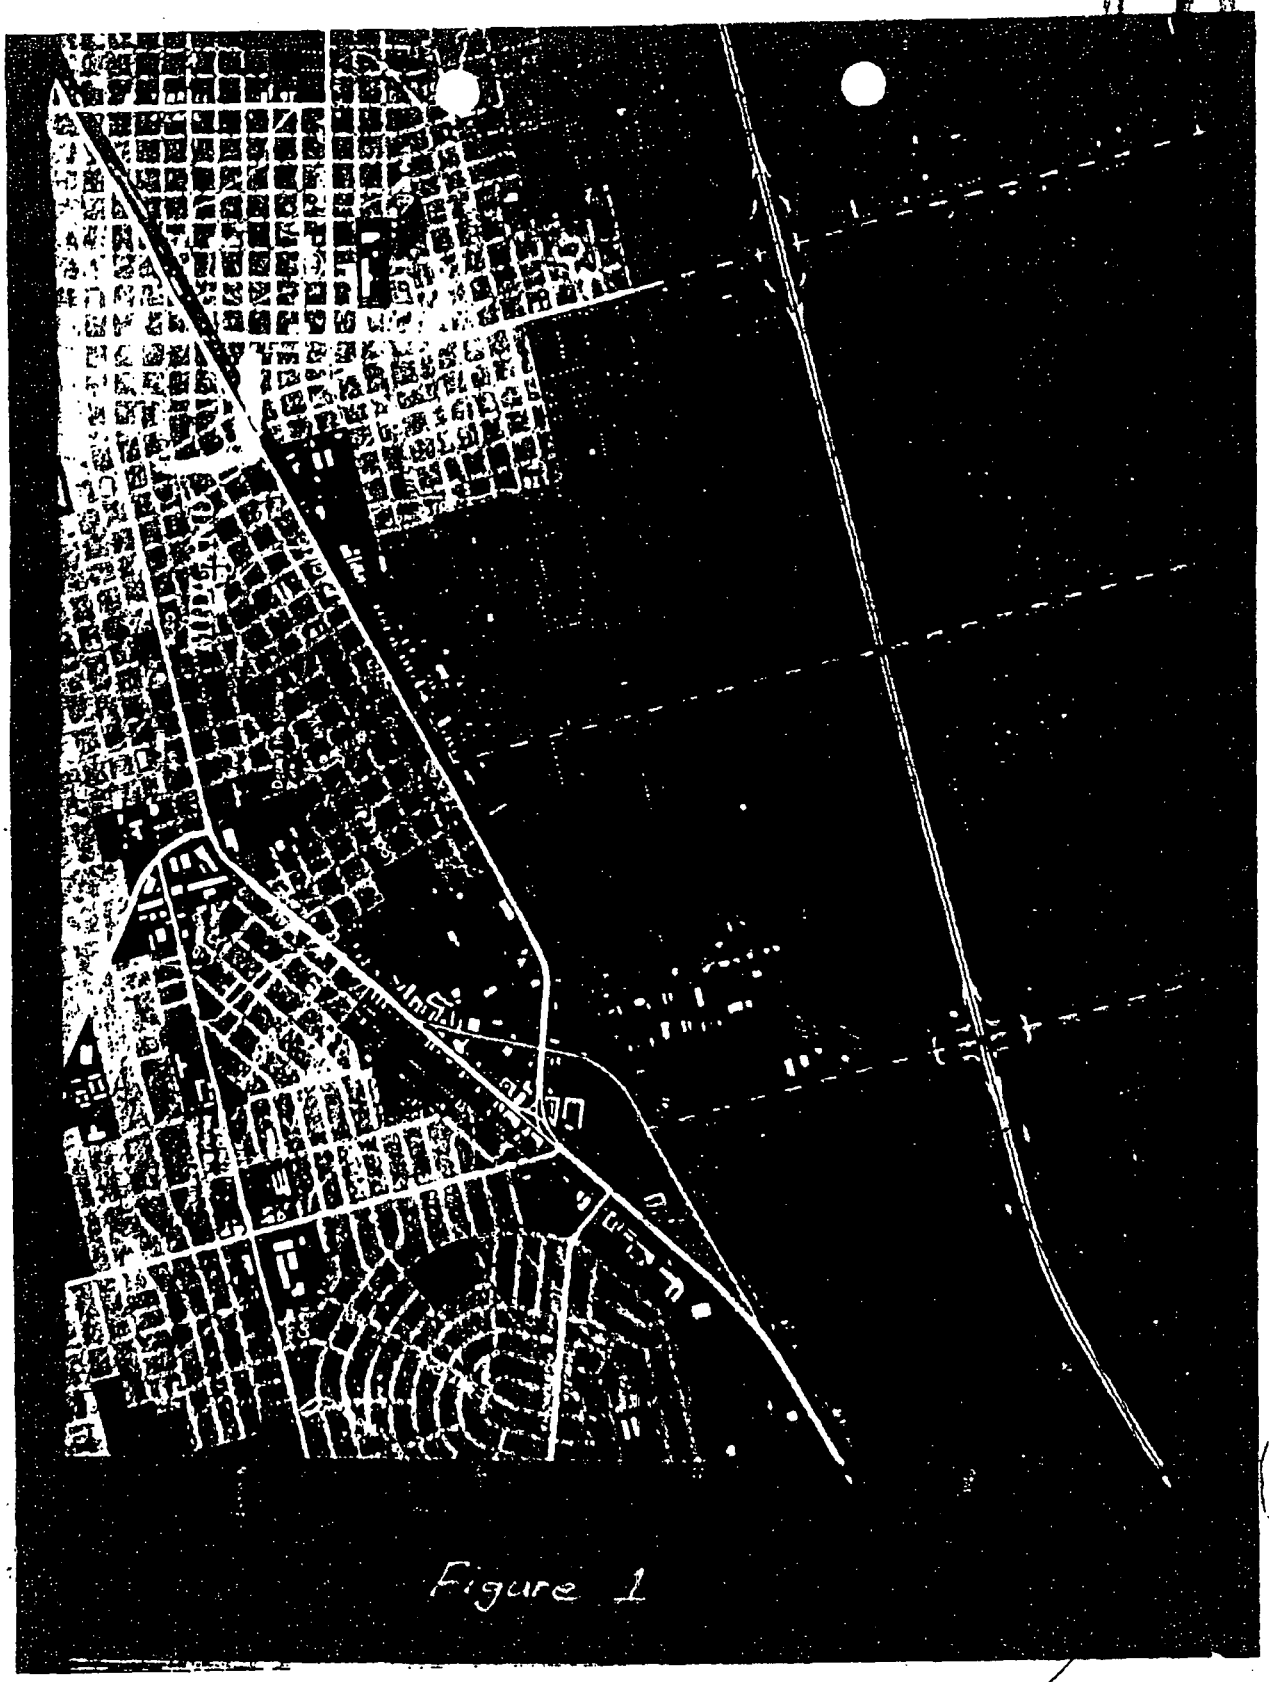
As shown in Figure 1, the contaminated well is on the edge of an industrial complex. Water depths and samples were taken from these water wells from an area to the west, around the north to the northeast. One well to the far southwest and another well to the east were sampled. All these wells were found to be clean. Figure 1 shows water table depths at the different wells as measured during the investigation. Figure 2 is a contour of water table elevations calculated using measured depths corrected for topography and indicates a slight hydraulic gradient to the west-northwest. This is directly opposite to the natural gradient but is possible due to drawdown of the water table caused by pumping of nearby wells.
