Field Report for Airborne Data Collected In Support of US EPA Region VI International Terminal Corporation Fire 17 March 2019

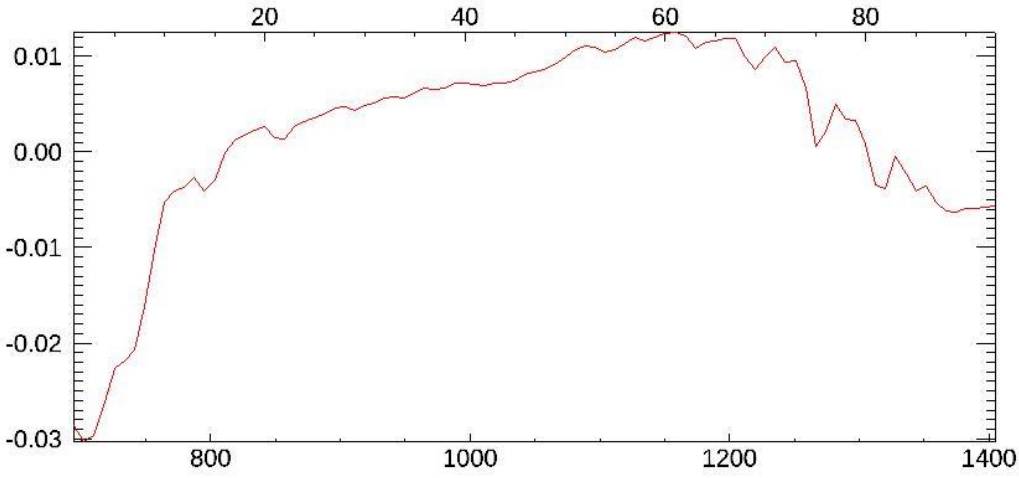
Figure 6: Acetone Spectra, Run 4, International Terminal Corporation Fire

Spectral examination of the fire indicated that this particular fire did not generated many detectable compounds. It should be stressed that while ASPECT can detect many compounds, normal and aromatic hydrocarbons are very difficult to detect passively due to the presence of CO_2 and water vapor. Figure 6 does show the present of very low levels of acetone which was observed the passes nearest the fire. The two peaks located at approximately 1250 and 1350 are the two primary peaks of acetone in the atmospheric window. The greatly elevated spectra is indicative of a hot radiometric environment. Consequently, the relatively low signal to noise ratio of the acetone detections indicate very low concentrations (less than 1 ppm). It is possible that this compound may be a feature of the urban air and not necessarily generated by the fire.

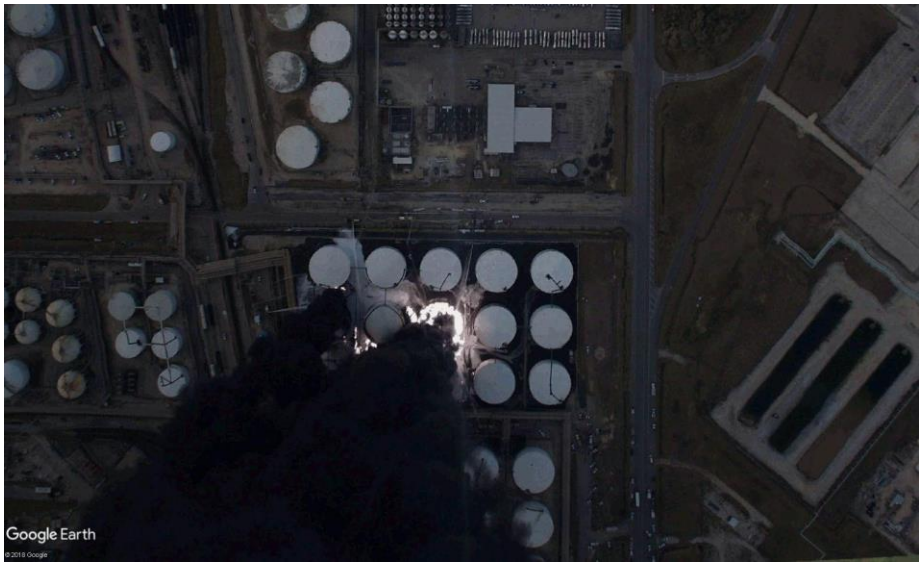
Figure 7: Aerial Image of the International Terminal Corporation Fire.

A full set of high resolution aerial digital photography were collected as part of the flight. Figure 7 shows a representative image collected as part of each pass. This image clearly shows the presence of fire in the center tank with additional fire surrounding the tank. The fire is generating a large amount of smoke which is rising nearly vertical. The low light conditions of the image are actually a result of the plume shading the area as the aircraft passed over the site.
