Field Report for Airborne Data Collected In Support of US EPA Region VI International Terminals Company LLC Fire 19 March 2019

Data Results Flight 3, 19 March 2019

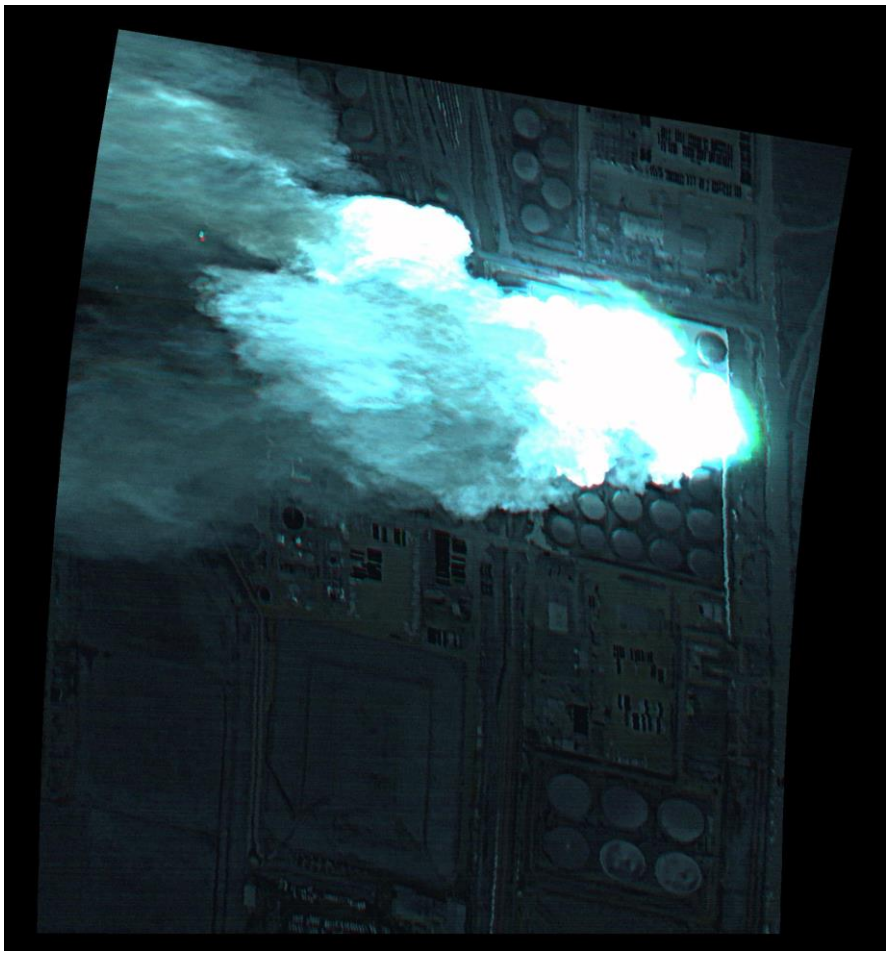
Figure 5: IR image ITC, 19 March 2019, Run 6

A total of 2 test and 8 data passes were made in the proximity of the site and an infrared line scanner images were generated for each pass. Figure 5 shows a typical 3-band infrared image obtained from data collected for Run 6. The overall thermal signature of the fire is very large. A qualitative analysis of the image indicates that the region of total saturation of the detector (white) is roughly 280 meters across (north to south) and about 600 meters in length. As with prior flights almost total obscuration of the ground signal is being masked by heat and/or particulates. Figure 6 shows a comparison of IR data collected on 18 March 2019 (left) and 19 March 2019 (right). The images are roughly scaled to the same size. It is evident that the magnitude of the fire on 19 March 2019 is measurably larger than on previous flights.
