EPA POTENTIAL HAZARDOUS WASTE SITE IDENTIFICATION AND PRELIMINARY ASSESSMENT

A. SITE NAME: Texas Electric Co-Op

RCRA 3012 PRELIMINARY ASSESSMENT COMMENTS
TEXAS ELECTRIC CO-OP
JASPER, TEXAS

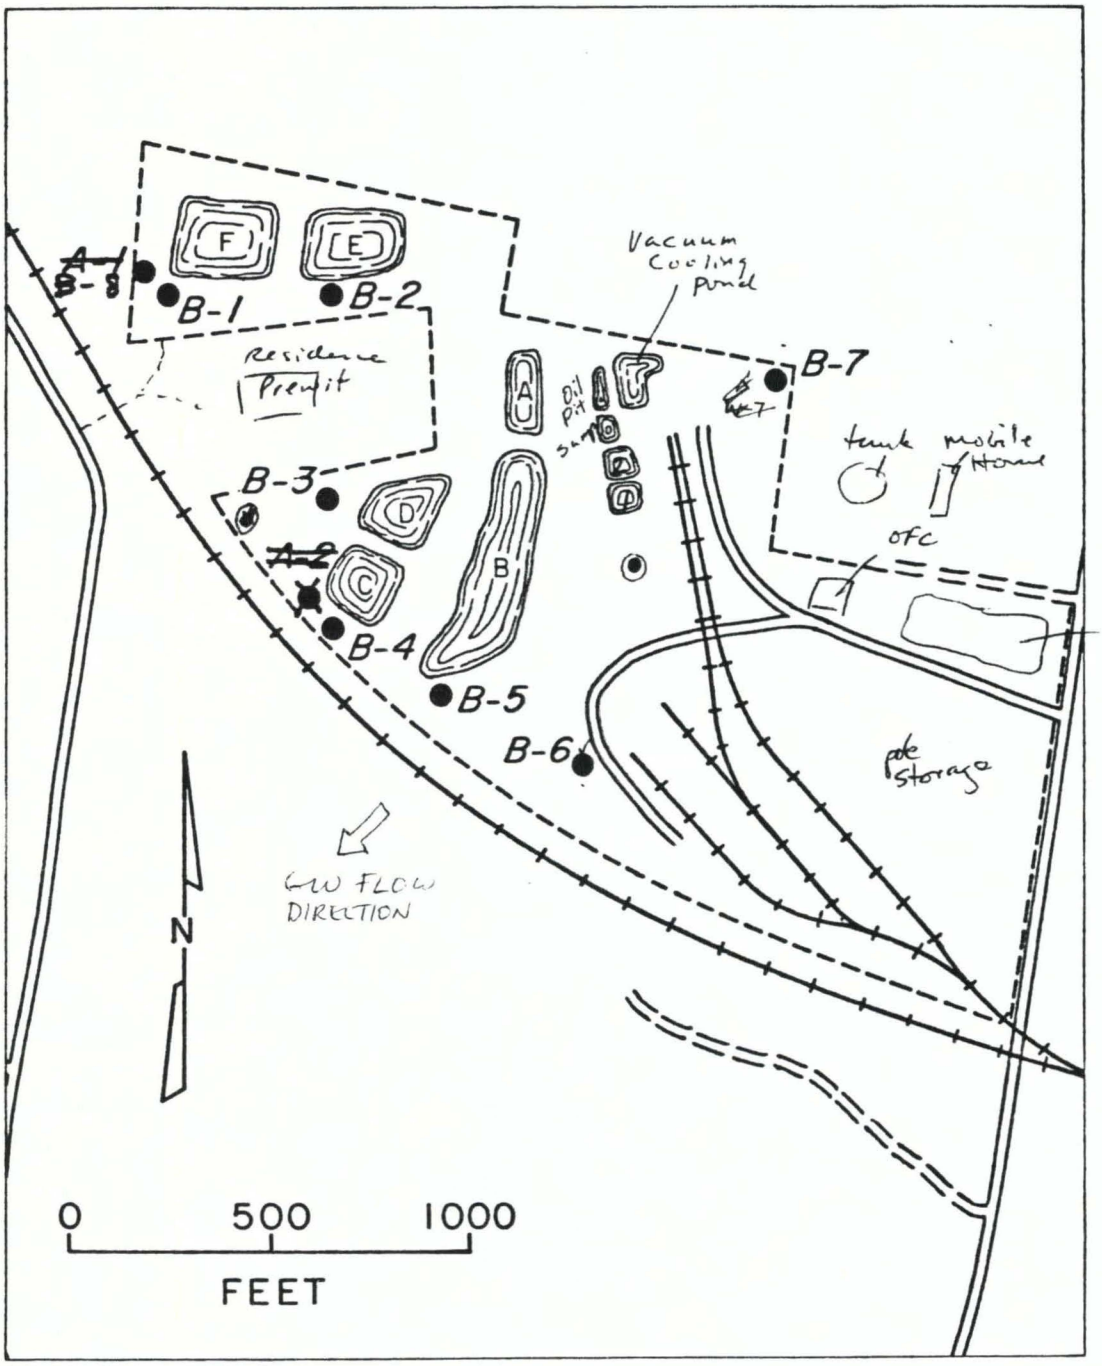
Figure 7. SUGGESTED LOCATIONS FOR MONITOR WELLS

~~A-1~~, B-1 MONITOR WELL NUMBER, LETTER INDICATES SAND IN WHICH WELL IS TO BE COMPLETED
