Airborne
Spectral
Photometric
Environmental
Collection
Technology

ASPECT Air Quality Survey after Hurricane Ida
Baton Rouge, LA
September 4, 2021

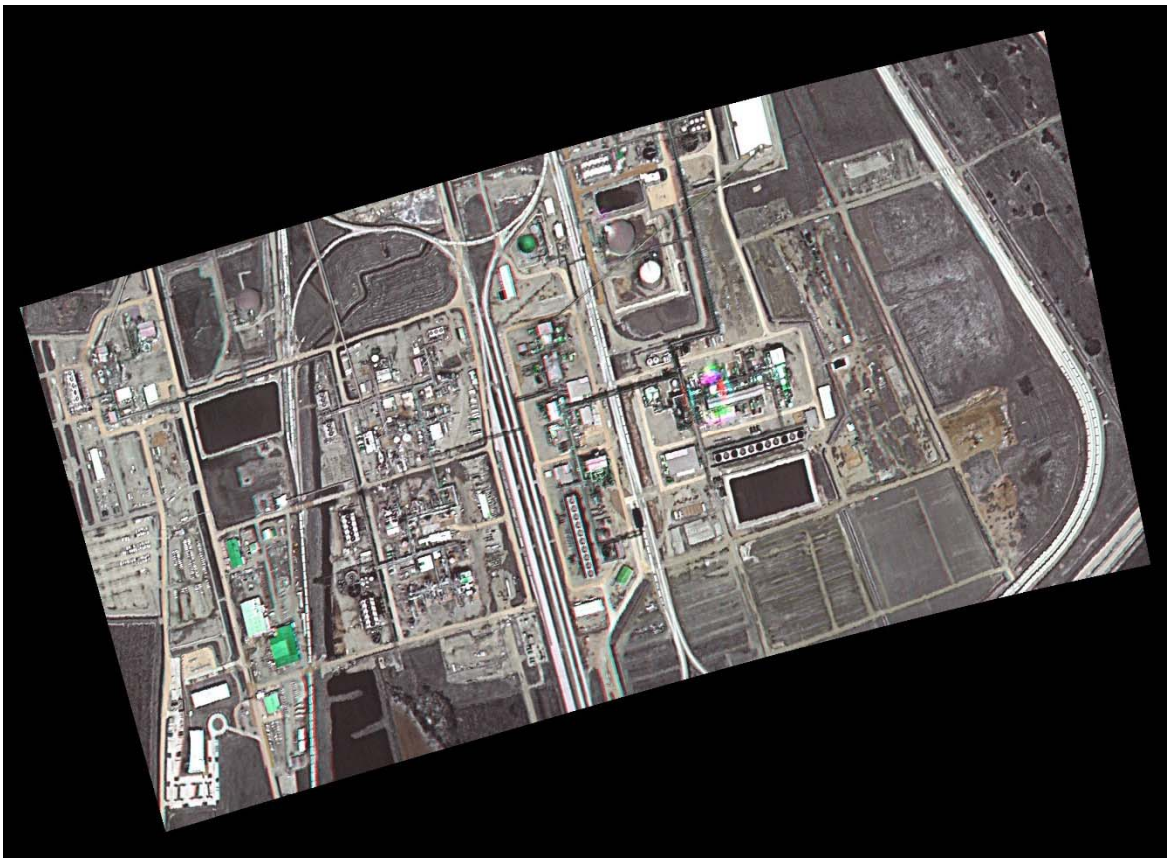
A total of 31 data collection runs were made over the target facilities and an infrared line scanner image was generated for each collection run. Figure 3 shows a 3-band infrared image collected over the CF Industries facility. Thermal analysis shows that many of the facilities are showing process units have some activity. The process unit located in the middle of Figure 3 indicates hot units and hot piping. Other than thermal, no chemical plumes can be observed being emitted from the facility. Figure 4 shows a similar image collected on Flight 6 over the Occidental Chemical facility.

Figure 3. Three band IR image, CF Industries in the Baton Rouge Area, Run 23, Flight 5, September 4, 2021

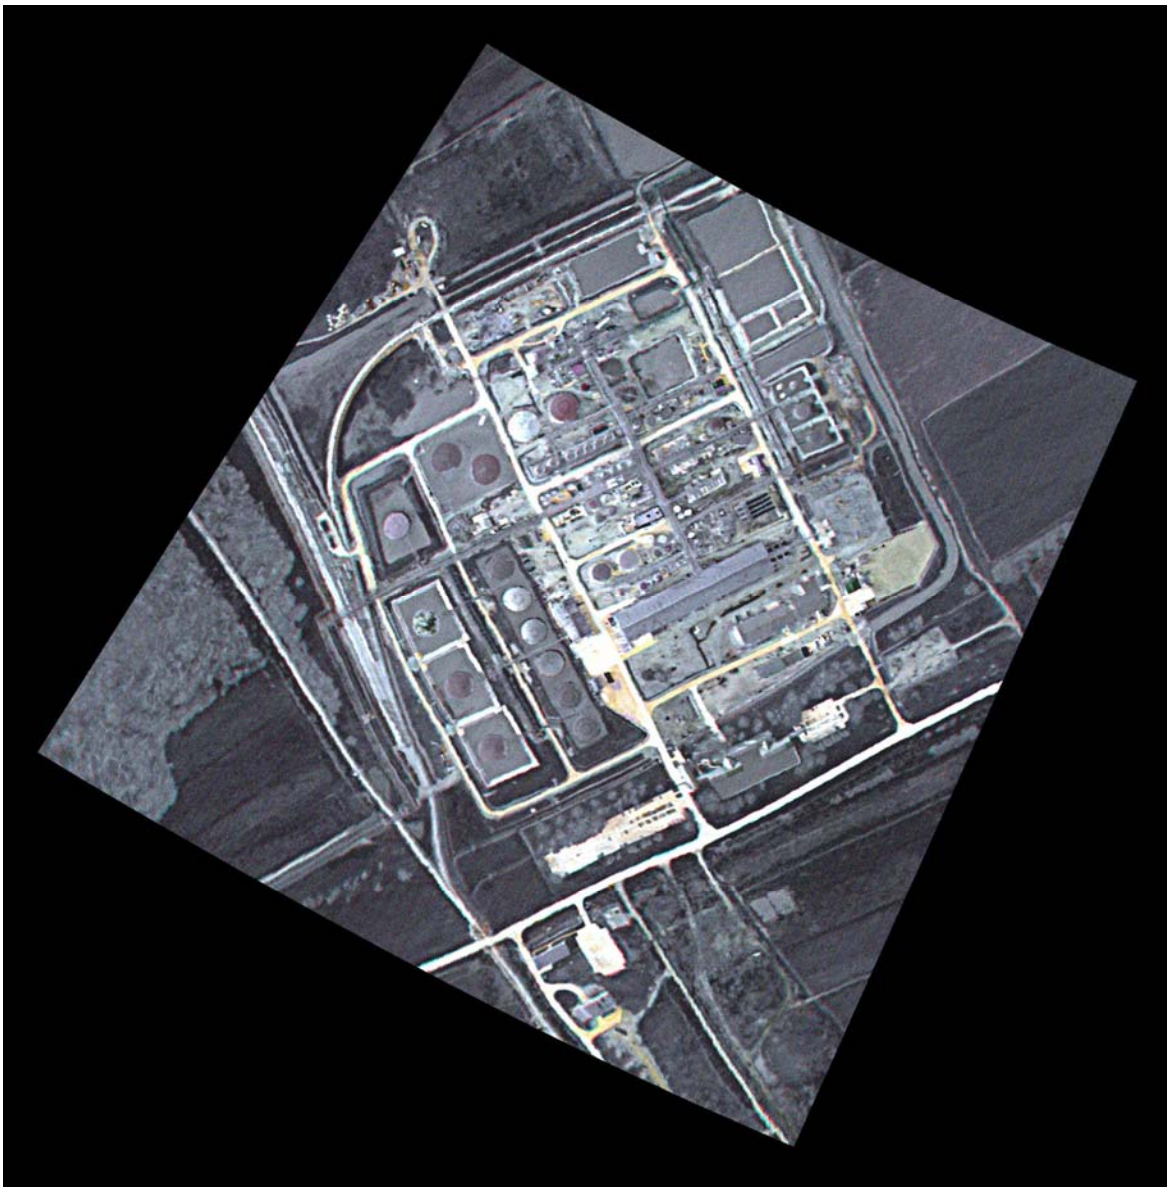
Figure 4. Three band IR image, Occidental Chemical Facility in the Baton Rouge Area, Run 5, Flight 6, September 4, 2021

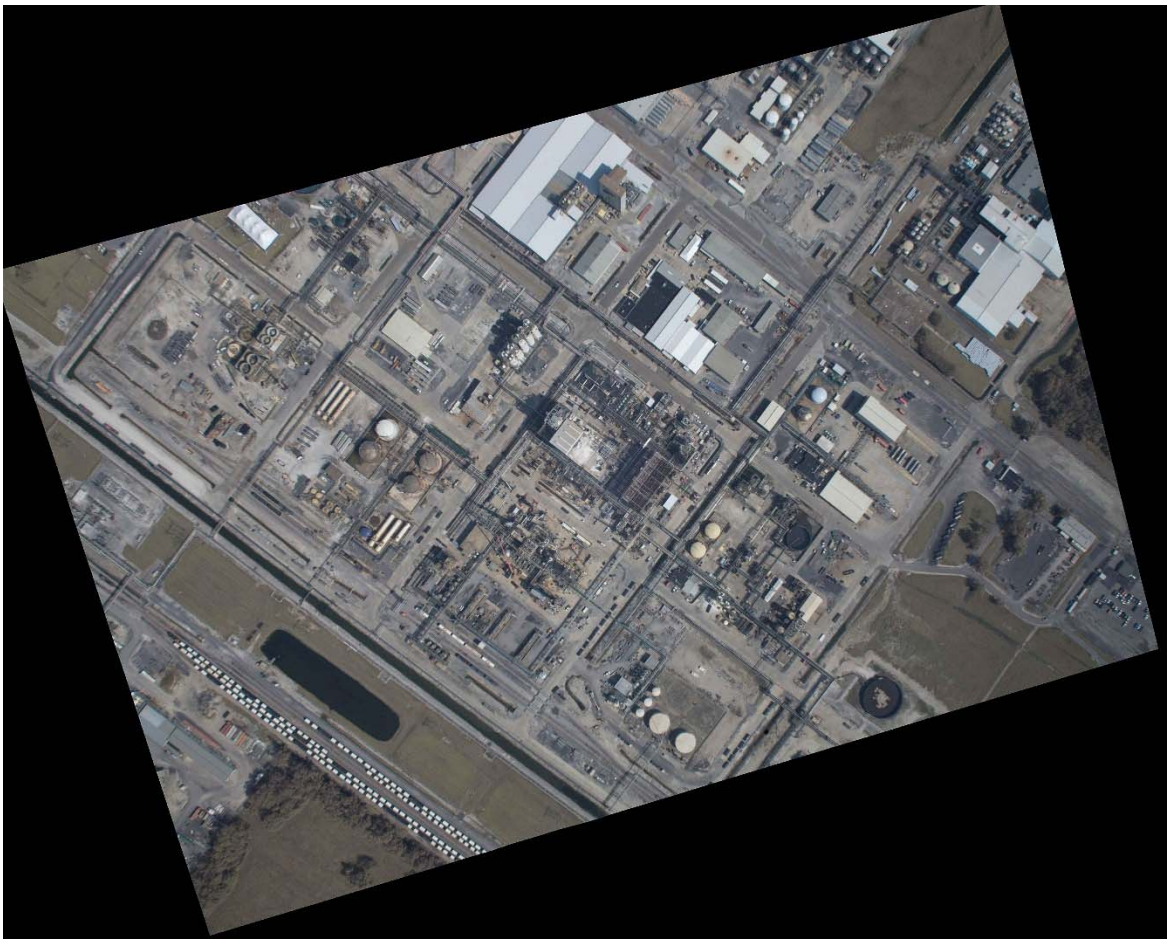
Figure 7. MSIC image of the Syngenta Crop Protection facility, Flight 5, September 4, 2021
