Airborne
Spectral
Photometric
Environmental
Collection
Technology

ASPECT Air Quality Survey after Hurricane Ida
Baton Rouge, LA
September 3, 2021

ASPECT Air Quality Survey
Hurricane IDA
Baton Rouge, LA
September 3 2021

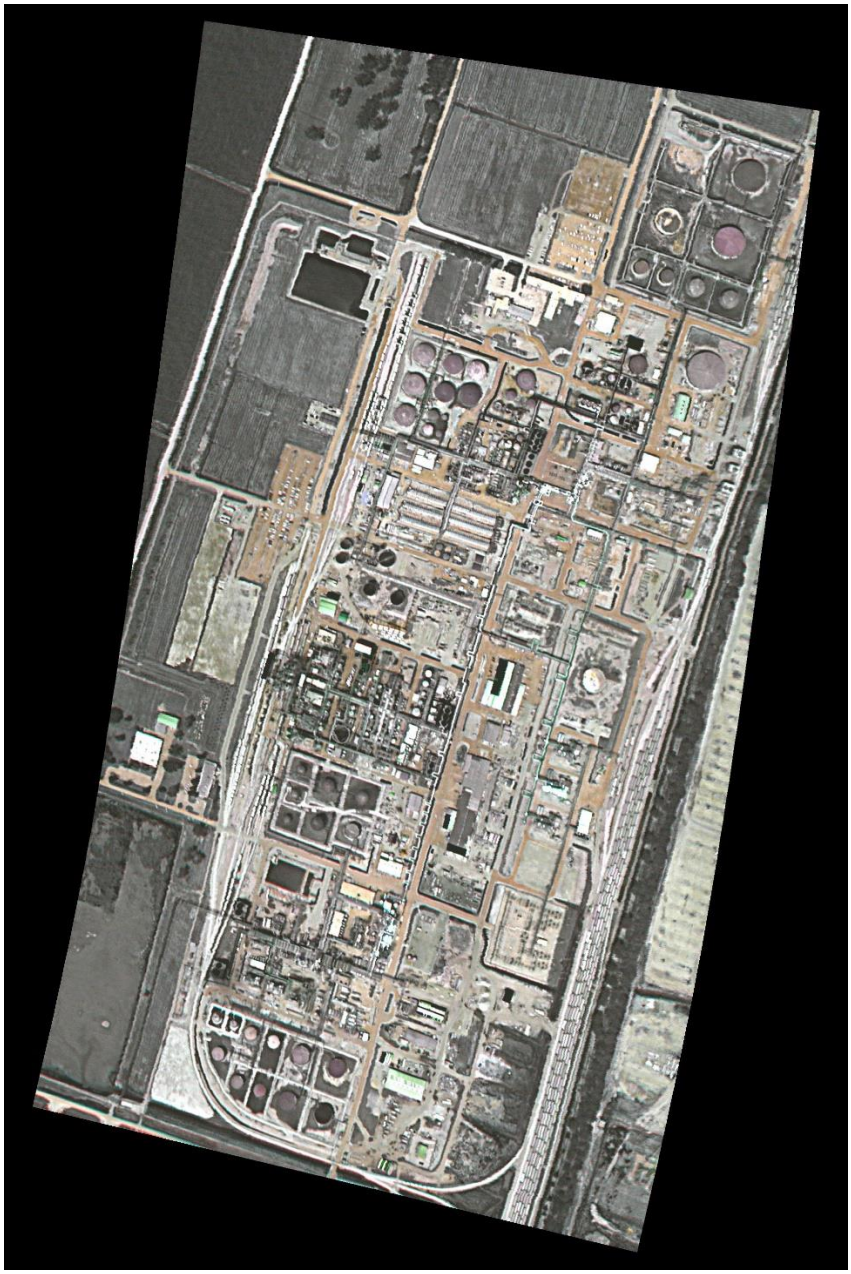
Figure 3. Three band IR image, Baton Rouge Area, Run 2, Flight 3, September 3, 2021

A total of 14 data collection runs (2 system checks and 12 data runs) were made over the Baton Rouge area and during each collection run an infrared line scanner image was generated. Figure 3 shows a 3-band infrared image collected over a facility collected as part of Flight 3. Minimum elevated thermal information is present in the image indicating little activity at the facility. Figure 4 shows a similar image collected on Flight 4 with flare signatures present on the northern portion of the facility. No chemical plumes can be observed being emitted from the facility.
