SUBJECT: Addendum to Hazardous Waste Site Inspection Report

SUBJECT: Hazardous Waste Site Inspection Report

POTENTIAL HAZARDOUS WASTE SITE
SITE INSPECTION REPORT

A. SITE NAME: EXXON CO. USA Baton Rouge Refinery

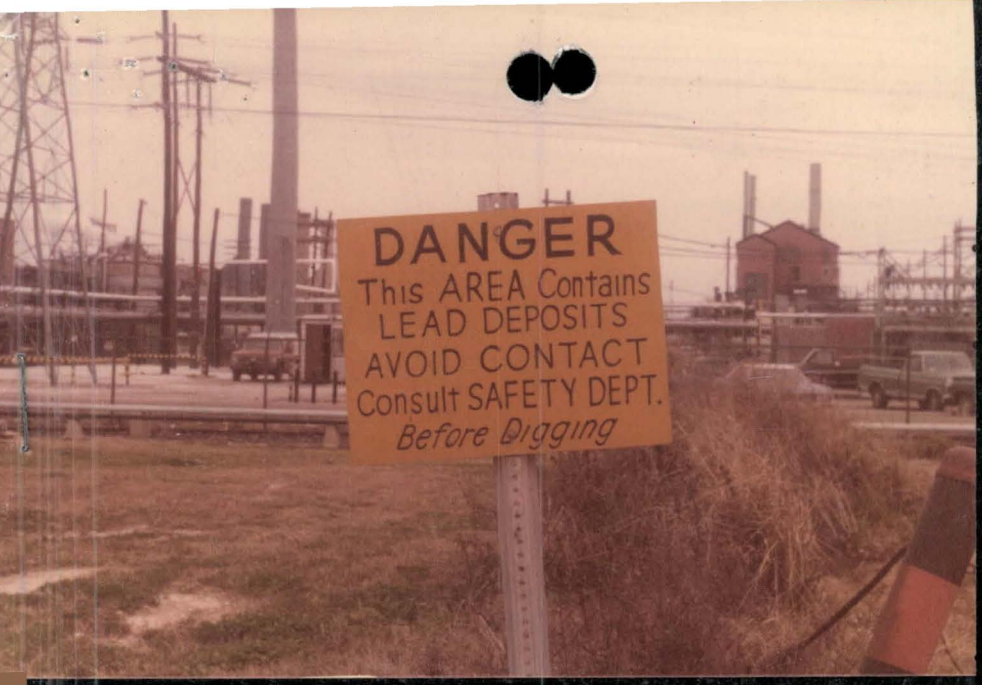
SUBJECT: North Bathure hand fill
LOCATION: north side MAP #⑥
EXXON USA
CITY: Baton Rouge COUNTY: E.B. Rouge STATE: LA
DATE: 2/14/80 TIME: 1034
WEATHER: [SUN] [HAZE] [CLOUDY] [RAIN] [SNOW]
PHOTOGRAPHER (Sig.) B.J. Pritchard
WITNESS: Richard Gigger
CAMERA: Vivitar
FILM TYPE: C135-24 ASA: 100 T: 1/500 f: 8
NEGATIVE LOCATION: GASAH FILE #:
PROCESSED BY: Fox Photo
PHOTO #: 4 of 8
Mel

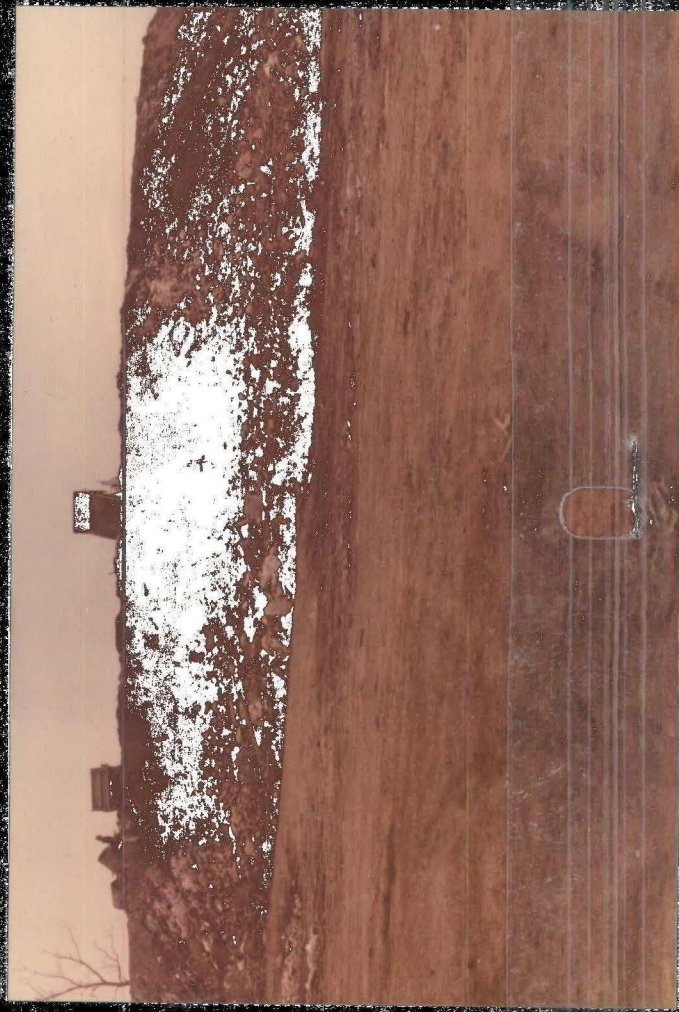
SUBJECT: North Batture Landfill
LOCATION: South Side MAP #6
EXXON USA
CITY: Baton Rouge COUNTY: E.B. Rouge STATE: LA
DATE: 2/14/80 TIME: 1034
WEATHER: [SUN] [HAZE] [CLOUDY] [RAIN] [SNOW]
PHOTOGRAPHER (Sig.) B.J. Ritchard
WITNESS: Richard Gigger
CAMERA: Vivitar
FILM TYPE: C135-24 ASA: 100 T: 1/500 f: 8
NEGATIVE LOCATION: GASAH FILE #:
PROCESSED BY: FOX Photo
PHOTO #: 5 of 8
Mel
