VELSICOL TX 4707

POTENTIAL HAZARDOUS WASTE SITE
SITE INSPECTION REPORT

A. SITE NAME: Mobil Chemical Co. Old Terphthalic Acid Plant
B. STREET (or other identifier): West Port Arthur Road
C. CITY: Nederland
D. STATE: TX
E. ZIP CODE: 77705
F. COUNTY NAME: Jefferson

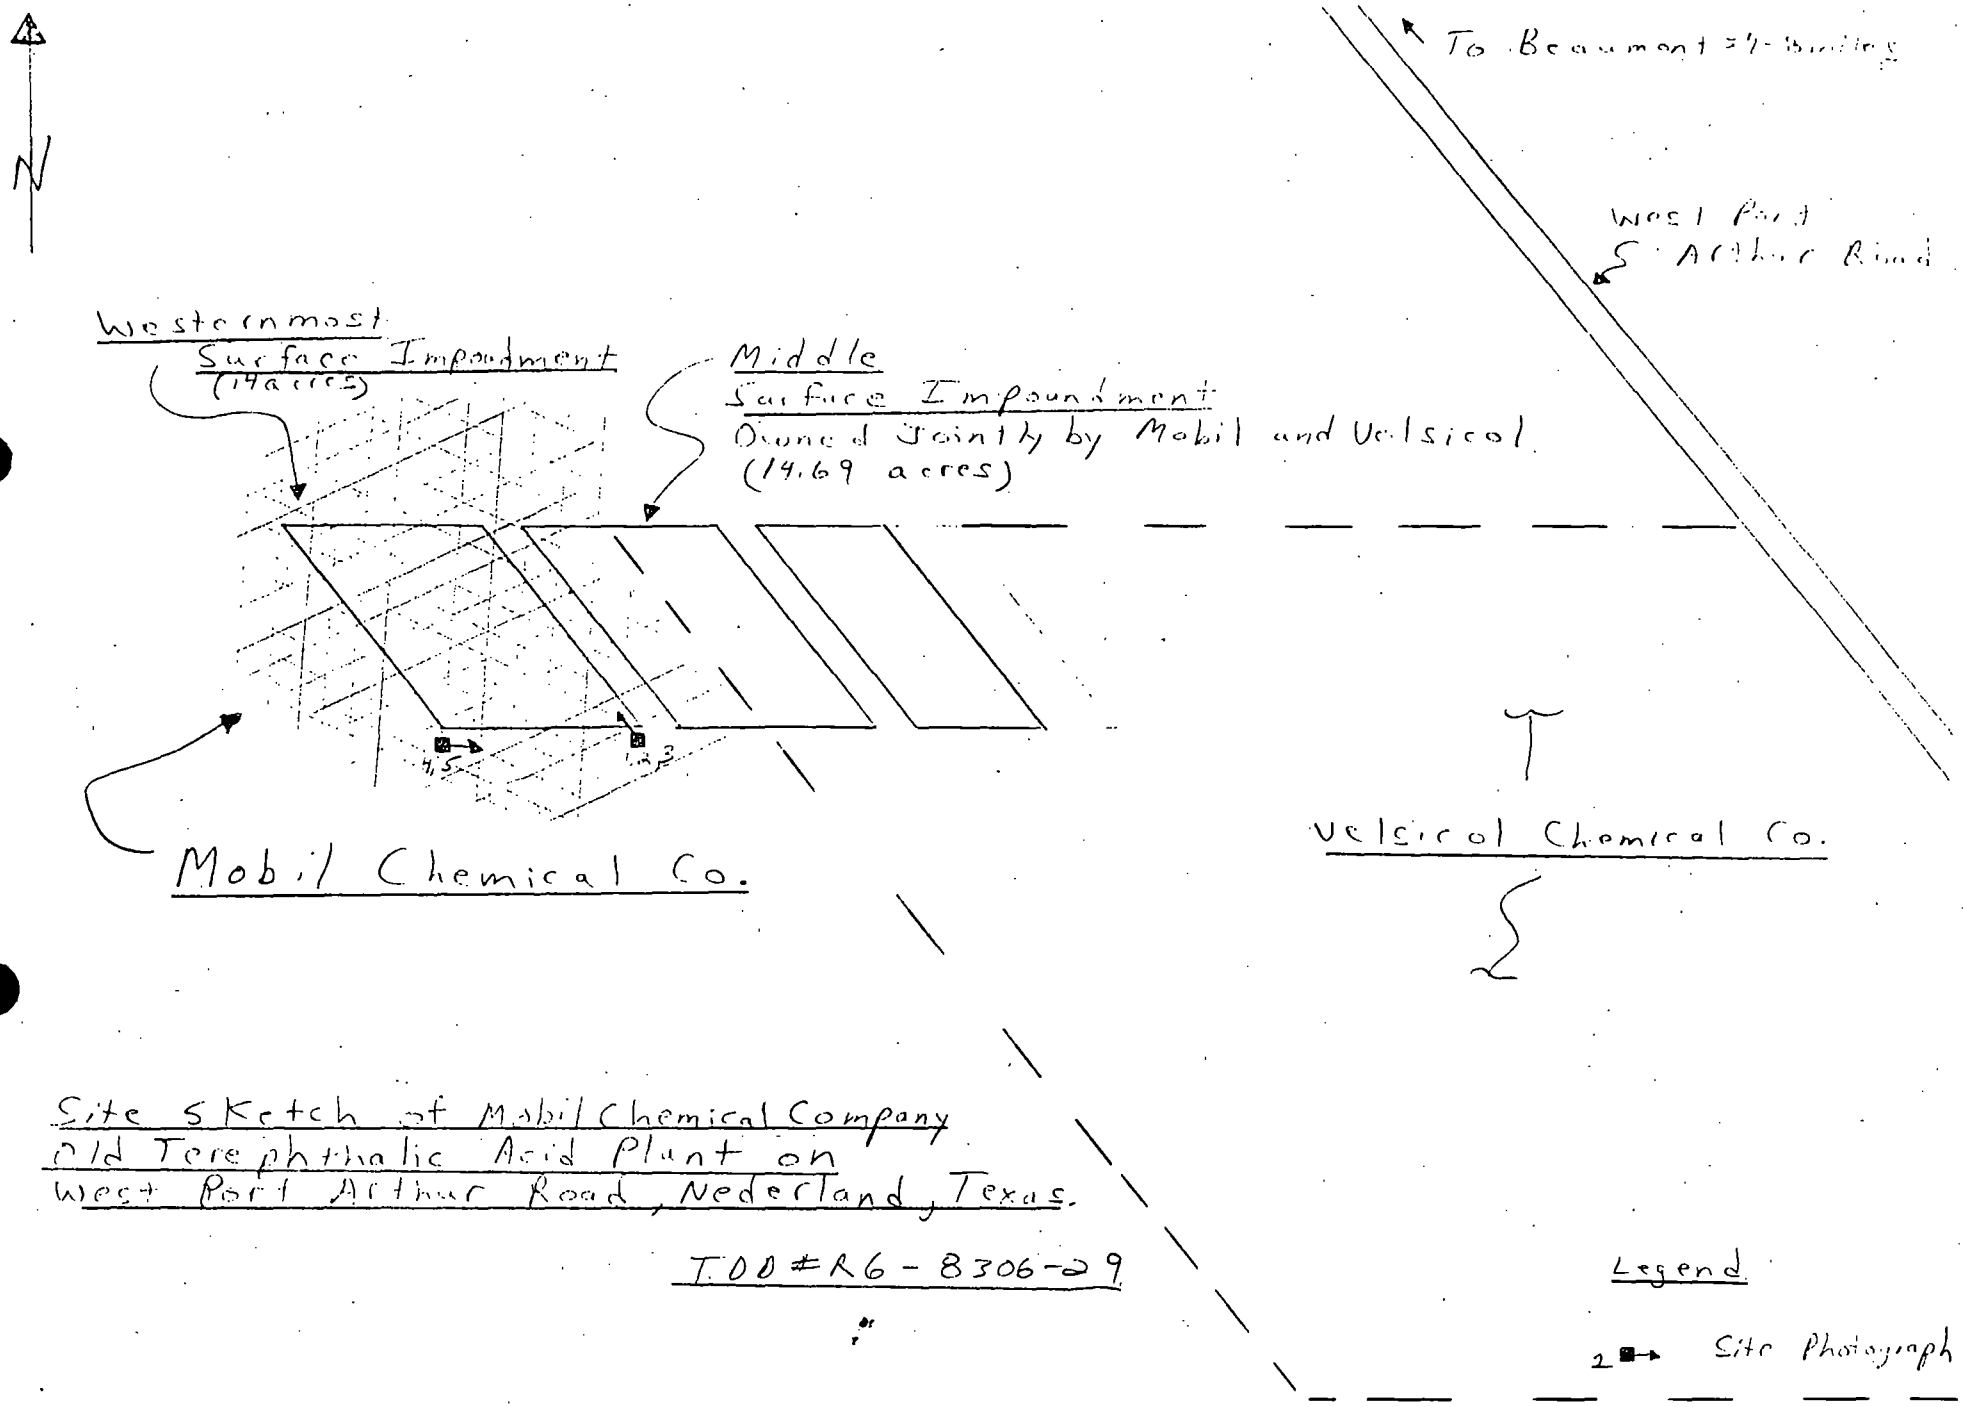
Site Sketch of Mobil Chemical Company
Old Terephthalic Acid Plant on
West Port Arthur Road, Nederland, Texas.

The middle impoundment (see sketch) is jointly owned by the Velsicol Chemical Corp. and Mobil Chemical Company. Potentially contaminated plant runoff water from the Velsicol Plant may enter the middle impoundment. Possible seepage from the impoundment may cause contamination of the surface waters in the area.

The westernmost impoundment is breached on theSE, SW & NW corners. The middle impoundment appears to be stable.
