POTENTIAL HAZARDOUS WASTE SITE
SITE INSPECTION REPORT

A. SITE NAME	B. STREET (or other identifier)		
Nipco, Inc.	2104 W. 42nd St. P.O. Box 1785		
C. CITY	**D. STATE**	**E. ZIP CODE**	**F. COUNTY NAME**
Odessa	TX	79760	Ector

Plating and coating operation (Nickel, Tin, Zinc)

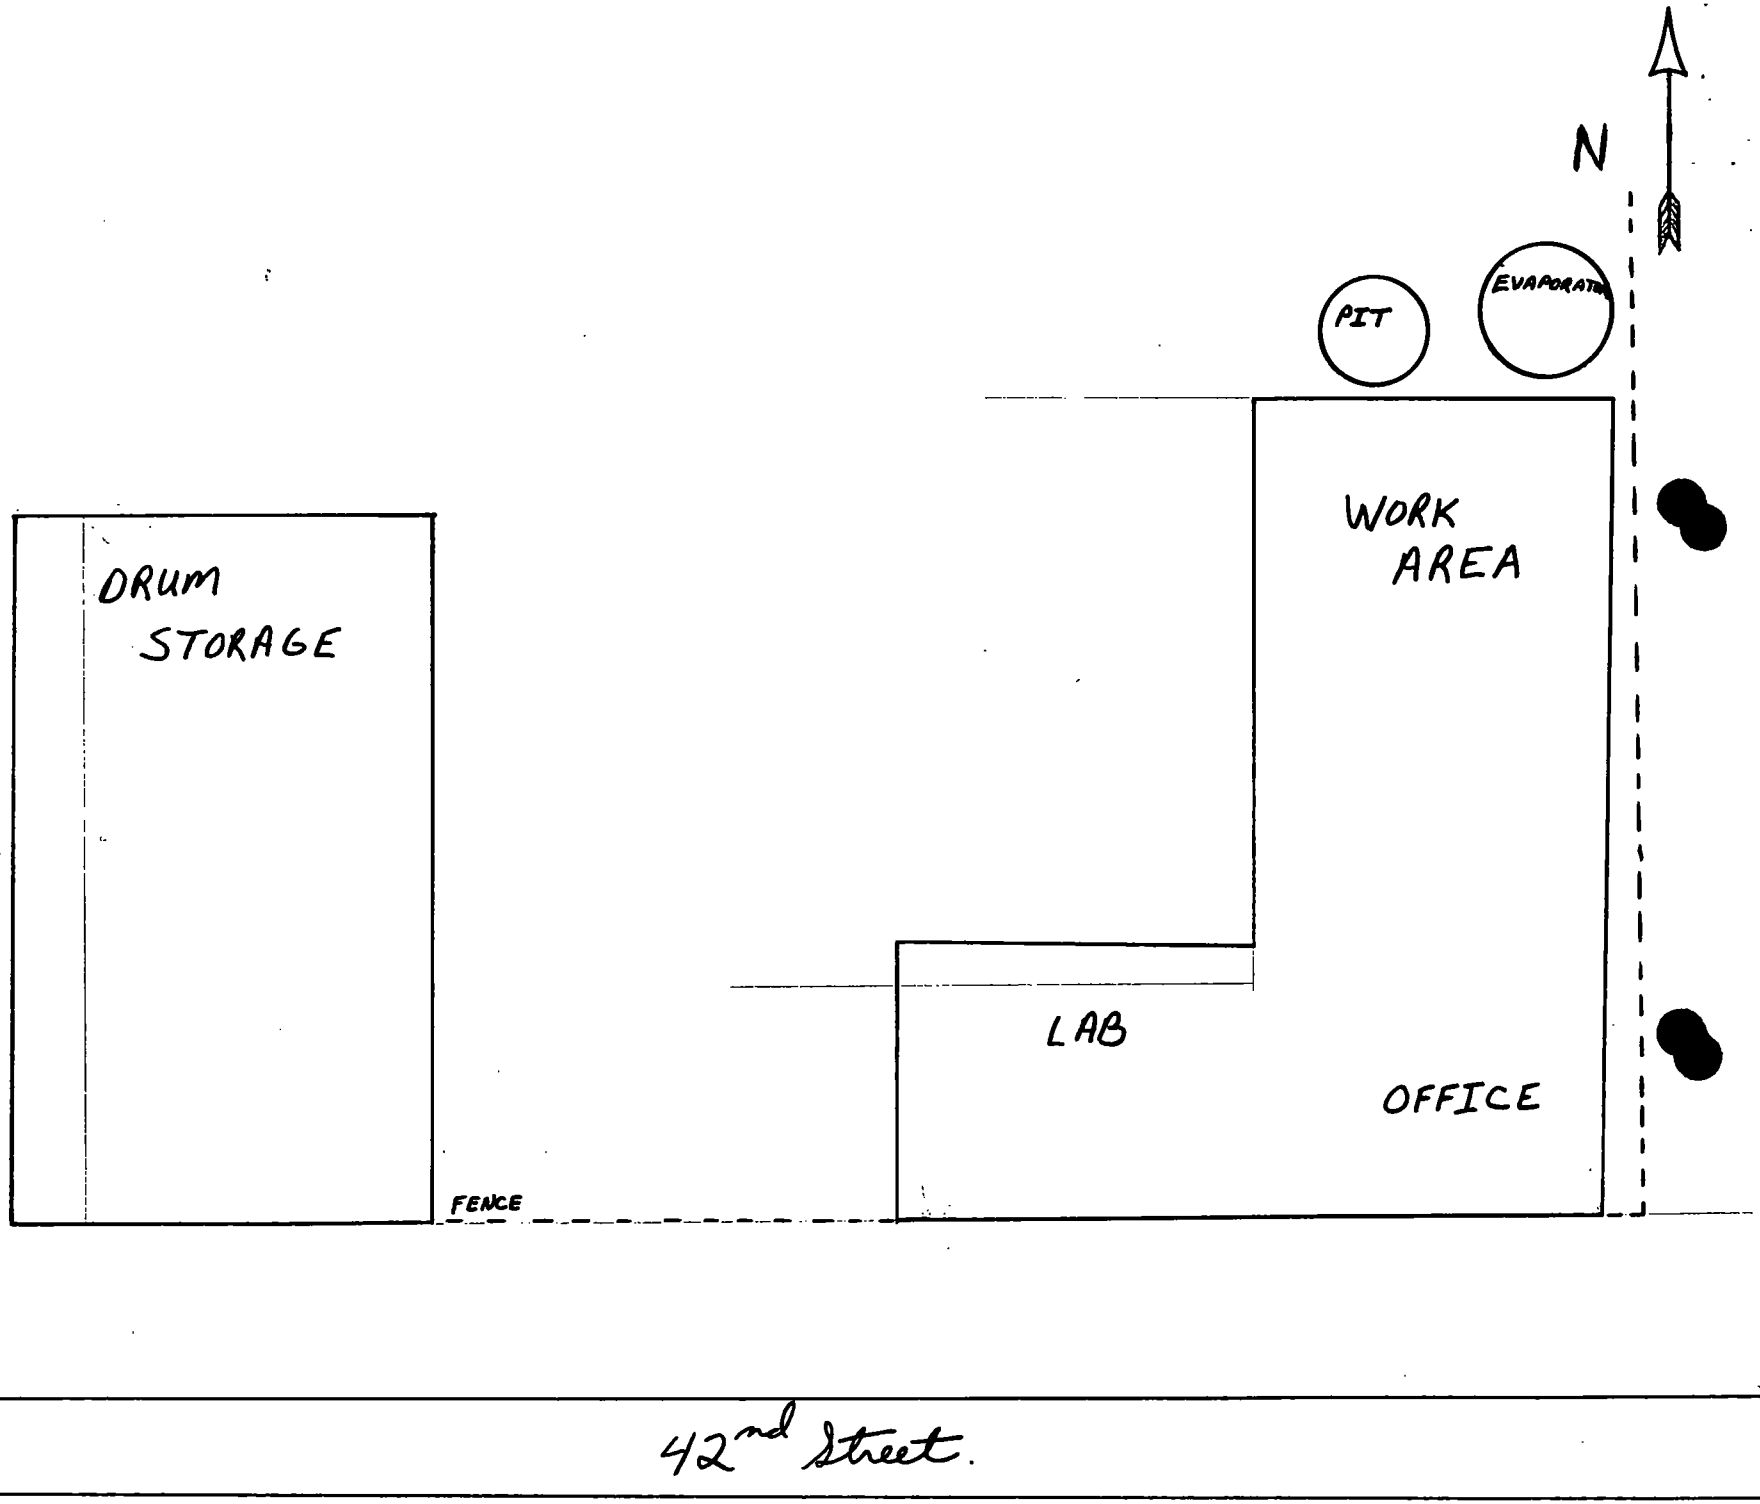
Attachment A

☒ U. OTHER (specify): Operations were started at present site in Dec, 1978. Factory was set up so that wash and rinse water ran into an unlined sump at the north end of the building. The sump was originally 4 to 6 feet deep. In 1979 TDWR inspectors found this set up unsatisfactory. In August of 1979, the swamp was dug out and a fiber-glass tank placed in the hole as a liner. This was to hold the water so that it could be recycled for usage in rinse water and cleaning of materials for plating (see attachment A). The nickel solution must be changed periodically. the two vats (one 400 gallons, the other 132 gallons) are emptied into barrels and hauled by the generator (NIPCO) to a BFI injection well. Since TDWR has been maintaining a yearly inspection schedule at this site, no further FIT/EPA action is recommended.

N
PIT
EVAPORATOR
WORK AREA
DRUM STORAGE
LAB
OFFICE
FENCE
42nd Street.
