Field Report for Airborne Data Collected In Support of US EPA Region VI TPC Fire 27 November 2019

Flight 1 -- 27 November 2019

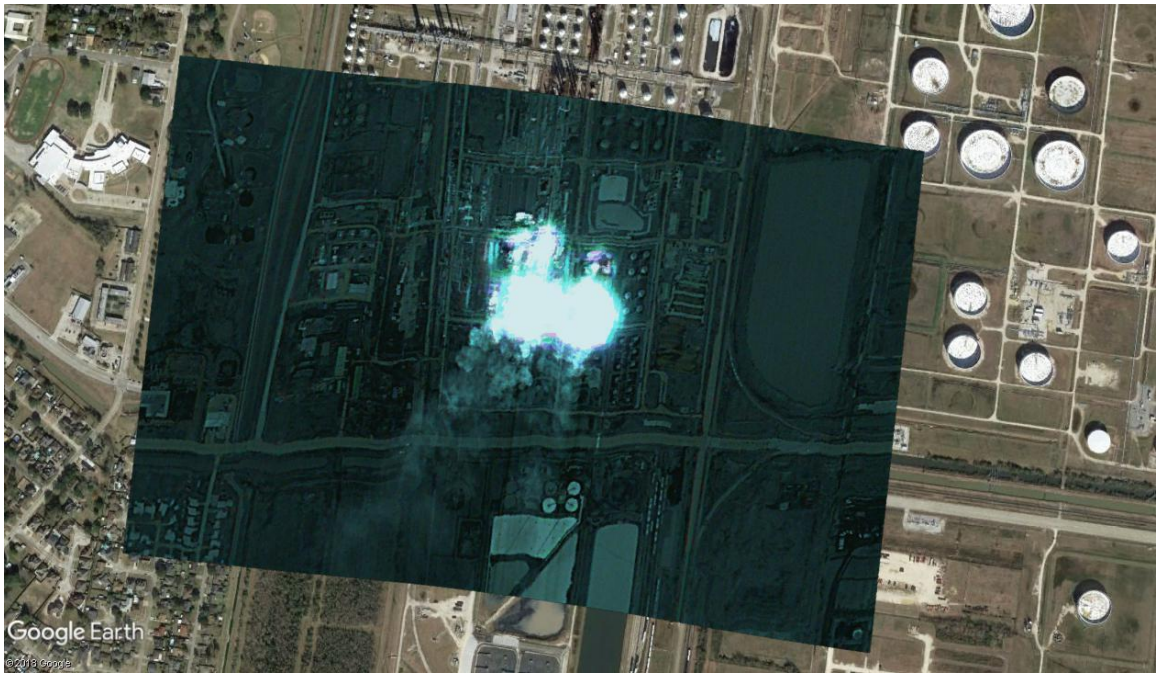
Figure 3: – 3 band IR image, Run 5, KMCO Fire, Pass 2

A total of 1 test and 11 data passes were made in the proximity of the fire and an infrared line scanner image was generated for each pass. Figure 3 shows a typical 3-band infrared image obtained from data collected for Run 2. This image was generated by flying approximately 100 meters downwind of the facility. The white area within the image is the hot signature of the fire. A thermal plume can be seen being emitted from the active fire location within the facility perimeter with no evidence of a chemical plume being generated by the fire.

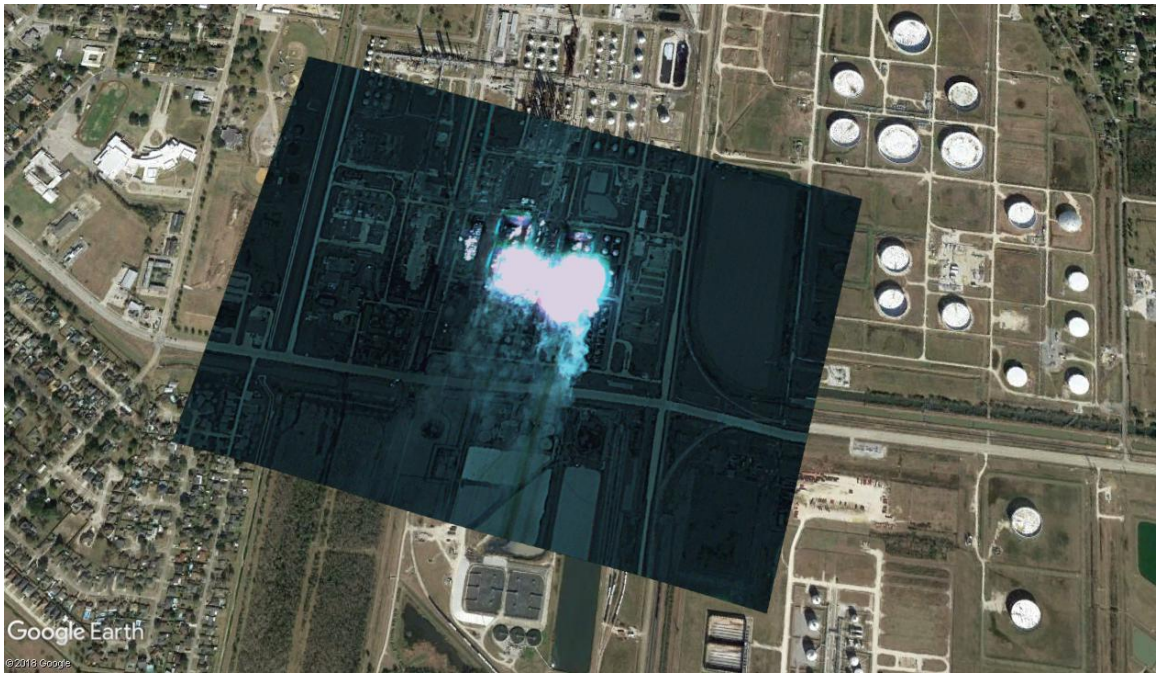
Figure 11: – 3 band IR image, TPC Group fire, Flight 3, Run 6

A total of 4 test and 3 data passes were made in the proximity of the fire and an infrared line scanner image was generated for each pass. Analysis of IR imagery generally shows consistency from early flights namely very intense heat within the field of view (figure 11).
