Project: San Jacinto River Waste Pits Superfund Site
Project #090557-01

Subject: Time Critical Removal Action Meeting Minutes
February 11, 2010, EPA Offices in Dallas, TX

San Jacinto River Superfund Site Time Critical Removal Action

DRAFT MEMORANDUM – FOR DISCUSSION PURPOSES ONLY

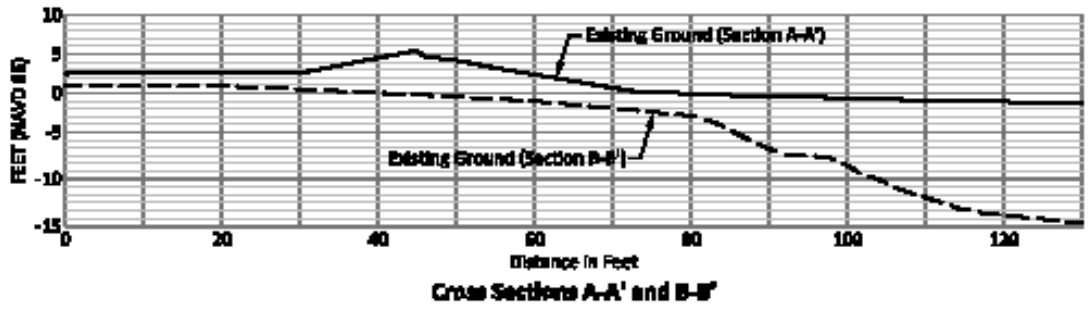
Cross Sections A-A’ and B-B’ Western Berm Stability

Figure 2 depicts cross sections A-A' and B-B' referred to on Figure 1. Section A-A' is taken through the western berm and shows the definite shape of the original berm that remains stable at a +6 foot (NAVD 88 datum). In addition a shallow buttress located at the base of the berm is present, which provides resistance against instability.

Section B-B' is taken through the location of the historic northwestern berm and is also shown on Figure 2. As can be seen, the undermining has caused the berm to fail and flow to a more stable angle of repose. The slope appears stable now, but the definite shape of the original berm (as seen is A-A') is gone. In fact, as a result of the dredging, areas of the original waste impoundment that were at or above sea level along this shoreline are now at -16 feet (NAVD 88 datum). Important features of the impoundment that were evaluated in the development of the TCRA design elements include the following:
