POTENTIAL HAZARDOUS WASTE SITE
SITE INSPECTION REPORT

REGION	SITE NUMBER (to be assigned by Hq)
6	TX 10448

TXD 000778 621

A. SITE NAME	B. STREET (or other identifier)		
Centralized Tie Plant	Hwy 36		
C. CITY	**D. STATE**	**E. ZIP CODE**	**F. COUNTY NAME**
Somerville, TX	TX	77879	Burleson

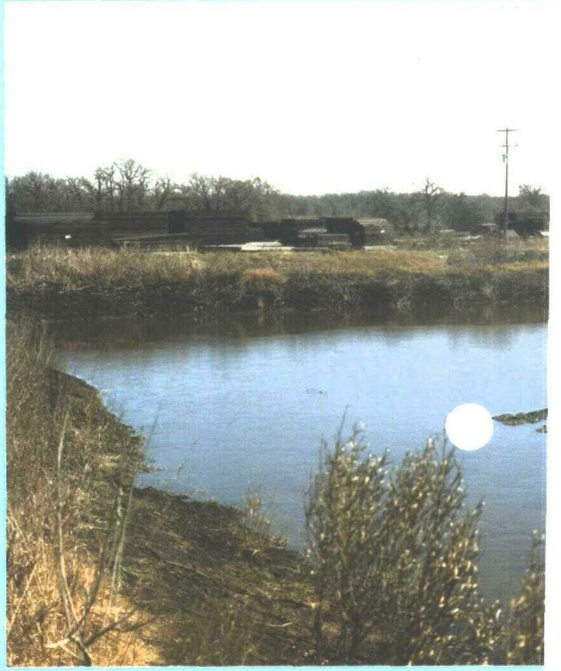
PHOTOS # 12-14

Lagoon D: Creosote Oil (Sludge)

Excellent

INACTIVE WASTE LAGOON FOR CREOSOTE CONTAMINATED WASTE. (LABELED D ON SITE MAP.)
