TARGETED BROWNFIELDS ASSESSMENT (TBA)
PHASE II ENVIRONMENTAL SITE ASSESSMENT (ESA)

Tulsa Club Building TBA Site

115 East Fifth Street
Tulsa, Tulsa County, Oklahoma 74103

JANUARY 14, 2015

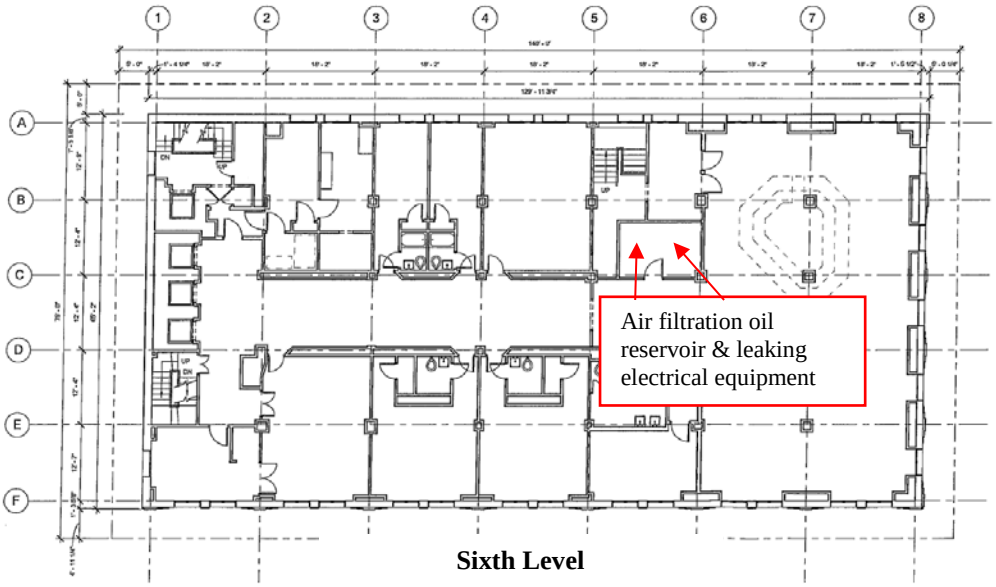
Sixth Level

A total of six (6) PCB wipe samples were collected from oils associated with leaking electrical equipment observed within the building. Two (2) samples were collected on the sixth floor, one (1) on the seventh, and one (1) on the eighth, all from electrical equipment associated with vintage air filtration systems. Additionally, two (2) samples were collected adjacent to leaks in the elevator mechanical room on the thirteenth floor.

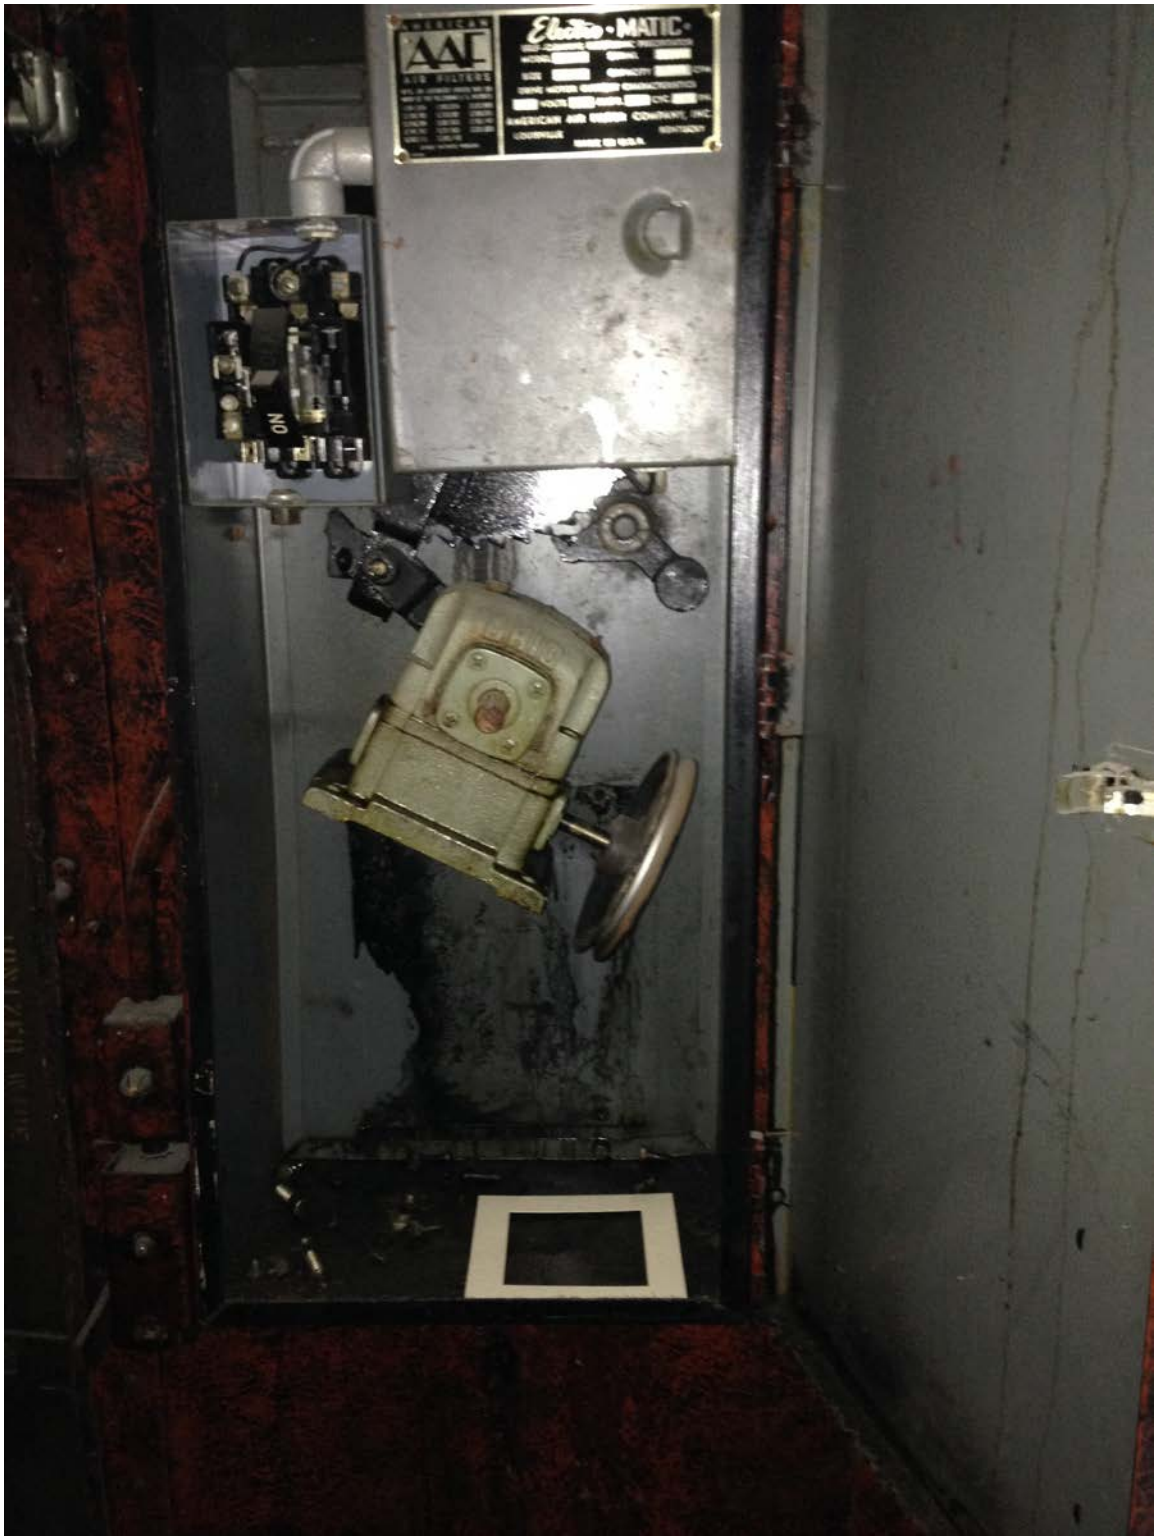
Photograph 4. Sampling location below leaking electrical motor on the 8th floor.

Photograph 5. Close view of the 8th floor sample location.

Photograph 6. Sampling location near leaking electrical equipment in the elevator mechanical room.

Photograph 7. Close view after sampling in the elevator mechanical room.

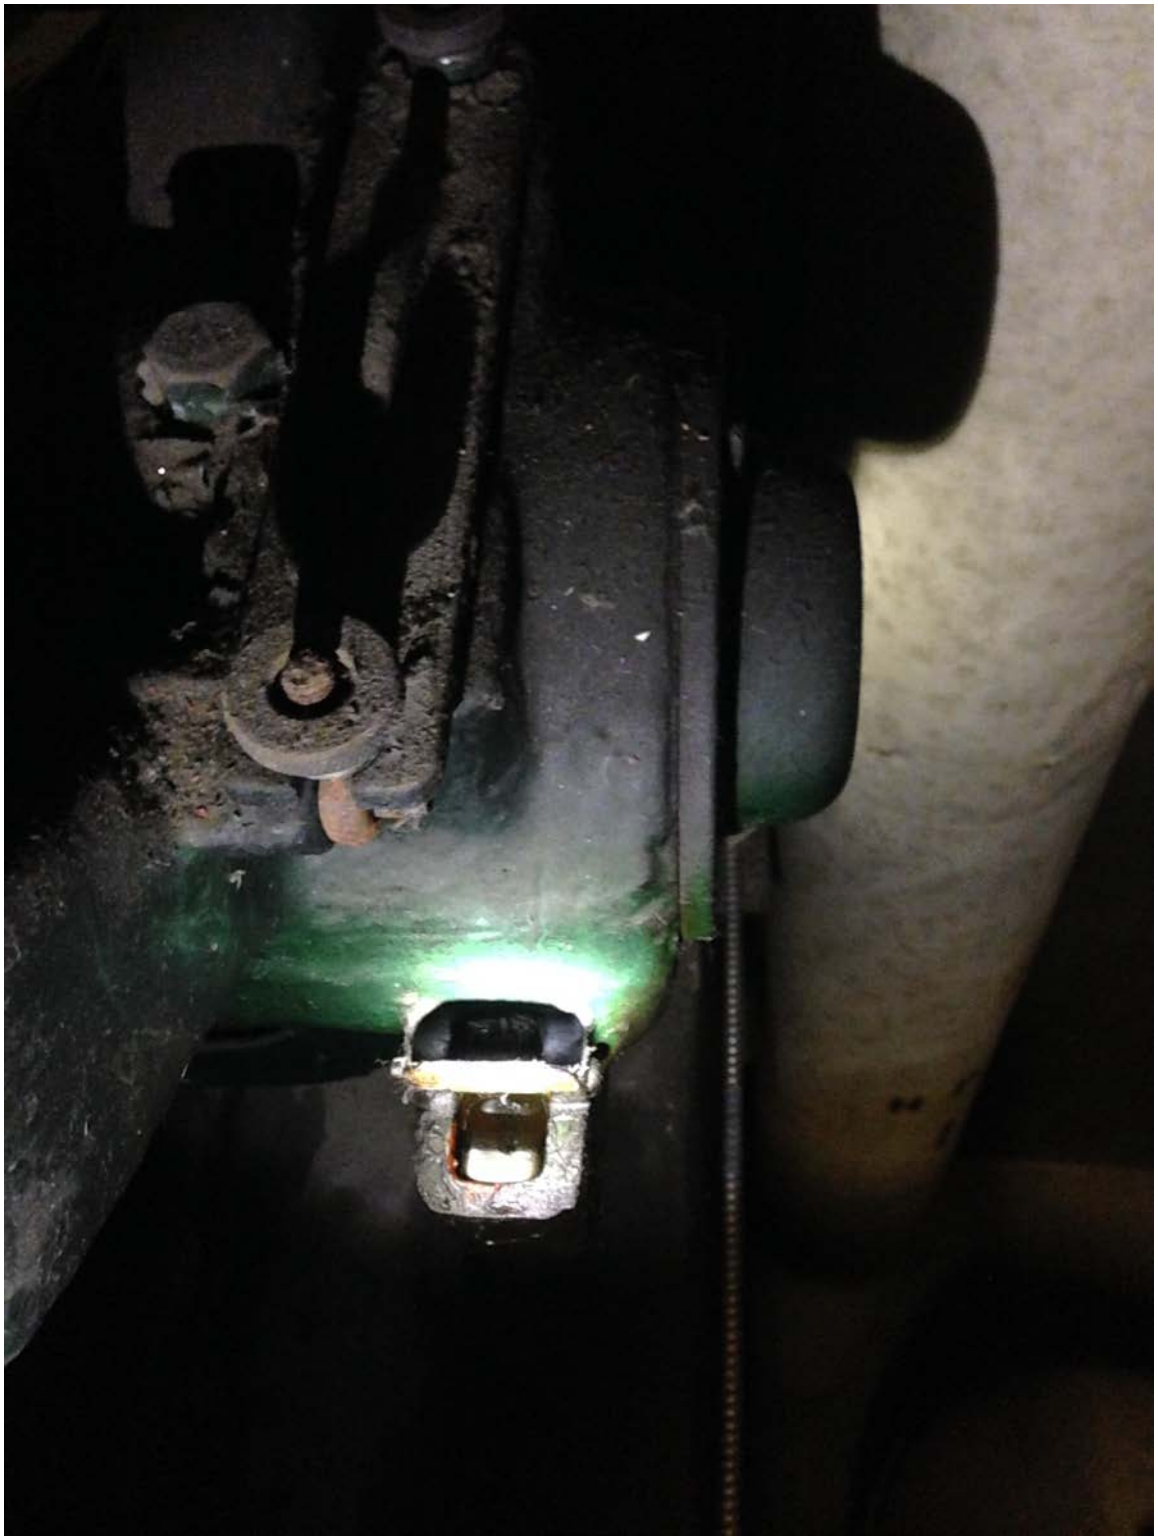
Photograph 8. Small reservoir on motor in the elevator mechanical room.

Photograph 9. Leaking electrical equipment in the elevator mechanical room.

Photograph 10. Leaking equipment in the elevator mechanical room.

Photograph 11. Sample template near leaking equipment in the elevator mechanical room.
