UNITED STATES ENVIRONMENTAL PROTECTION AGENCY
REGION 6
1445 ROSS AVENUE, SUITE 1200
DALLAS, TEXAS 75202-2733

June 16, 2015

SUBJECT: Impromptu visual cap inspection at the San Jacinto River Waste Pits superfund site

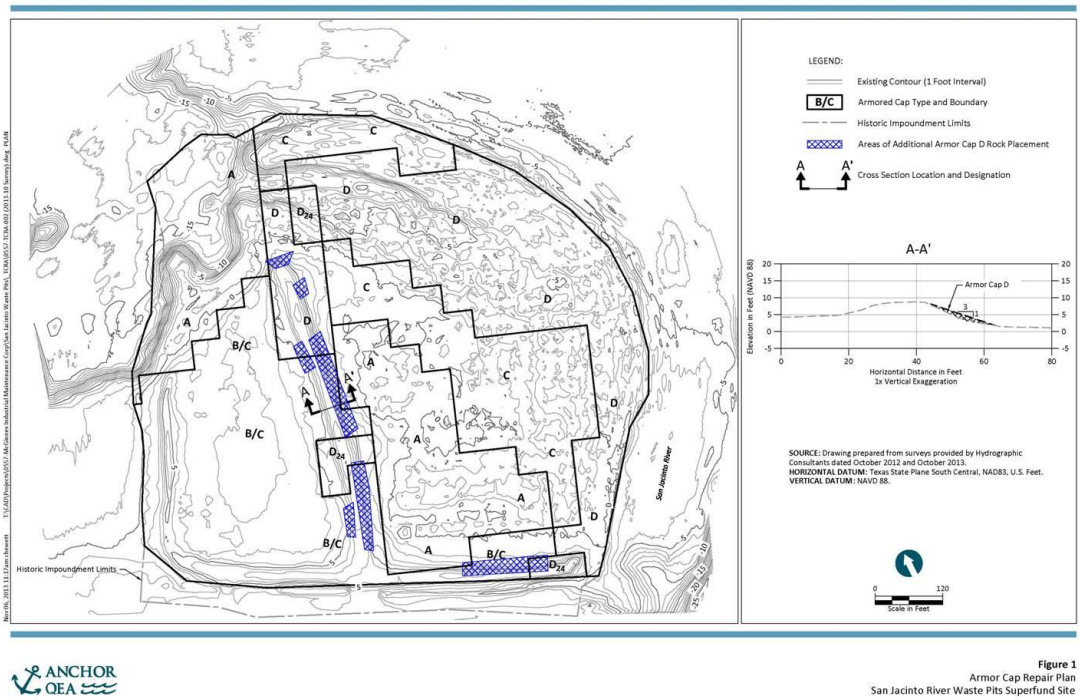
Figure 1- Areas to be covered with additional rock and flatten slopes from November 2013 Armor Cap Enhancement plan

In addition to inspecting the overall integrity of the armor cap, seven additional areas (see Figure 1) were inspected where additional rock was placed and the slopes flattened to provide more stability and strength per the enhancement work plan dated November 2013. The section of the armor cap located above water level (western cell) was observed to be intact with no areas of cap erosion evident (see Photo 1-2). It was noted that several small areas of minor cap erosion along the central berm were evident by patches of the geotextile filter fabric exposed (See Photos 3-5).
