To:	Gary Miller and Anne Foster U.S. Environmental Protection Agency	**Date:**	August 14, 2015
From:	John Laplante, John Verduin, Wendell Mears, and David Keith, Anchor QEA	**Project:**	090557-01
Cc:	Phil Slowiak, IP David Moreira, MIMC		
Re:	Post-TCRA Semi-Annual Inspection Report – July 2015

This document reports the results of the July 2015 inspection of the armored cap cover, fencing, and signage installed for the Time Critical Removal Action (TCRA) at the San Jacinto River Waste Pits Superfund Site (TCRA Site).

Figure 3
July 2015 Semi-Annual Inspection
Post TCRA Semi-Annual Inspection (July 2015)
San Jacinto River Waste Pits Superfund Site

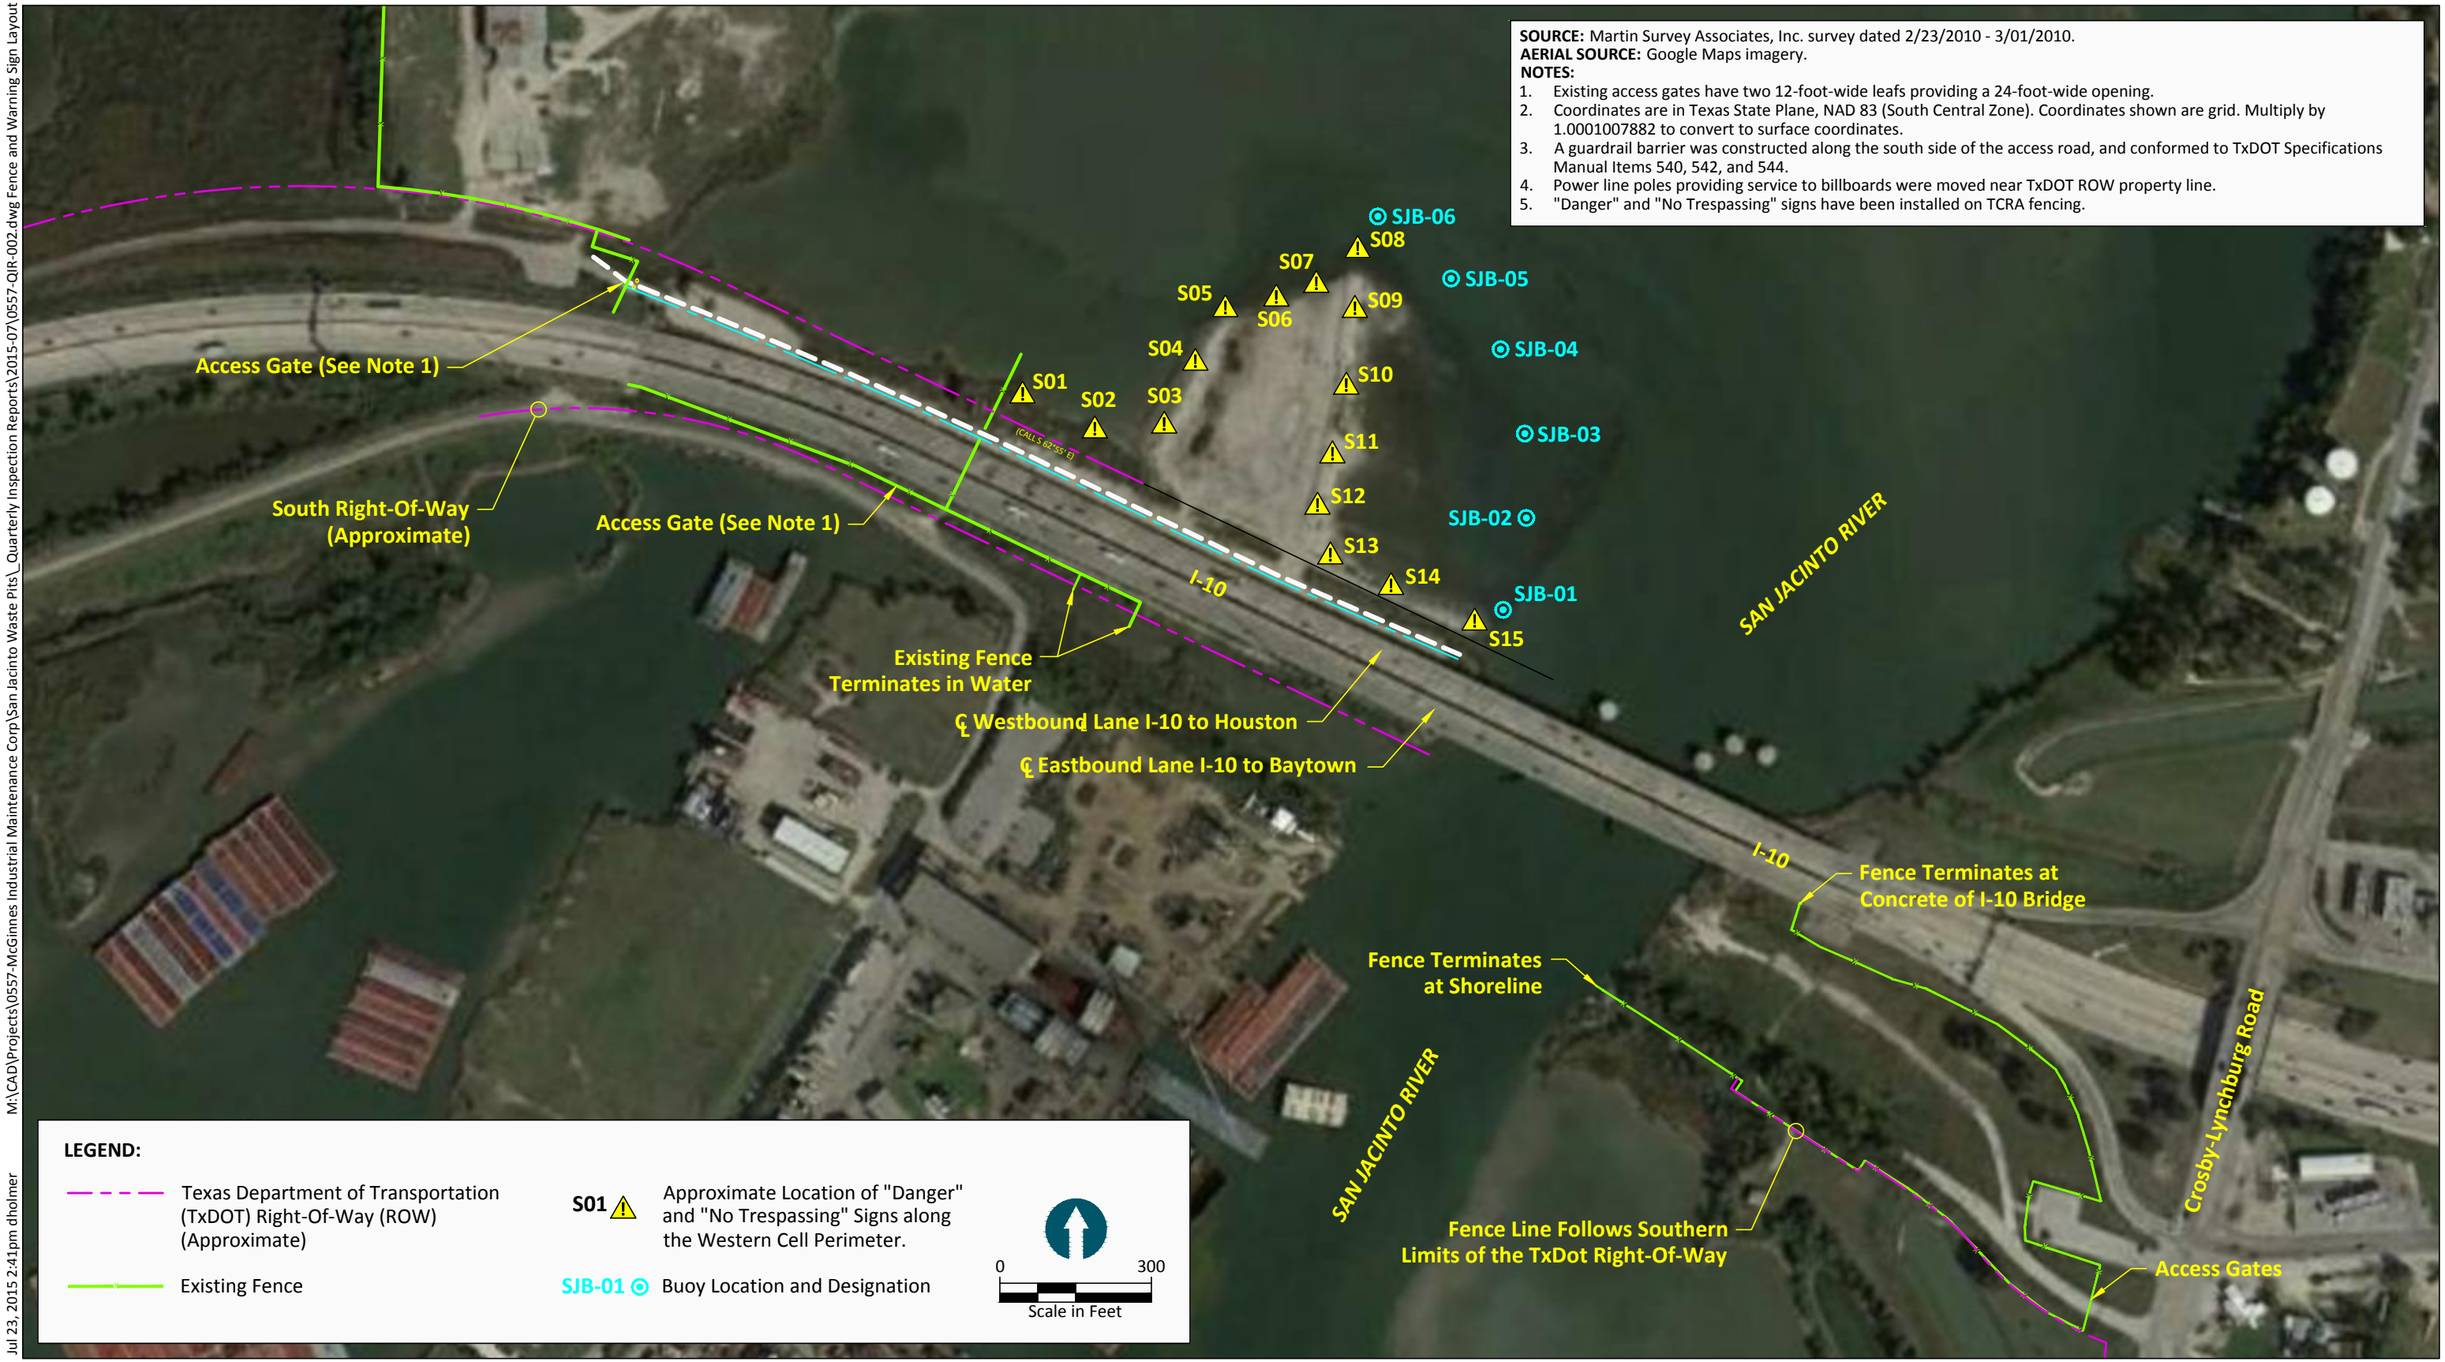
Figure 2
Fence and Warning Sign Layout
Post TCRA Semi-Annual Inspection (July 2015)
San Jacinto River Waste Pits Superfund Site

The perimeter fencing on the west and east banks of the San Jacinto River was visually inspected for breaches or other signs of damage. No breaches or other signs of fence damage were observed during the inspection for any of the three sections of the fence: the east bank, the west bank on the north side of I-10, or the west bank on the south side of I-10. For examples, see Photographs 10 through 14 in Appendix A.

"Danger" and "No Trespassing" signs are posted at regular intervals on the perimeter fencing surrounding the TCRA Site. For examples, see Photographs 10 and 13 in Appendix A. These signs were observed to be in place during the July 1, 2015 inspection.

A total of fifteen signs were installed at the TCRA Site around the perimeter of the land portion of the TCRA Site; the signs are mounted on steel posts and set in concrete pads. For examples, see Photographs 3 and 4 in Appendix A. These signs are intended to face the San Jacinto River to deter water-based entry to the TCRA Site. A few of these signs had rotated out of proper alignment due to the wind; the affected signs were re-aligned to the intended viewing perspective.
