UNITED STATES ENVIRONMENTAL PROTECTION AGENCY
REGION 6
1445 ROSS AVENUE, SUITE 1200
DALLAS, TEXAS 75202-2733

June 16, 2015

SUBJECT: Impromptu visual cap inspection at the San Jacinto River Waste Pits superfund site

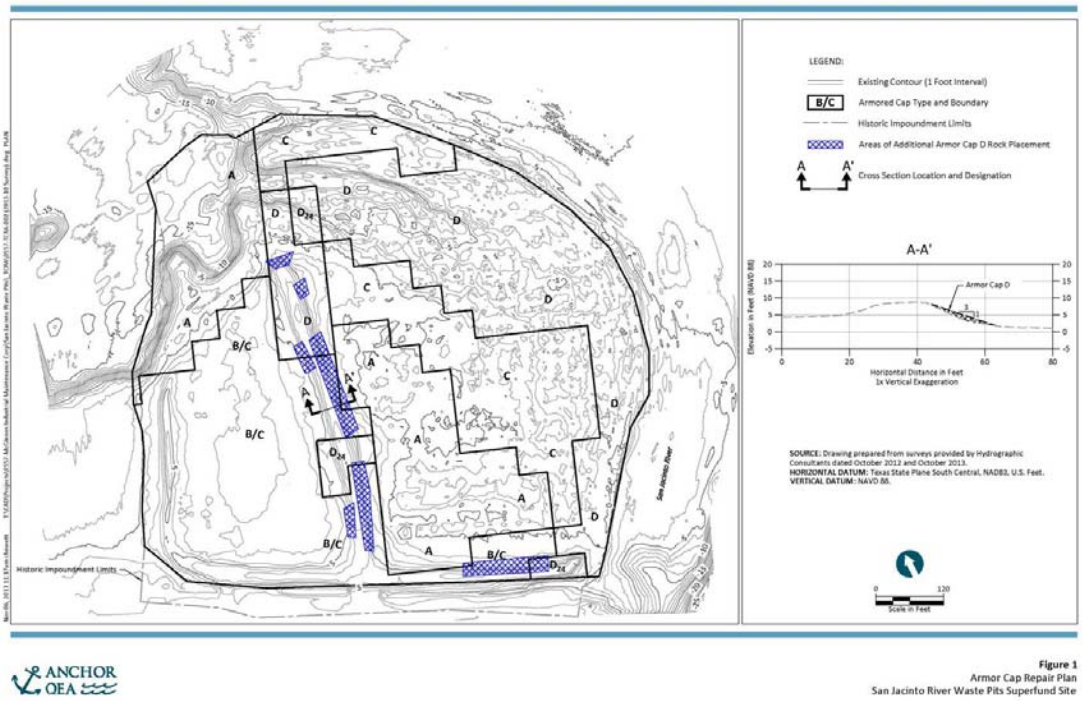
In addition to inspecting the overall integrity of the armor cap, seven additional areas (see Figure 1) were inspected where additional rock was placed and the slopes flattened to provide more stability and strength per the enhancement work plan dated November 2013. The section of the armor cap located above water level (western cell) was observed to be intact with no areas of cap erosion evident (see Photo 1-2). It was noted that several small areas of minor cap erosion along the central berm were evident by patches of the geotextile filter fabric exposed (See Photos 3-5).

Figure 1- Areas covered with additional rock and flatten slopes from November 2013 Armor Cap Enhancement plan
