POTENTIAL HAZARDOUS WASTE SITE
SITE INSPECTION REPORT

A. SITE NAME	B. STREET (or other identifier)		
INTERNATIONAL GALVANIZERS	500 Industry Rd.		
C. CITY	**D. STATE**	**E. ZIP CODE**	**F. COUNTY NAME**
Beaumont	TX	77702	Jefferson

I. SITE DESCRIPTION Steel galvanizing plant with underground waste storage tanks. Two surface impoundments were used to store waste in the past.

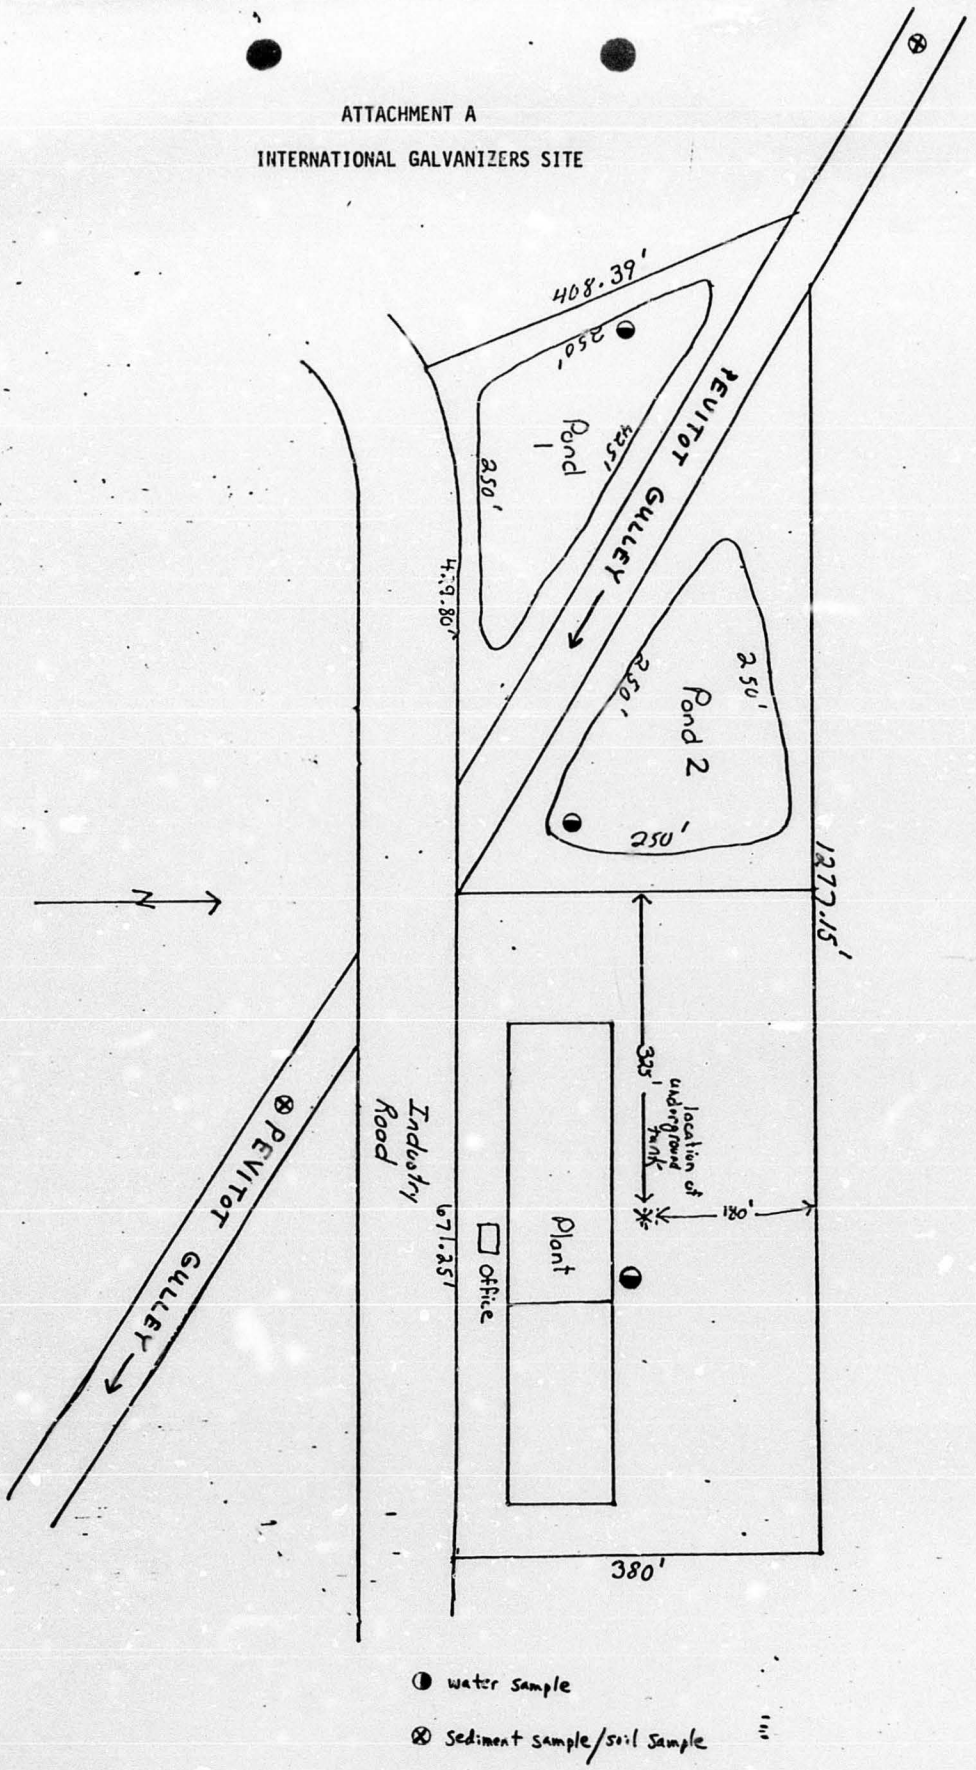
INTERNATIONAL GALVANIZERS SITE

See attached sketch for location of sample points. The on-site soil sample contained significant levels of nickel (180 ppm) and zinc (1,300 ppm) and slightly elevated levels of arsenic, chromium, copper and lead. A comparison of the sediment samples (upstream and downstream) taken from the stream shows that the only metal that increases in concentration in the downstream sample is lead (upstream = 22.2 ppm; downstream = 32.4 ppm). Nevertheless, the downstream lead concentration is only slightly above the mean soil background. The two water samples taken from the on-site ponds contained high levels of chromium, cobalt, manganese, zinc and iron; and lesser elevated levels of arsenic, nickel and vanadium. The pH of the ponded waters was low (pond #1-2.2; pond #2-2.3).
