From: Humphrey, Alan
To: Gannon, Nick; Todd, Brandi; Leos, Valmichael
Subject: Re: SJWP Dive Report Draft - Round 2
Date: Tuesday, January 19, 2016 11:48:36 AM
Attachments: 2015-12-10_132414.jpg
2015-12-10_132440.jpg

From: Todd, Brandi
Sent: Tuesday, January 19, 2016 5:57 AM
To: Humphrey, Alan; Leos, Valmichael; Gannon, Nick
Subject: SJWP Dive Report Draft - Round 2

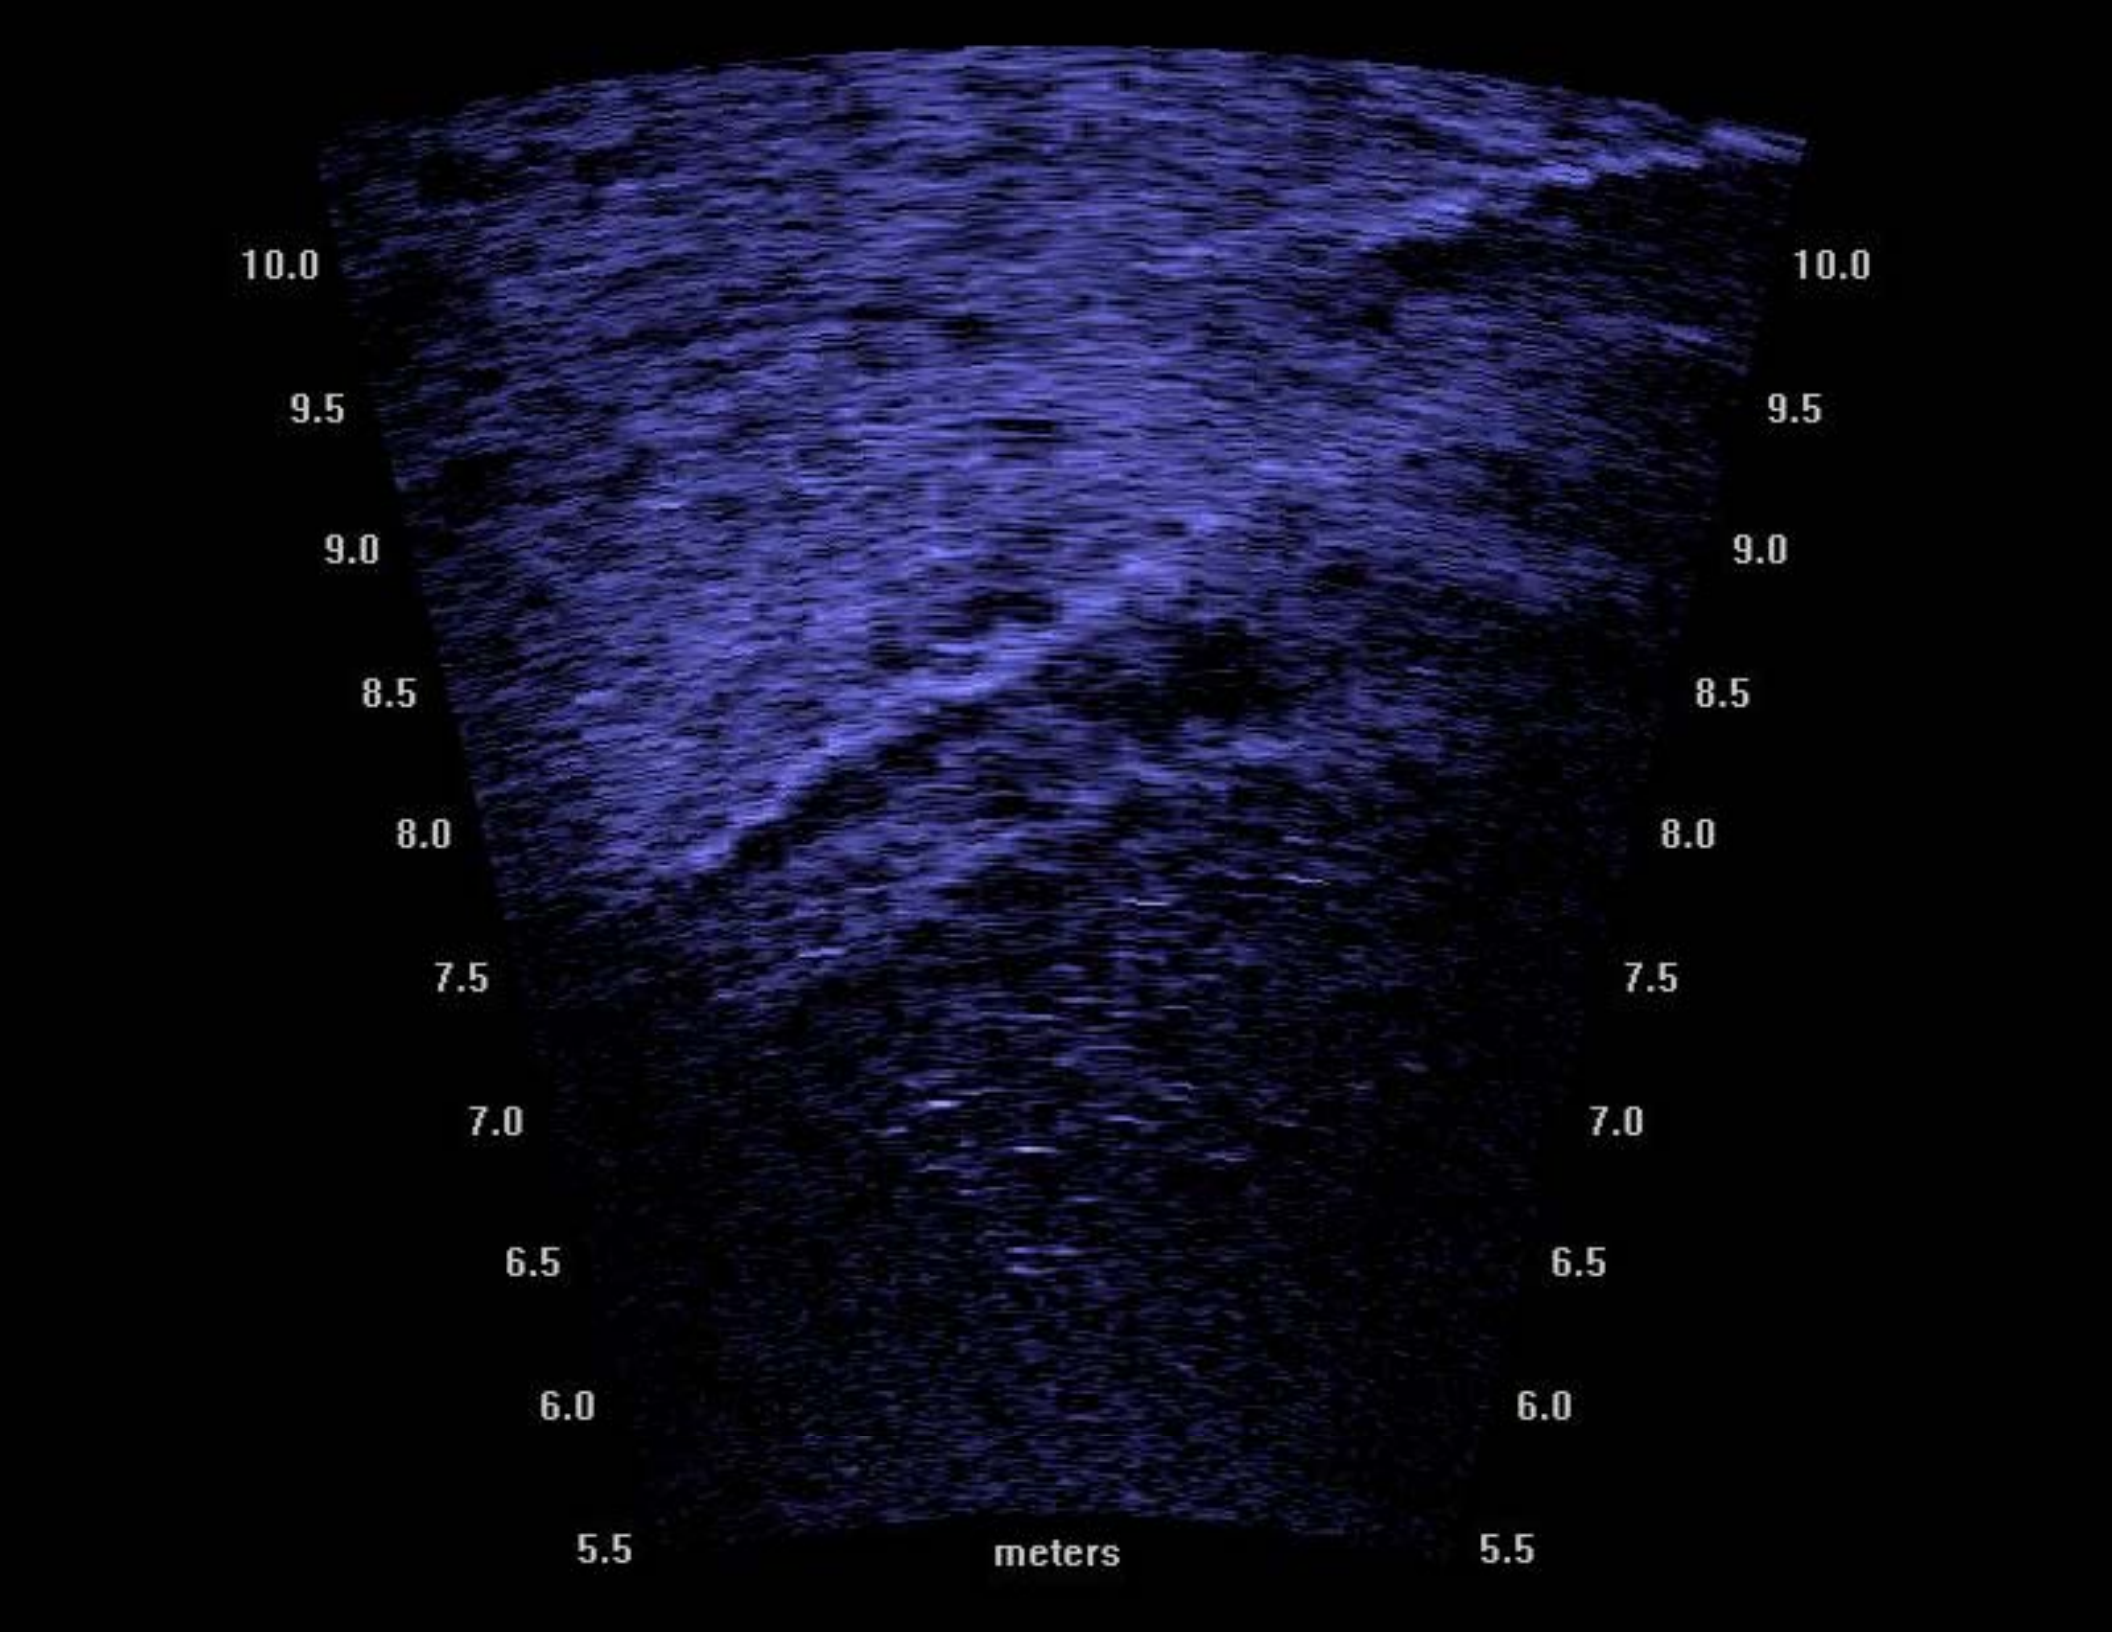
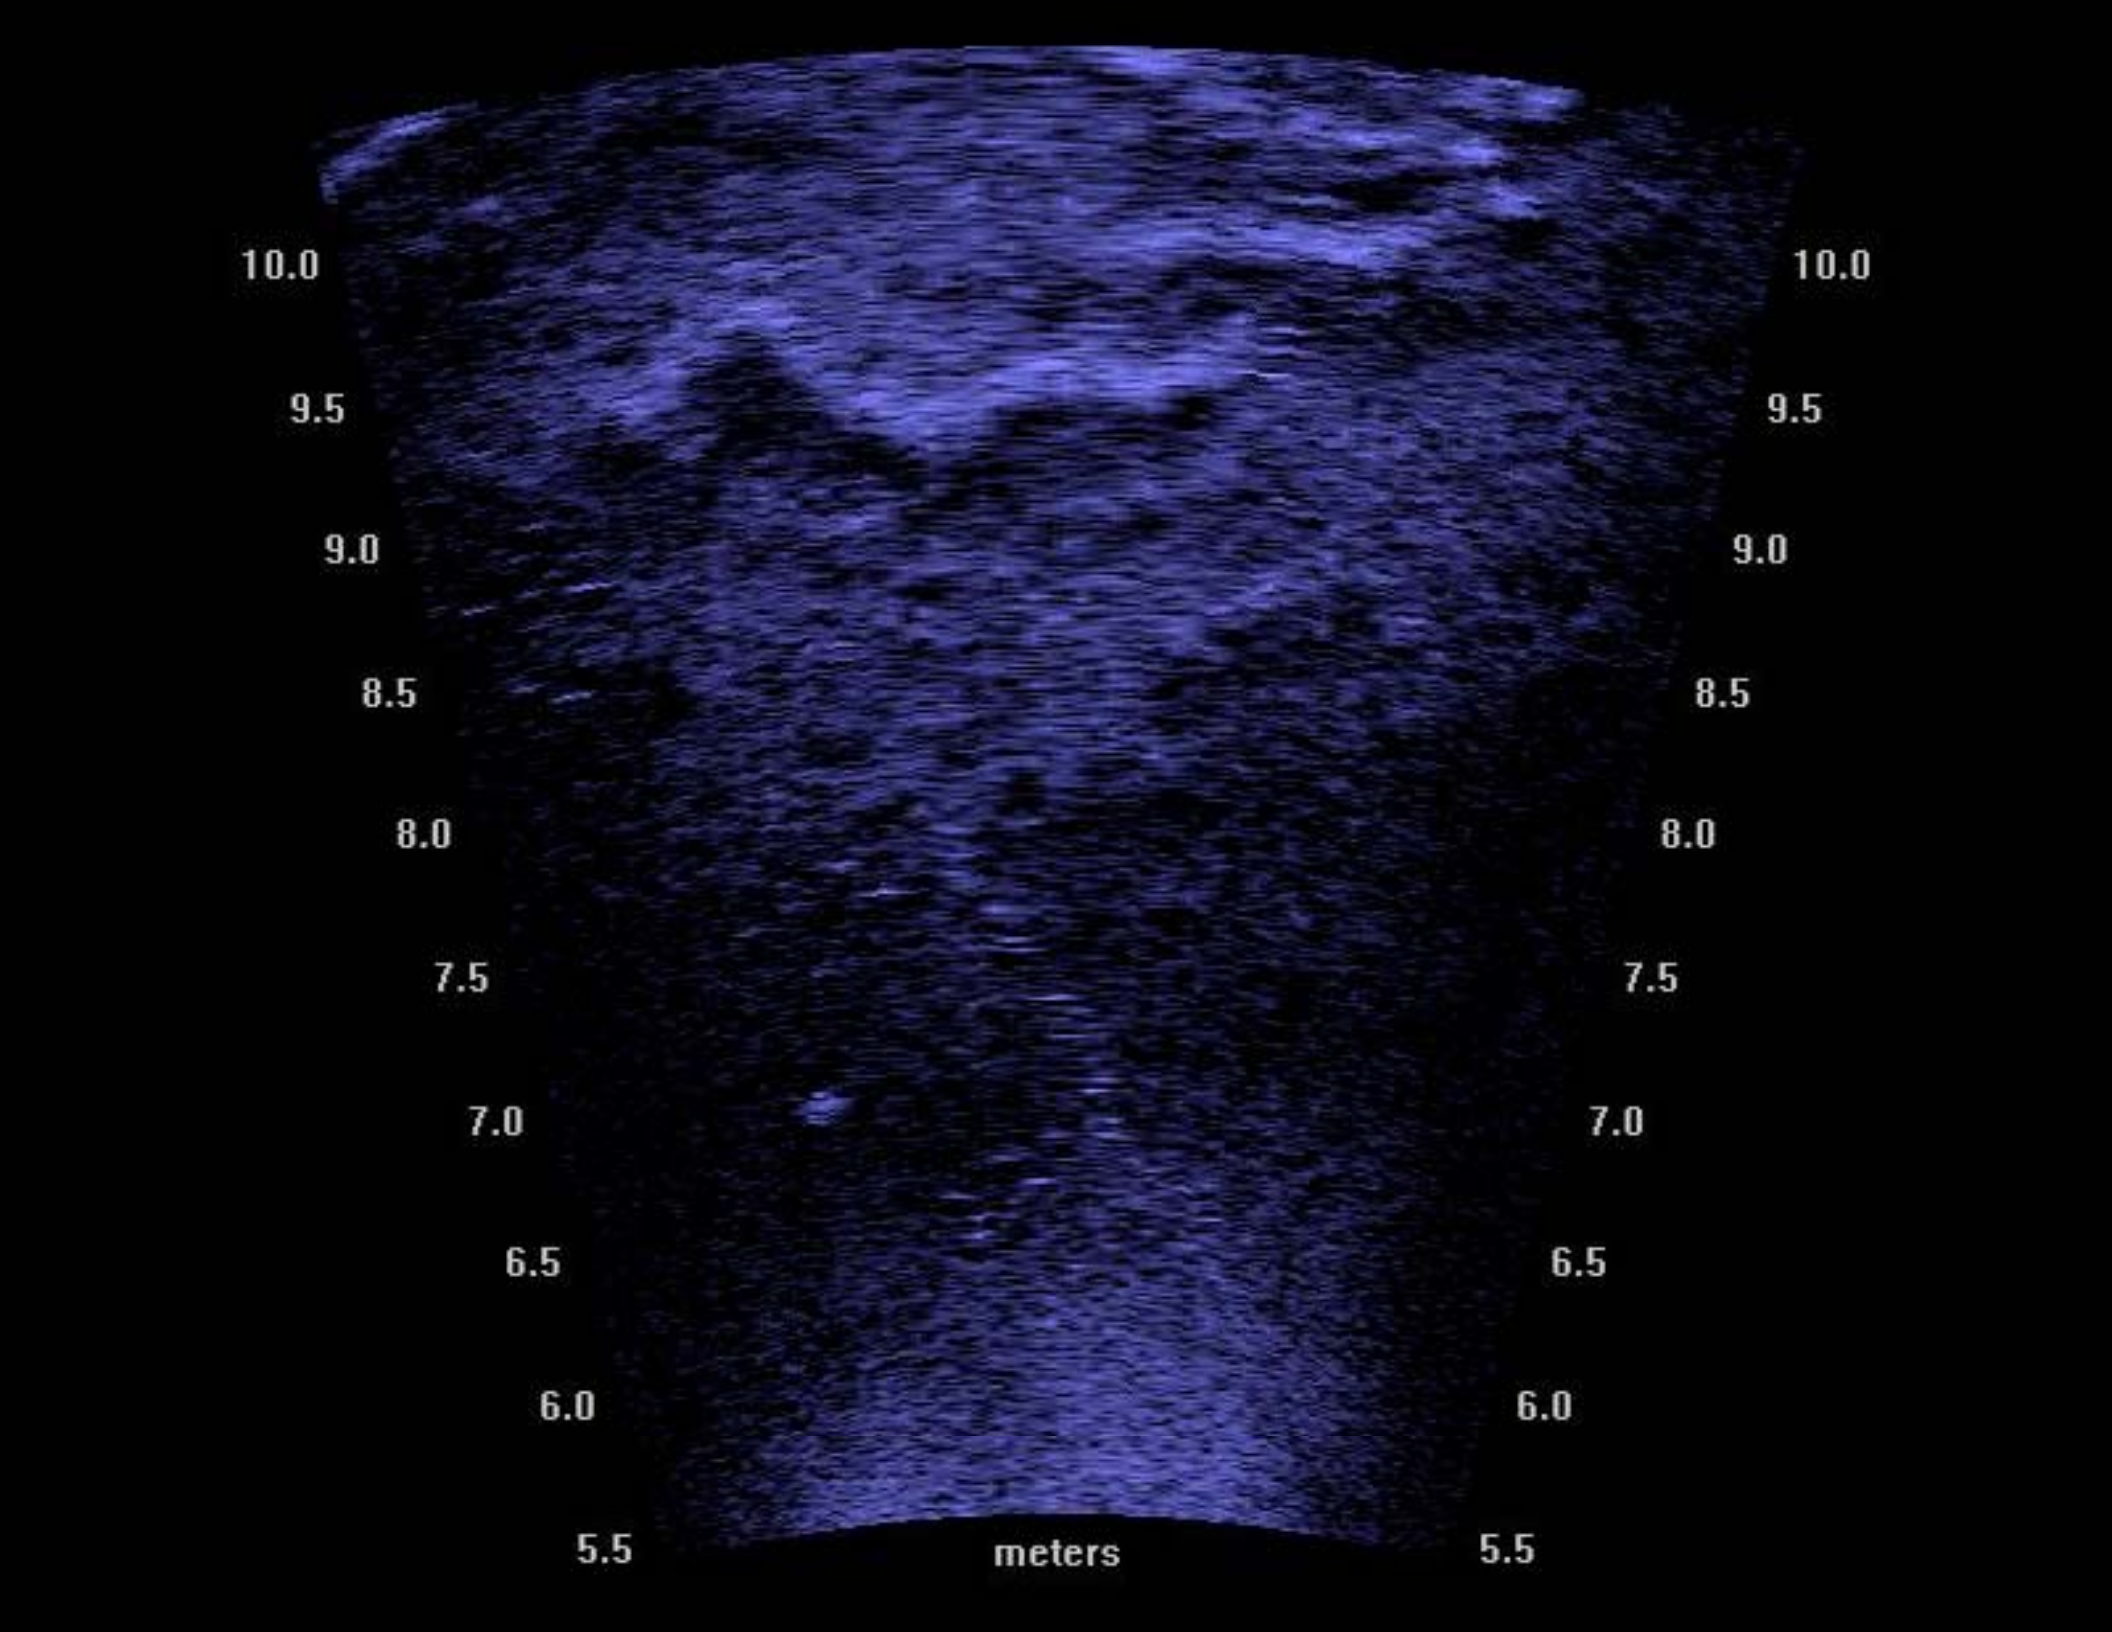
As far as sonar, please look at these two images, neither is great quality but the features are there. Note the lines running across the bottom. These are either old lines still there from prior sampling with growth on them or possibly tree branches or ridges or buckling in the surface of the rock cover. Nick, I think you were following some old line(s) on the bottom early on day one? Was there growth on them? You also ran into some tree branches also? Just trying to see whether we can rule these out as any other issues with the rock cover.
