To:	Valmichael Leos and Anne Foster, USEPA	**Date:**	February 21, 2014
From:	Wendell Mears, Randy Brown, David Keith, John Verduin, and John Laplante	**Project:**	090557-01.04
Cc:	Dave Moreira and Andrew Shafer, MIMC Phil Slowiak, IP		
Re:	San Jacinto River Waste Pits TCRA Armored Cap Enhancement Completion Report

Figure 1
Armored Cap Enhancement Locations
TCRA Enhancement
San Jacinto River Waste Pits Superfund Site

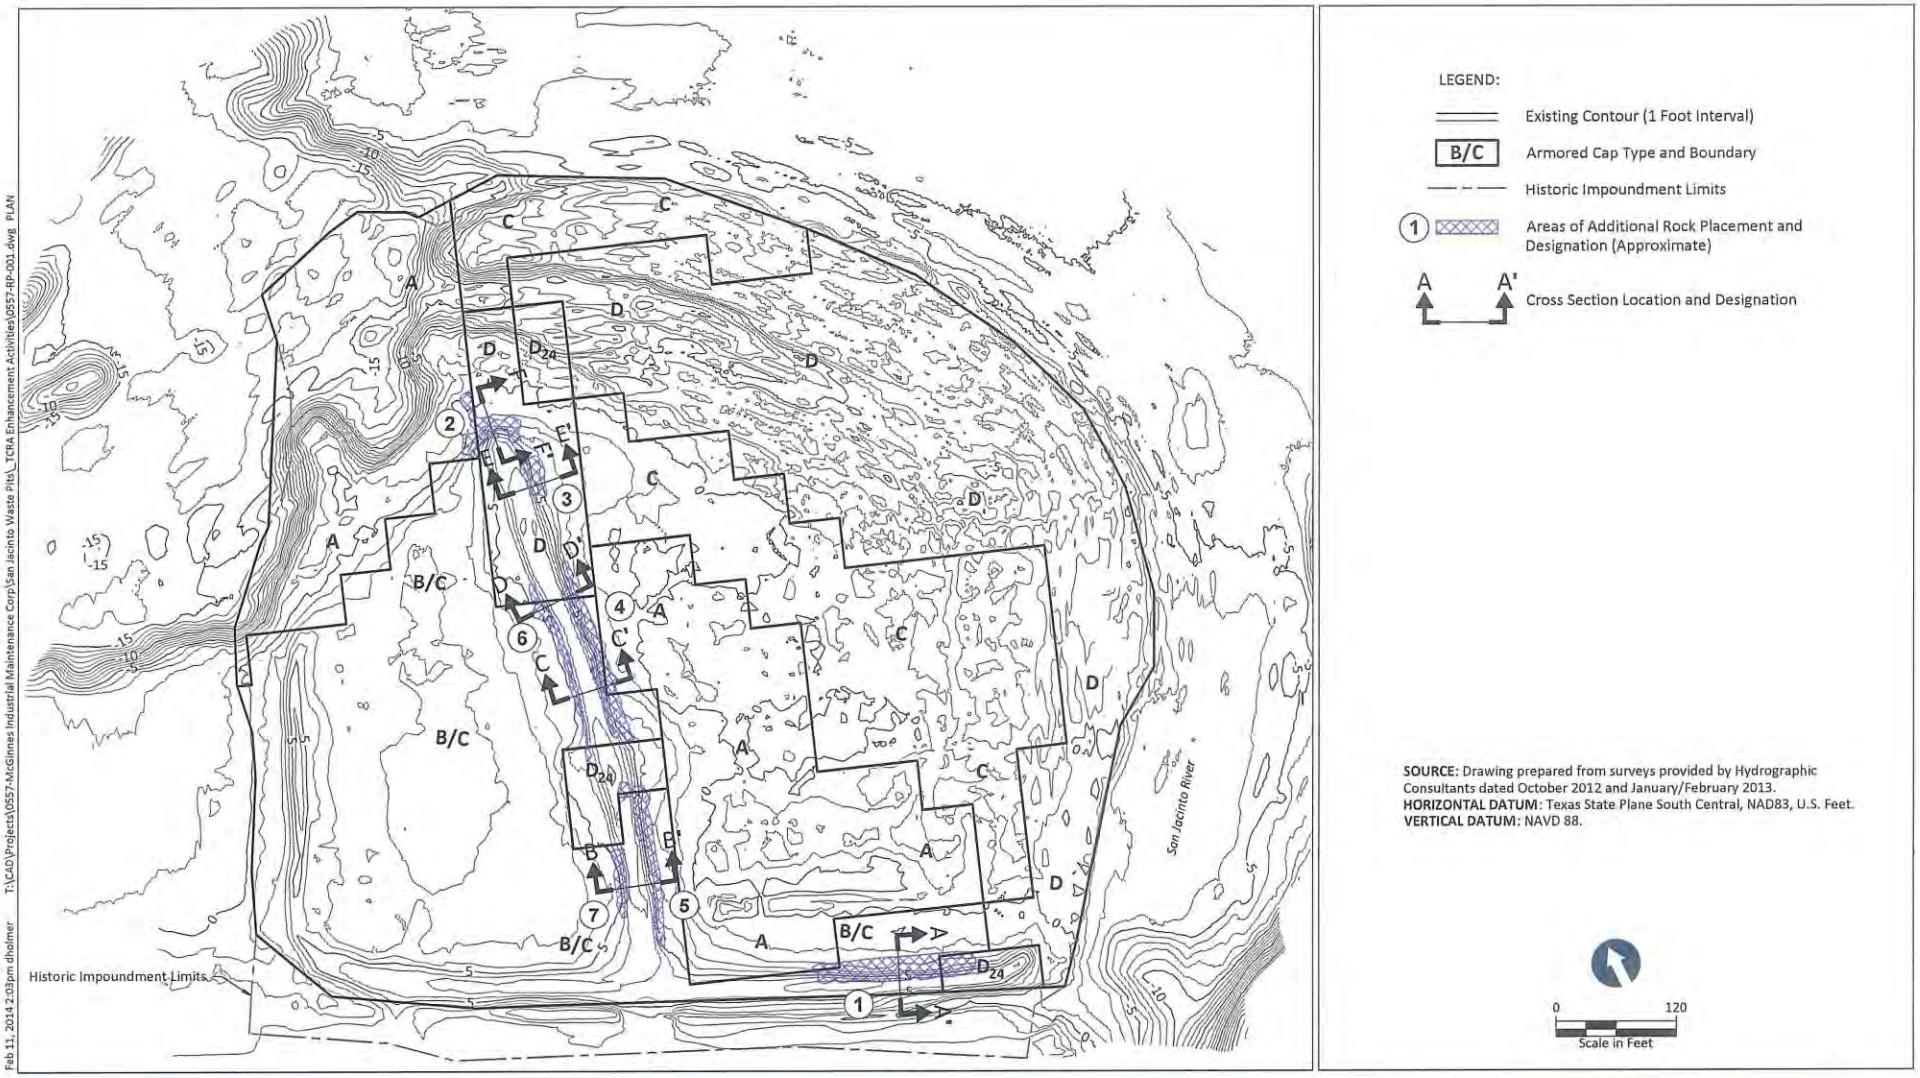
This Work Plan outlined the use of Armor Cap D natural rock to flatten armored cap slopes at the TCRA Site to 1V:3H or flatter at seven areas within the wave runup or surf zone that were identified using survey data collected during the October 2013 armored cap inspection (Figure 1). Armor Cap D rock used for the armored cap enhancement was previously stockpiled at a location approximately 15 miles from the TCRA Site; this rock was ordered, tested, and stockpiled as part of the TCRA construction project. As described by the Work Plan (Attachment 1), the Armor Cap D rock (D_{50}=10 inches, D_{85}/D_{15}=1.55) exceeds the computed Maynord equation D_{50} particle size and has a larger D_{50} than the Armor Cap C rock. The use of

To reduce the slopes to 1V:3H or flatter, the contractor will transport the Armor Cap D rock from the stockpile and place the rock in the locations shown in Figure 1. Using a small loader (Bobcat, Skid Steer or equivalent equipment as appropriate), the contractor will transport and place the rock in a manner that prevents breakage of the rock. The contractor's survey crew will monitor the rock placement to confirm the required grades are met during construction. After the contractor has completed the rock installation, the areas will be re-surveyed to confirm the slopes are 1V:3H or flatter. The Armor Cap D stockpile is located approximately 15 miles away from the TCRA Site. The Armor Cap D rock meets or exceeds the TCRA original design requirements for each area of the armored cap. The Armor Cap D rock was purchased and stockpiled expressly for maintenance purposes and has already been tested and approved for gradation and chemistry.

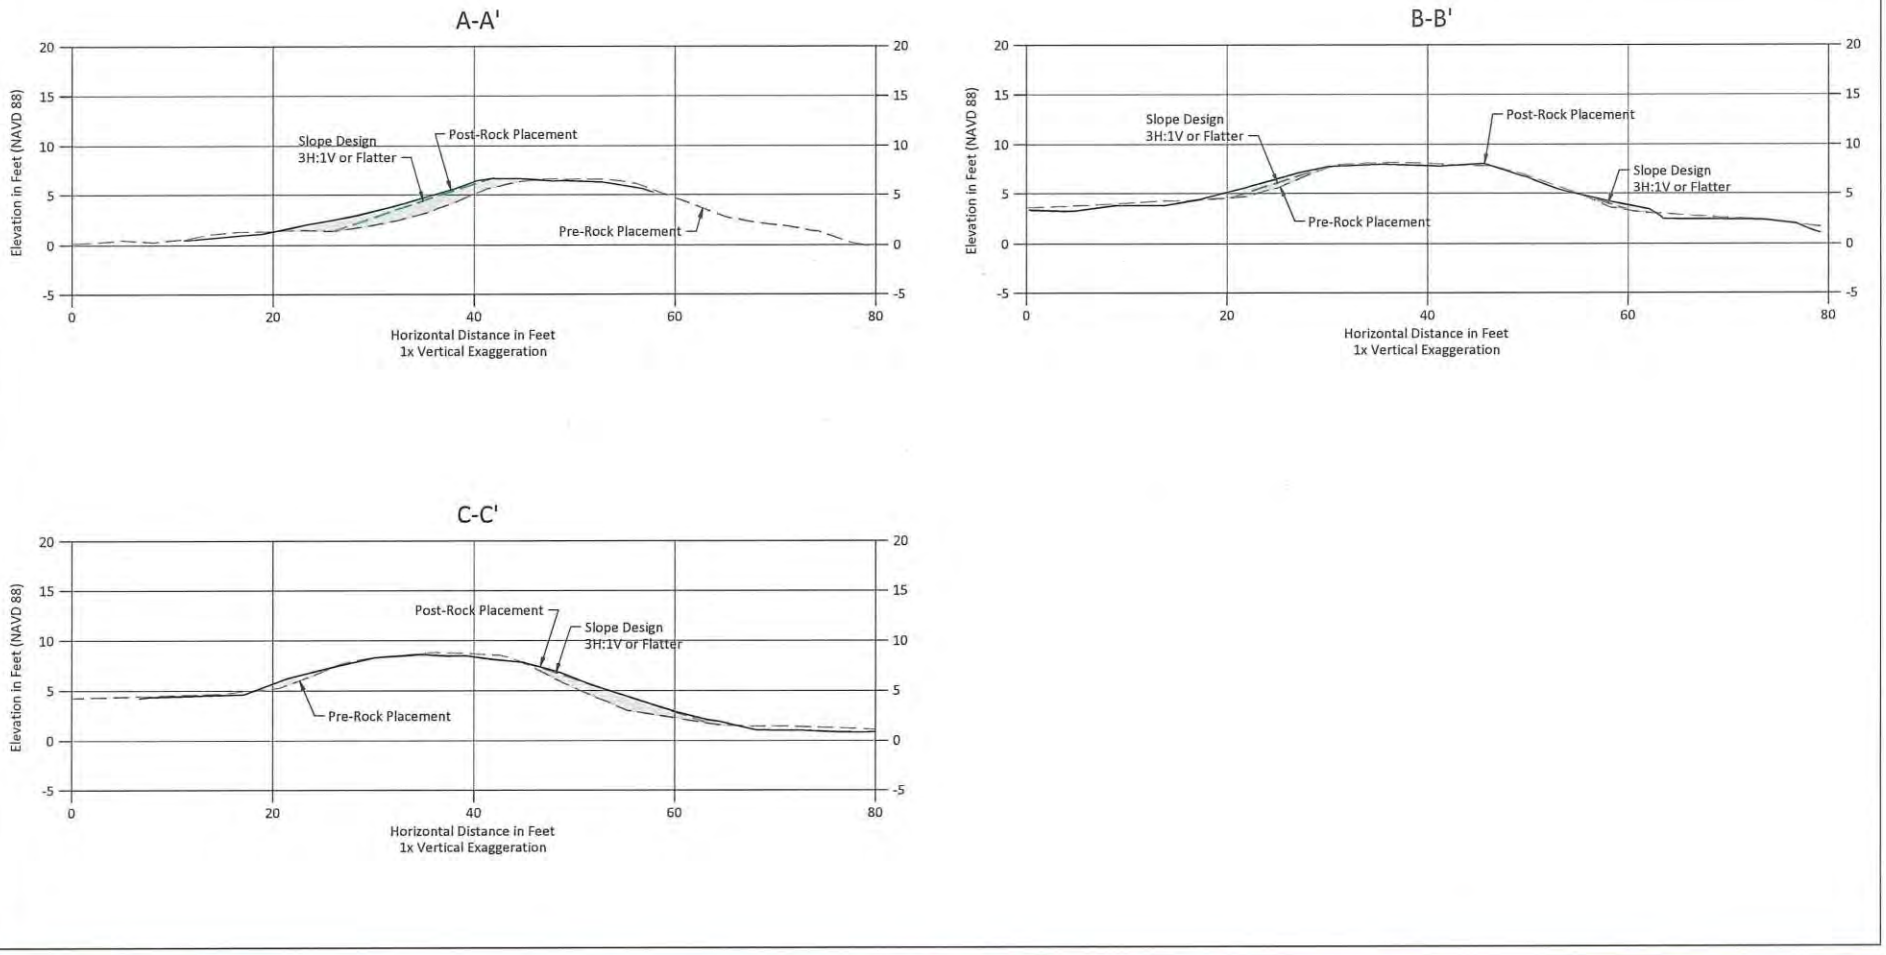
Figure 2
Cross Sections - Armored Cap Rock Enhancement
TCRA Enhancement
San Jacinto River Waste Pits Superfund Site

Before completing an enhancement area and moving to the next, the post-enhancement slopes were field-measured for 1H:3V or flatter slopes at approximately 20-foot intervals using marked wooden boards placed horizontally and vertically atop the armored cap using a field level.

Construction proceeded first on the South Berm, then on the Central Berm in a north-to-south direction on the Central Berm. There was no construction activity on Friday, January 24, 2014, due to safety concerns resulting from freezing rain which would have made transport of personnel and Armor Cap D rock treacherous. Armored cap enhancement construction was finished on Monday, January 27, 2014, and a post-construction topographic survey of the enhancement areas was completed on the same date. Figures 2 and 3 contain cross-sections of the enhancement areas; each cross-section displays pre- and post-construction topographic survey data, and a line depicting the target 1V:3H slope.

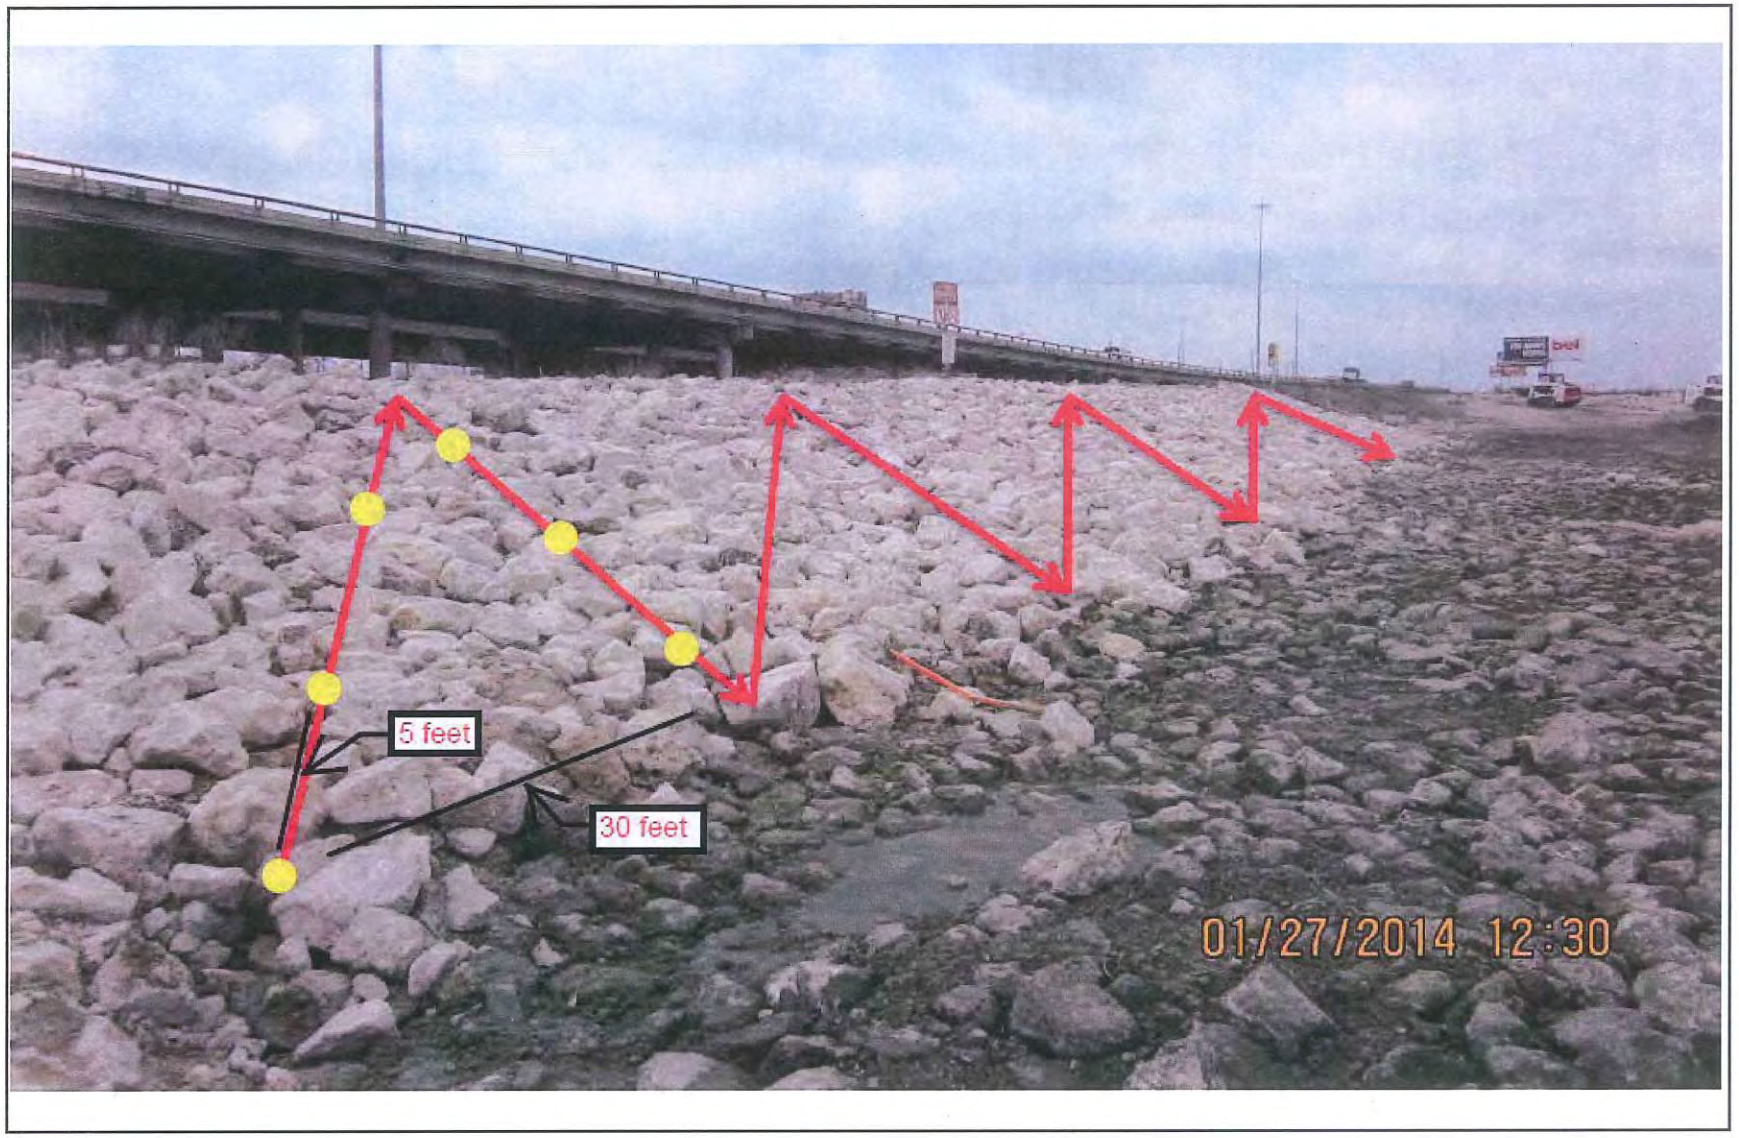
Figure 4
Typical Transect for Material Gradation Inspection
TCRA Enhancement
San Jacinto River Waste Pits Superfund Site

Using this method, the particle sizes of the Armor Cap D rock was measured along three transects within the enhancement areas: the South Berm, the eastern slope of the central berm, and western slope of the central berm. The inspection was conducted in a zig-zag pattern across each transect (see Figure 4), measuring a rock size every 5 feet; 177 measurements were taken. Each rock was measured using a ruler across its intermediate axis, perpendicular to both the longest and shortest axes of the rock.

At each transect, the median measured particle size was 9 to 9.5-inches, greater than both the 6-inch D_{50} specification for Armor Cap C rock recommended by USACE as part of their assessment (USACE, 2013) and the 8-inch D_{50} for Armor Cap D rock that was used for the enhancements. This quality assurance review indicates that the Armor Cap D rock used for the armored cap enhancements was appropriately sized and did not undergo significant change during transport, handling, and installation.

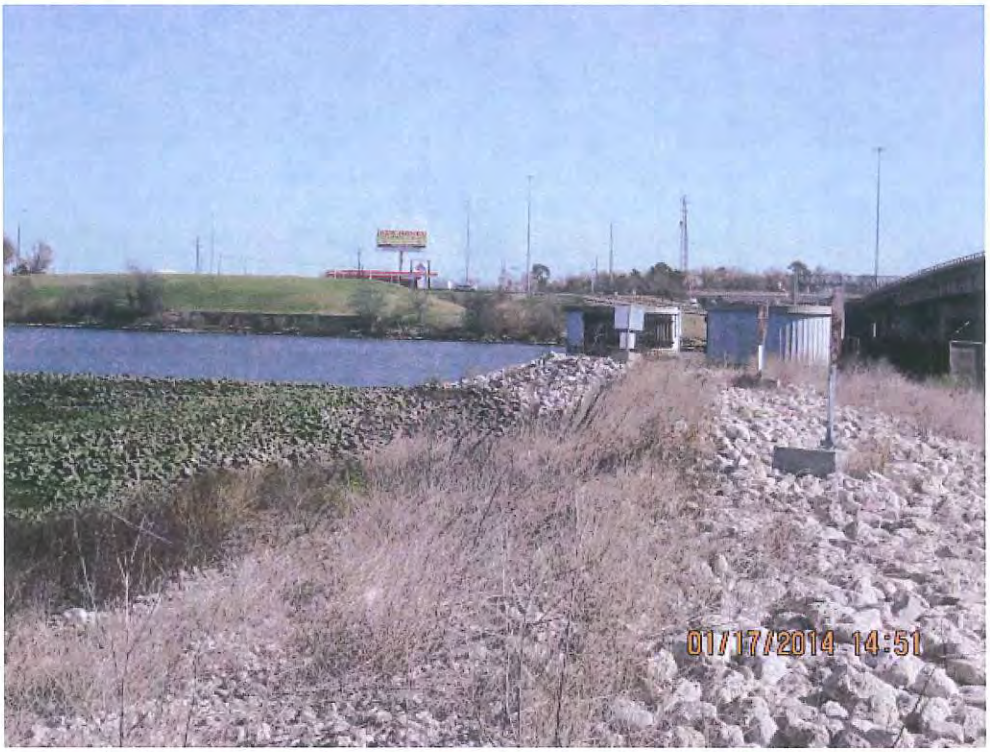
Photo 3 – Areas to receive armored cap enhancement marked along the South Berm.

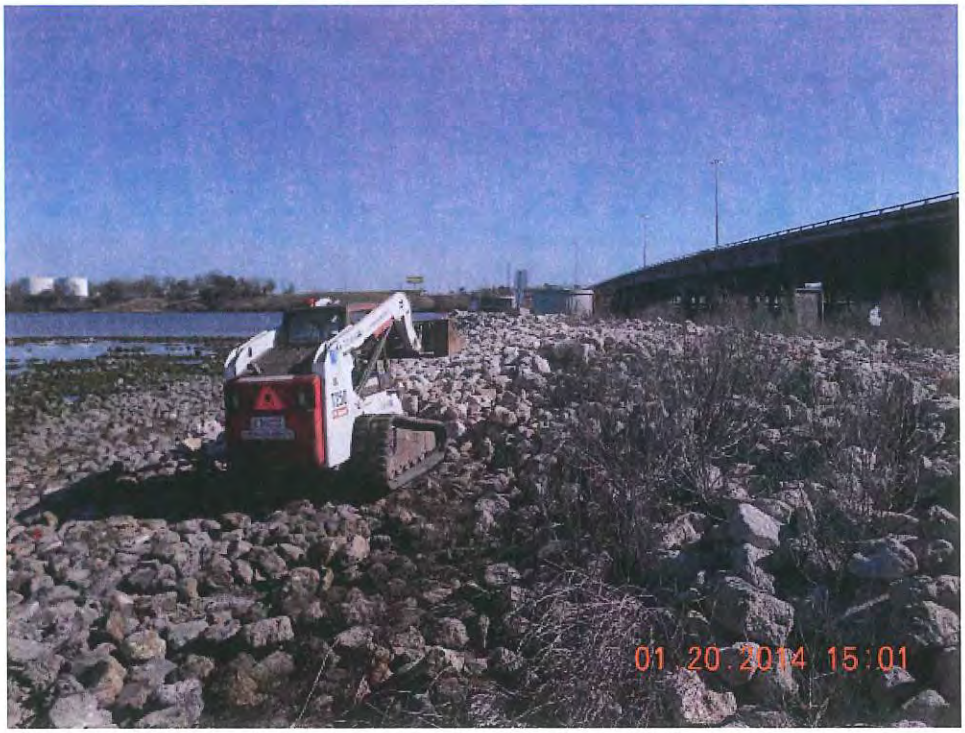
Photo 6 – Skidsteer placing Armor Cap D rock in the South Berm enhancement area.

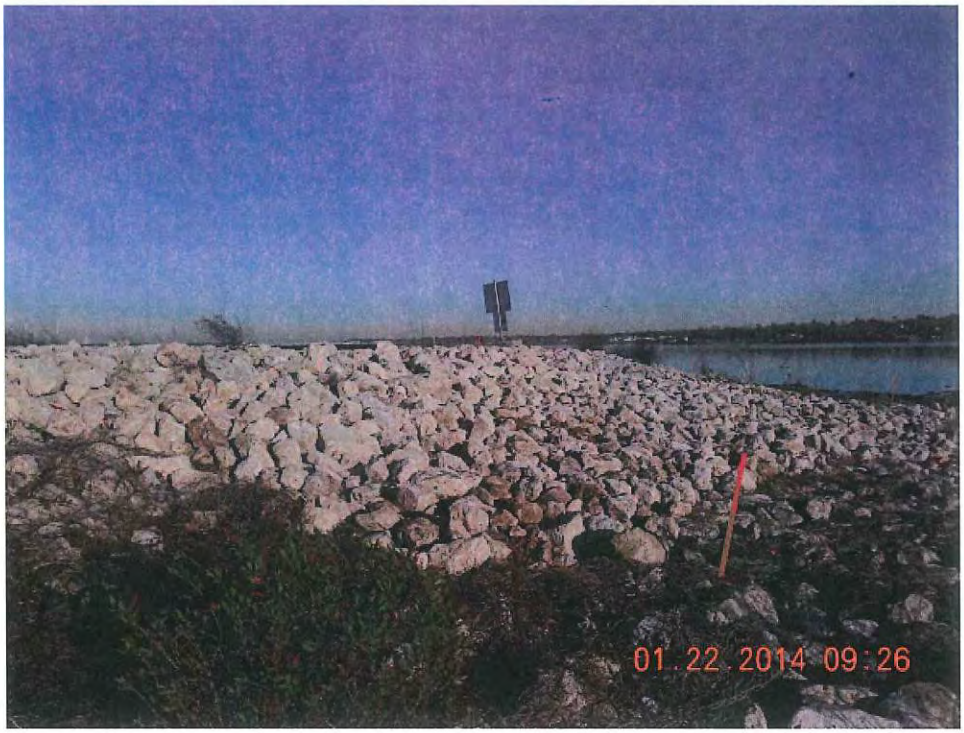
Photo 2 – Post-enhancement of Area #3.
