5 January 2016

RE: Field Activity Report
San Jacinto River Waste Pits
Remedial Investigation/Feasibility Study Oversight
Channelview, Harris County, Texas
Contract: EP-W-06-004
Task Order: 0130-RSBD-06ZQ

FIELD ACTIVITY REPORT
23 AND 28–31 DECEMBER 2015
SAN JACINTO RIVER WASTE PITS
CHANNELVIEW, HARRIS COUNTY, TEXAS

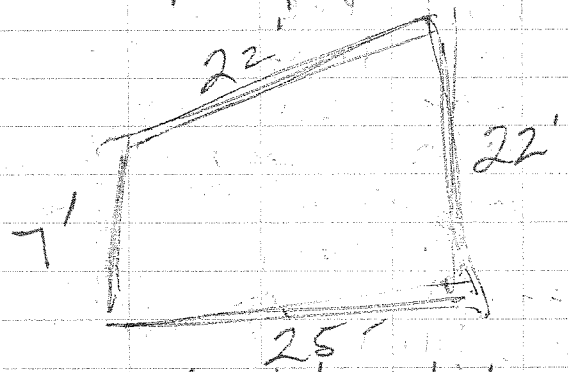
with pvc piping as follows:

12:00 - Complete staking damaged area (photo)
12:02 - Boat launch area to pick up sample kit from boat launch
12:30 - Boat arrives / prepare plan with all parties to collect sediment samples:
3 samples from damaged area
2 samples from Toe of slope
2 samples from approx 50 ft from Toe of slope
13:30 - Start collecting sediment samples from areas
Split samples as follows:
