Figure 1 - Gamma Radiation Measurements, Above Two Times Background
Barton 3 (220)
Red Mesa Chapter, Navajo Nation

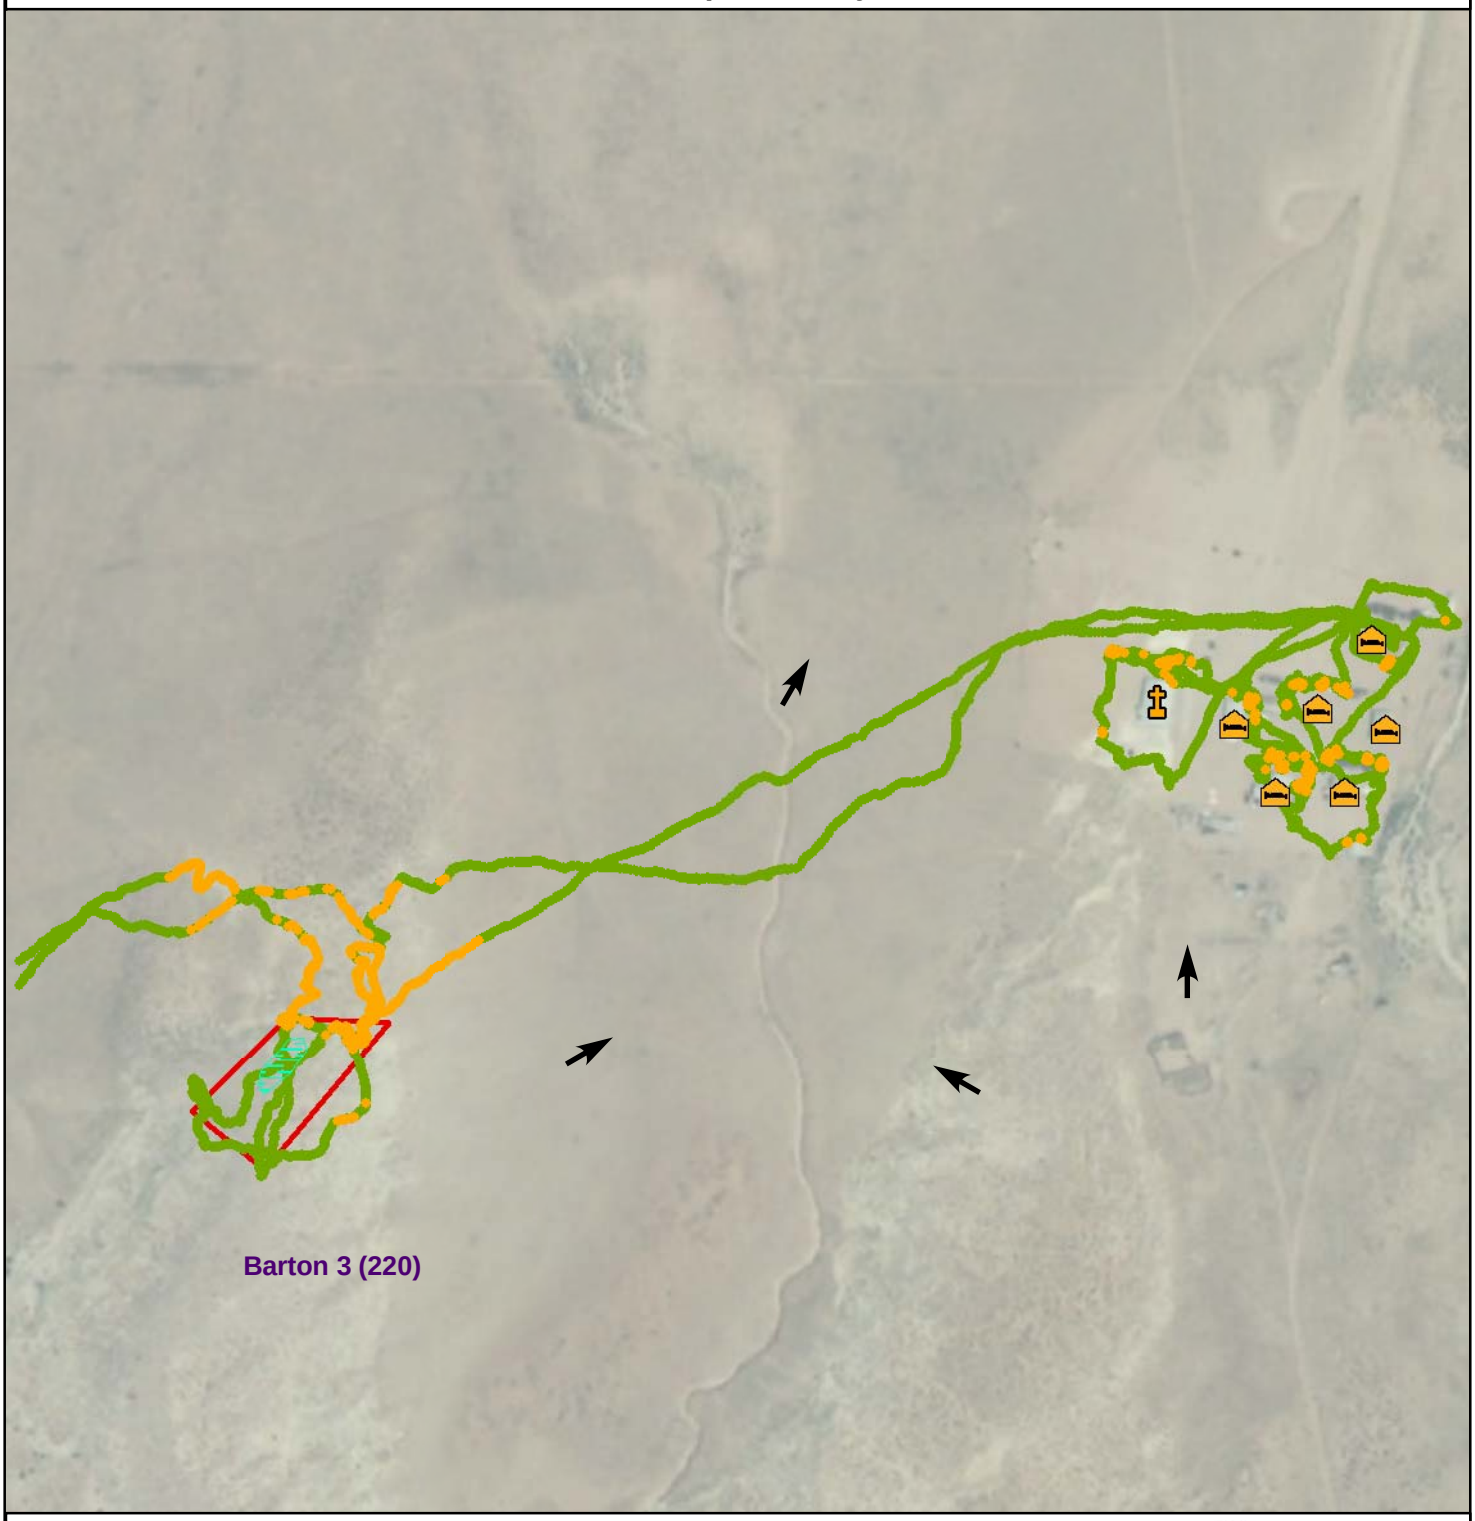
Gamma survey conducted 06/2010
Measured as counts per minute (cpm)

Average background = 8,232 cpm
