Memorandum

Subject: **Pre-CERCLIS Screening Assessment of the Section 19 Mine, New Mexico: No Further Action Under CERLCA Recommended**

Site name	Section 19	**Alias**	NA	**Street Address**	NA
City	NA	**State**	New Mexico	**Zip code**	NA
County	McKinley County				
Latitude	35° 25' 53.82" N	**Longitude**	107° 49' 28.26" W

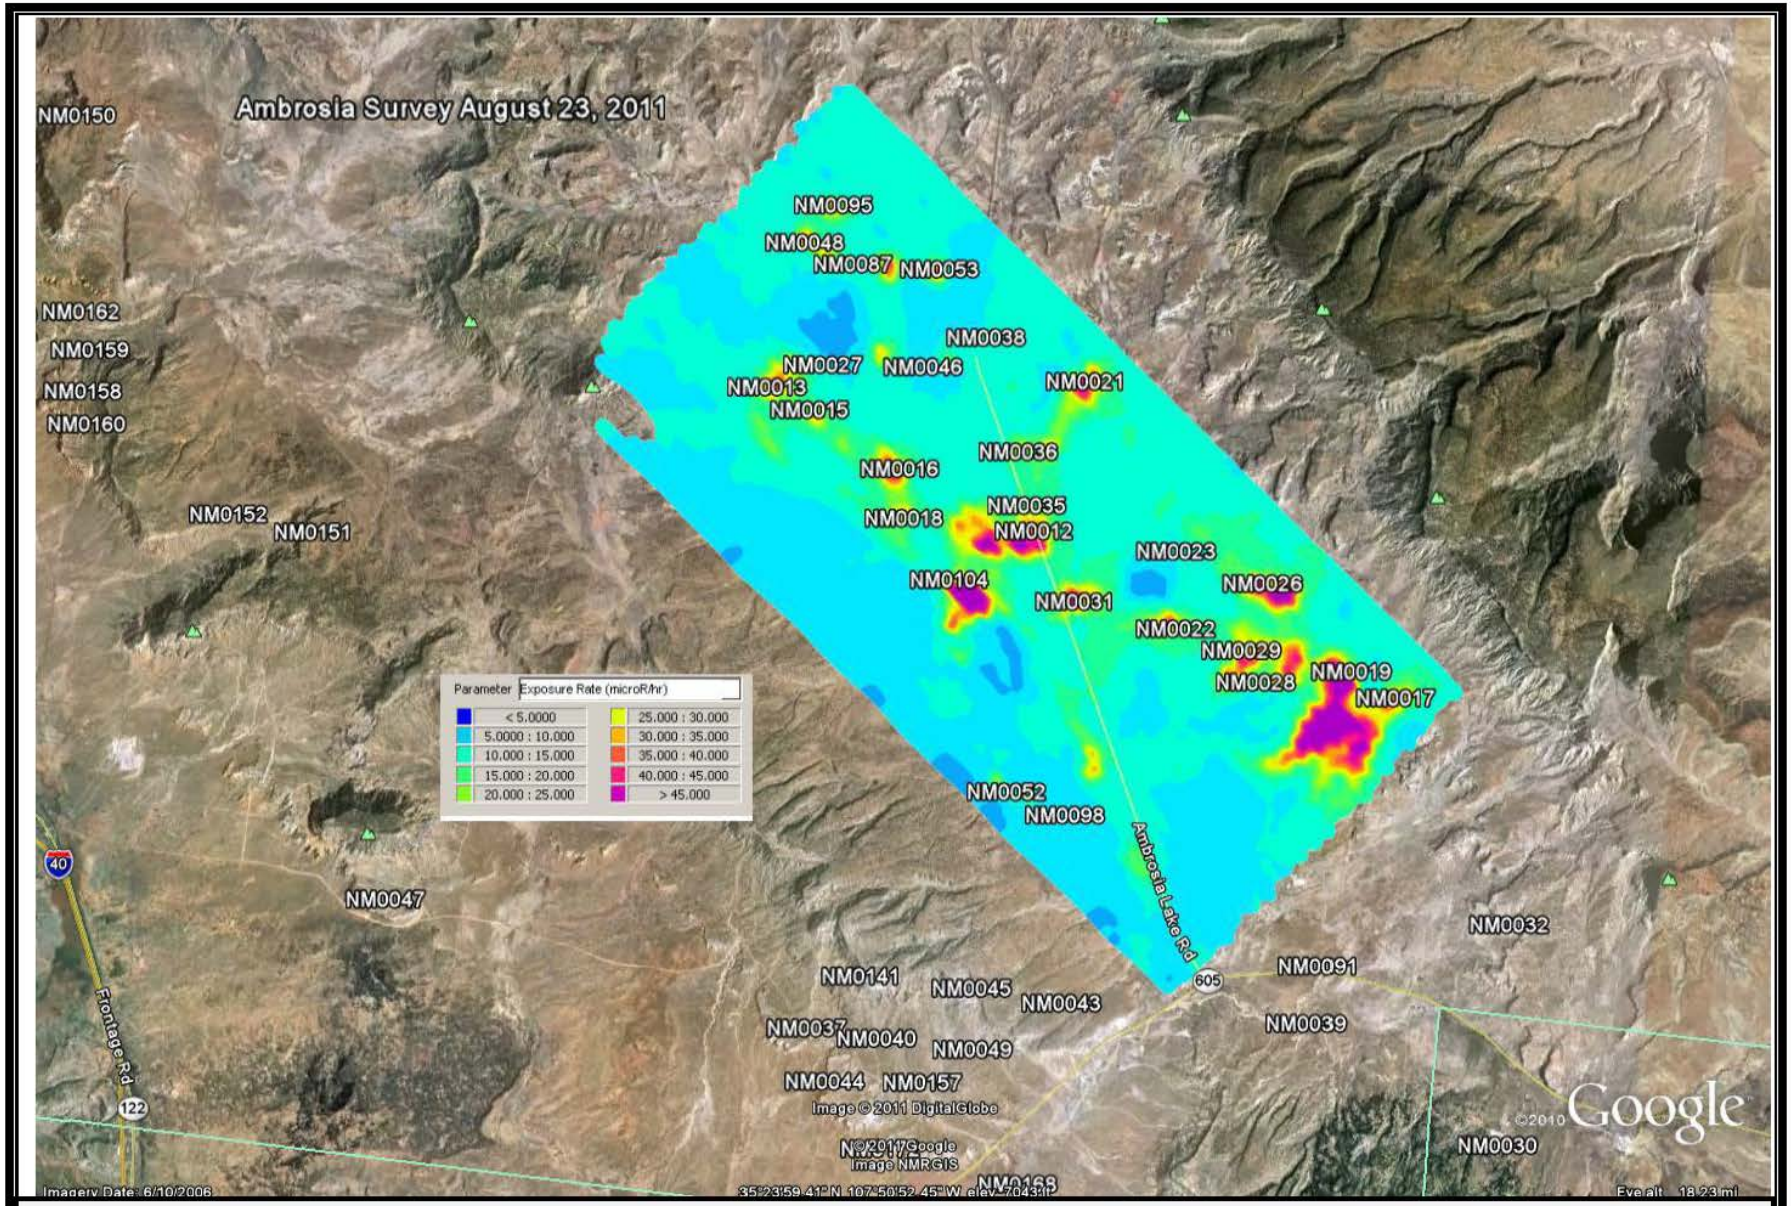
Figure 2. U.S. EPA ASPECT Exposure Rate Contour Map of Ambrosia Lake Mining District.

Airborne Spectral Photometric Environmental Collection Technology (ASPECT) operated by EPA has developed exposure rate contour map of the Ambrosia Lake Mining Sub-District that includes the Section 19 (NM0036) mine (Figure 2). The EPA ASPECT exposure rate

measurements were performed in part to evaluate if surface reclamation has been effective in the long-term elimination of such threats to human health and the environment. The map estimates radiation exposure rates on the ground and can be used to identify hazardous levels of radiation. Typical exposure rates in New Mexico range from 5 – 20 micro Roentgens per hour (µR/hr.). The ground surface exposure rates in and around the Section 19 mine are over one thousand times higher than the typical range, that is, ground surface radiological hazards were identified at most Ambrosia Lake uranium mine sites including the Section 19 mine (Ref. 6).
