Re: Work Plan for Rock Placement on the Time Critical Removal Action
Armored Cap, San Jacinto River Waste Pits Superfund Site, Channelview, Texas

Table 1
Armored Cap Maintenance Locations
March 2016

Figure 1
March 2016 Maintenance Areas
San Jacinto Waste Pits Superfund Site

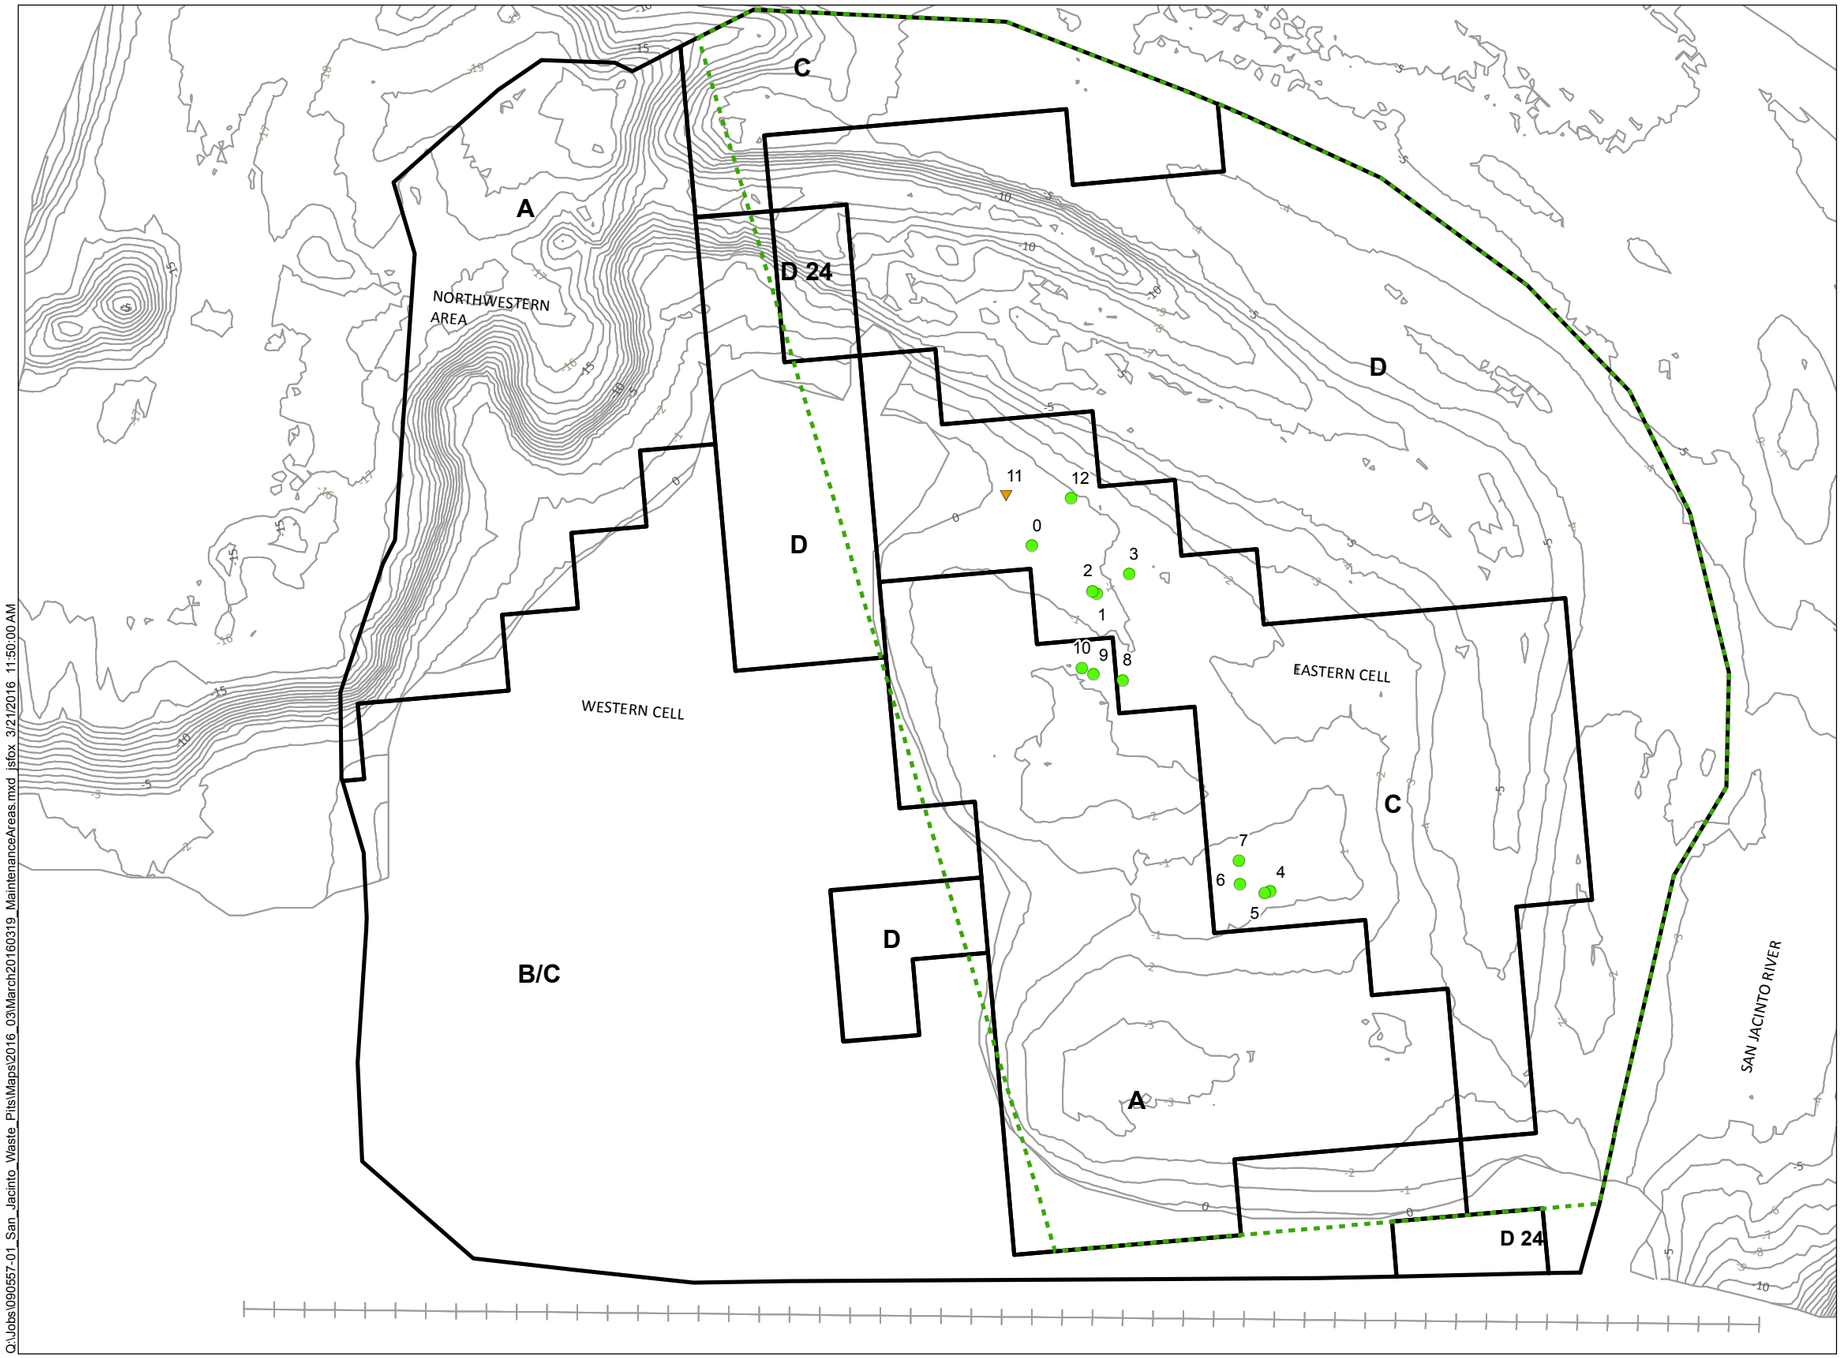
The results of the probing and visual inspection identified several discrete areas (e.g. 1' x 1') where geotextile was exposed, as summarized in Table 1 and shown on the attached Figure 1.

Maintenance Location	Comment	X (UTM NAD83 - 15N)	Y (UTM NAD83 - 15N)	Maintenance Plan
0	Exposed Geotextile with rock beneath. Indicative of Lap Joint.	300665.5156	3297847.47	Add rock
1	Exposed Geotextile is 2x2 feet. Some rock aggregate present. Thin cap rock region is 2x6 feet.	300672.5976	3297832.841	Add rock
2	Exposed geotextile 2x2 feet in area. Some rock aggregate present.	300672.013	3297833.713	Add rock
3	Exposed Geotextile 2x3 feet in area. Some rock aggregate present.	300680.1521	3297833.27	Add rock
4	Exposed Geotextile is 1x3 feet in area. Some rock aggregate present.	300675.29	3297763.589	Add rock
5	Exposed Geotextile is 1x1 feet in area. Some rock aggregate present.	300674.1382	3297763.769	Add rock
6	Exposed Geotextile is 1x1 feet in area. Some rock aggregate present.	300670.6068	3297767.763	Add rock
7	Exposed Geotextile is 1x1 feet in area. Some rock aggregate present.	300672.5902	3297771.977	Add rock

8	Exposed Geotextile is 2x1 feet in area. Some rock aggregate present.	300668.9628	3297815.019	Add rock
9	Exposed Geotextile is 1x1 feet in area. Some rock aggregate present.	300664.2992	3297818.844	Add rock
10	Exposed Geotextile is 2x2 feet in area. Some rock aggregate present.	300662.8045	3297821.023	Add rock
11	Exposed Geotextile, cause unknown. Some rock aggregate present. Possible joint.	300665.6821	3297858.861	Add rock and geotextile
12	Centroid for area of exposed geotextile and thin cap rock. Some rock aggregate present. 20 square feet of area total.	300676.9607	3297852.277	Add rock

Armor rock will be placed over each maintenance location shown on Figure 1 to assure that the design thickness of armor rock is present at all locations. As part of the Time Critical Removal Action planning for cap maintenance, two stockpiles of armor rock (armor rock C and armor rock D) were purchased and staged near the Site, and armor rock C will be used for this maintenance activity. Armor rock C is larger than or equivalent to the size of the

As you are aware, a skid steer front-end loader became disabled on the armored cap and the Respondents will place additional geotextile and armor rock in this area. In addition, the geotextile edge identified at Location 11 will also be addressed by placement of geotextile and armor rock.
