POTENTIAL HAZARDOUS WASTE SITE
SITE INSPECTION REPORT

A. SITE NAME	B. STREET (or other identifier)		
CAMERON IRON WORKS - CYPRESS PLANT	22301 Hempstead Hwy.		
C. CITY	D. STATE	E. ZIP CODE	F. COUNTY NAME
Houston	TX	77001	Harris

Steel melting, extruding and forging plant

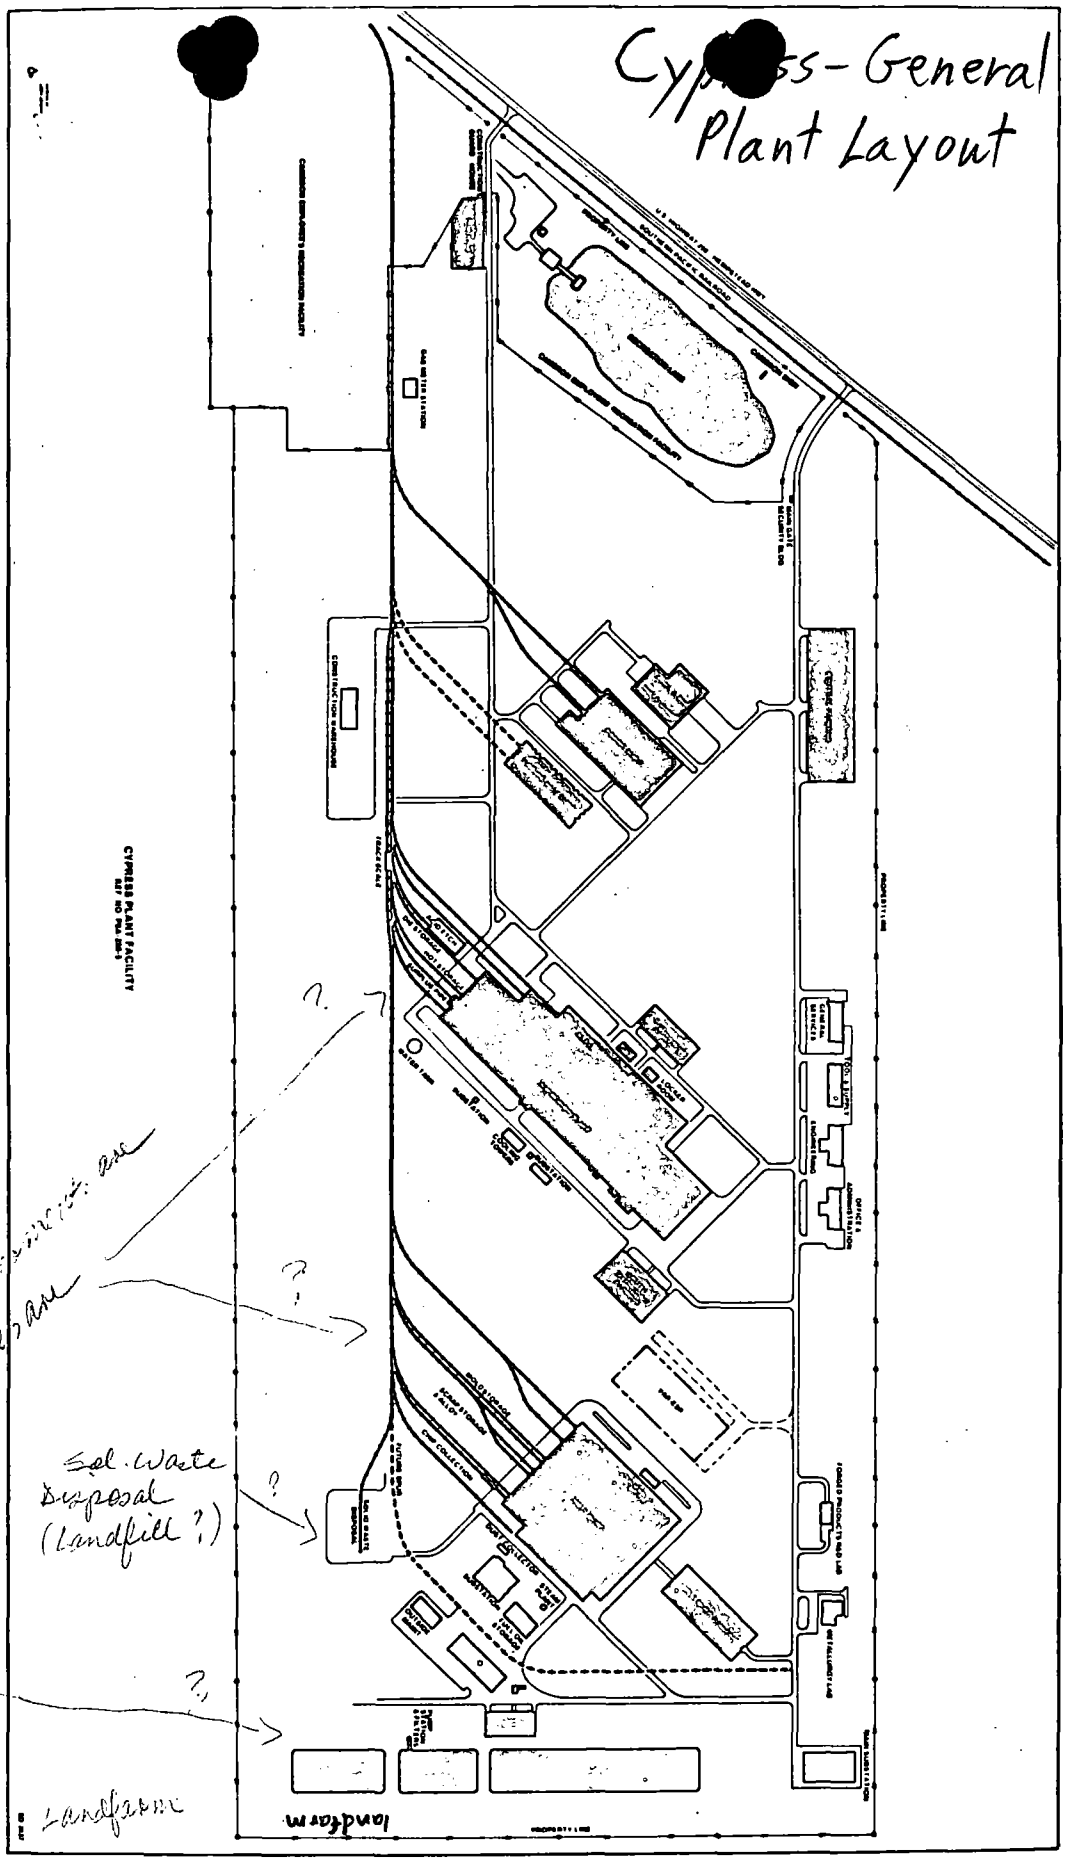
Cypress - General Plant Layout

Sol. Waste Disposal (Landfill ?)

cannot tell where surf. impoundments are or where piles are

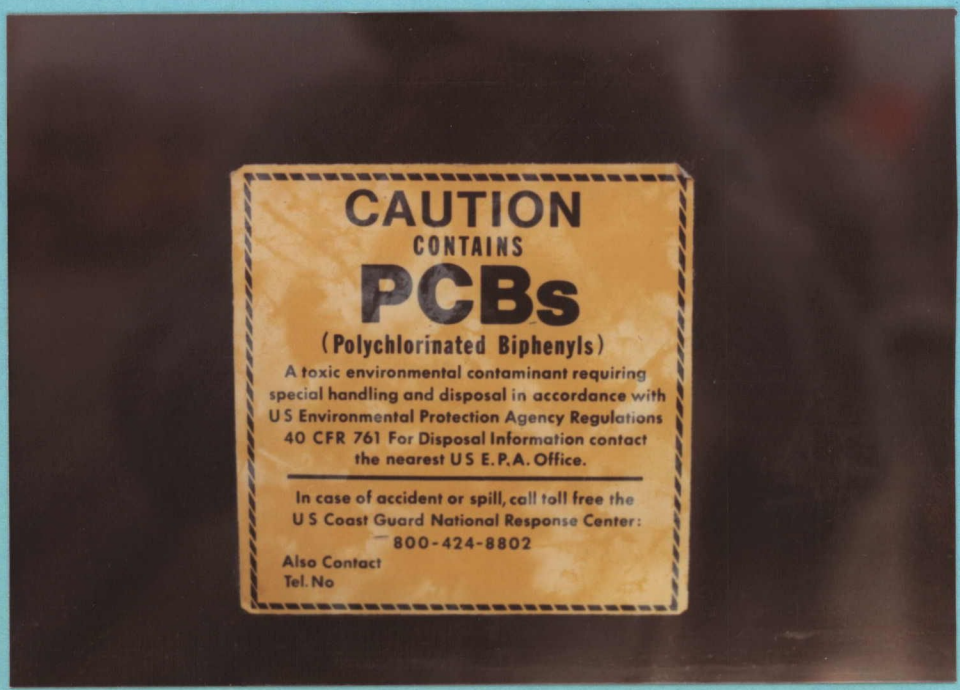
11/17/81 / 1:30 / SE

Comments: PCB STORAGE BUILDING
