EPA R6 and ERT Dive Team Operations
SUMMARY REPORT
Cap Assessment and Sampling Activities
San Jacinto Waste Pits
Channelview, TX
September 6 to 15, 2017

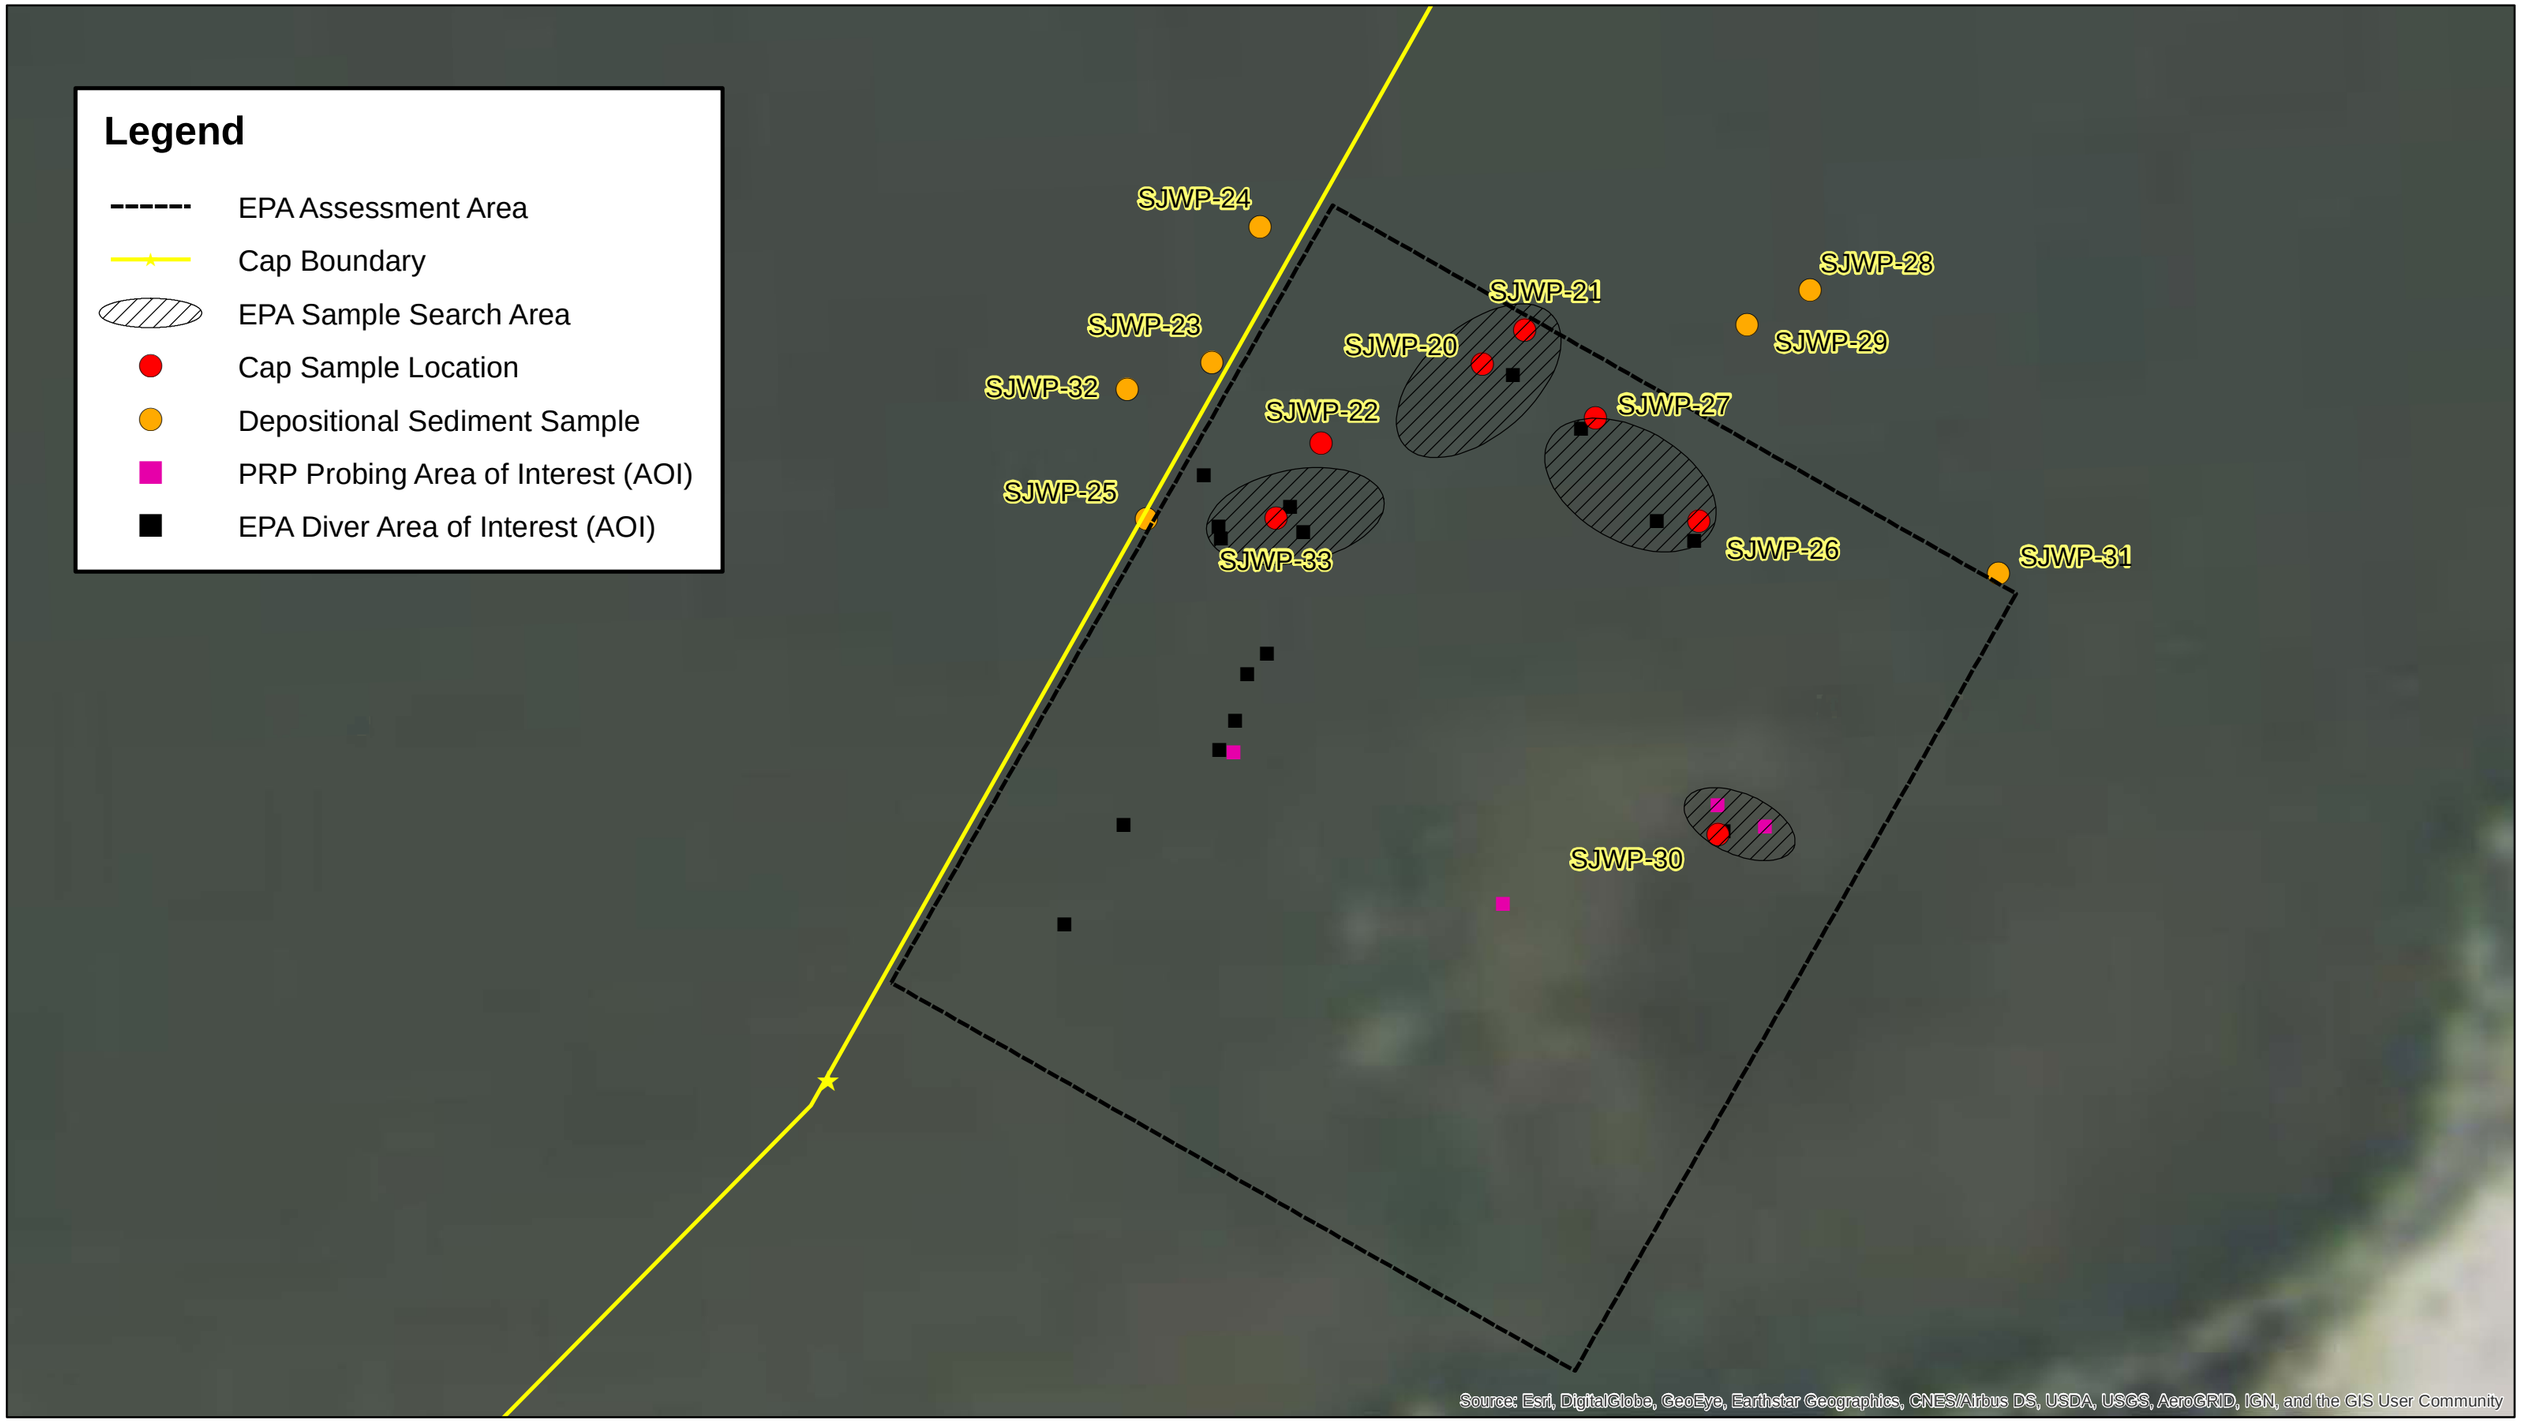
Figure 2
Probing and Diver Areas of Interest (AOI)
San Jacinto Waste Pits
Channelview, TX

southeastern corner was on the shoreline and most of the water in that quadrant was very shallow, but the deeper sections of that quadrant were assessed during the dives made on the west and east corners. Figure 2 shows the EPA Assessment Areas along with the EPA Diver AOIs. Diver descriptions for these AOIs are summarized in Table 3. During this survey, the divers observed that both the top and slopes of the cap contained varying thicknesses and coverages (complete/intact, intermittent, none) of armor stone. If there were significant gaps in the cap, the diver chose a possible area for sampling and a GPS point was taken. If there were multiple gaps in a larger area, one GPS coordinate was taken to be a representative sample of that area. At the base of the slope and extending into the river, the armor stone was found to be intact with up to 4 feet of what assumed to be depositional material on top of it. The thickness of the overlying sediments tended to be the thinnest near the base of the slope and generally got thicker heading away from the slope.
