A Supplemental Report Issued Following Hurricane Harvey

Examination of Selected Assertions by U.S. EPA in the Proposed Remedial Action Plan for the San Jacinto River Waste Pits Superfund Site

Doug Shields, Jr., Ph.D., P.E., D.WRE

October 6, 2017

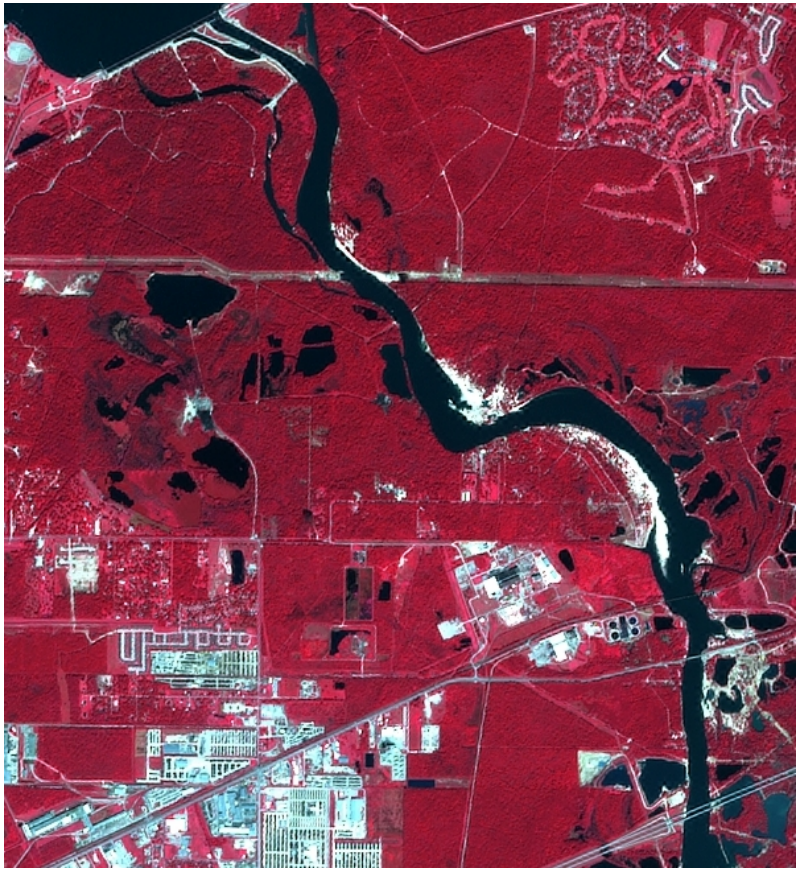
b. Lake Houston Dam to US Highway 90

Figure 3. Comparison of pre- and post-flood coverage of San Jacinto River, Texas. Color infrared imagery from Sentinel, European Space Agency.

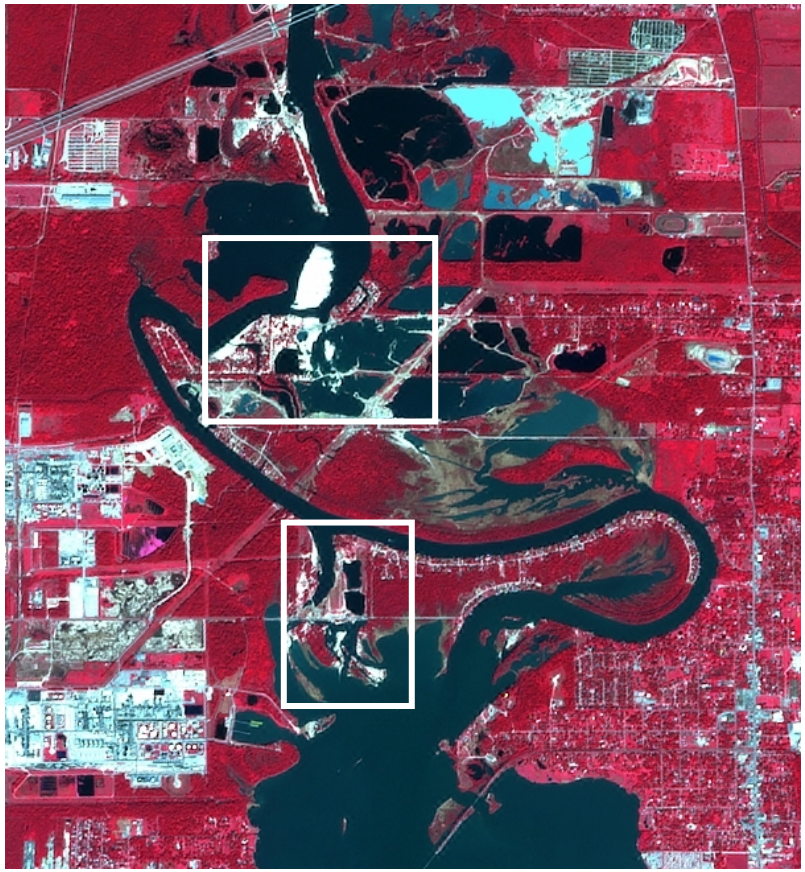
Figure 3. Comparison of pre- and post-flood coverage of San Jacinto River, Texas. Color infrared imagery from Sentinel, European Space Agency.

c. US Highway 90 to Bear Lake. White rectangles in October image highlight floodplain erosion and deposition.
