Anacast Foundry site,
Kennedale, Texas

TDD# : T06-9006-05
PAN# : TTXΦ25ΦSAA
CERCLIS : TXDΦ585Φ4762
OSC : Charles Fisher
TAT : MO ERFANI

Site Name Anacast Foundry

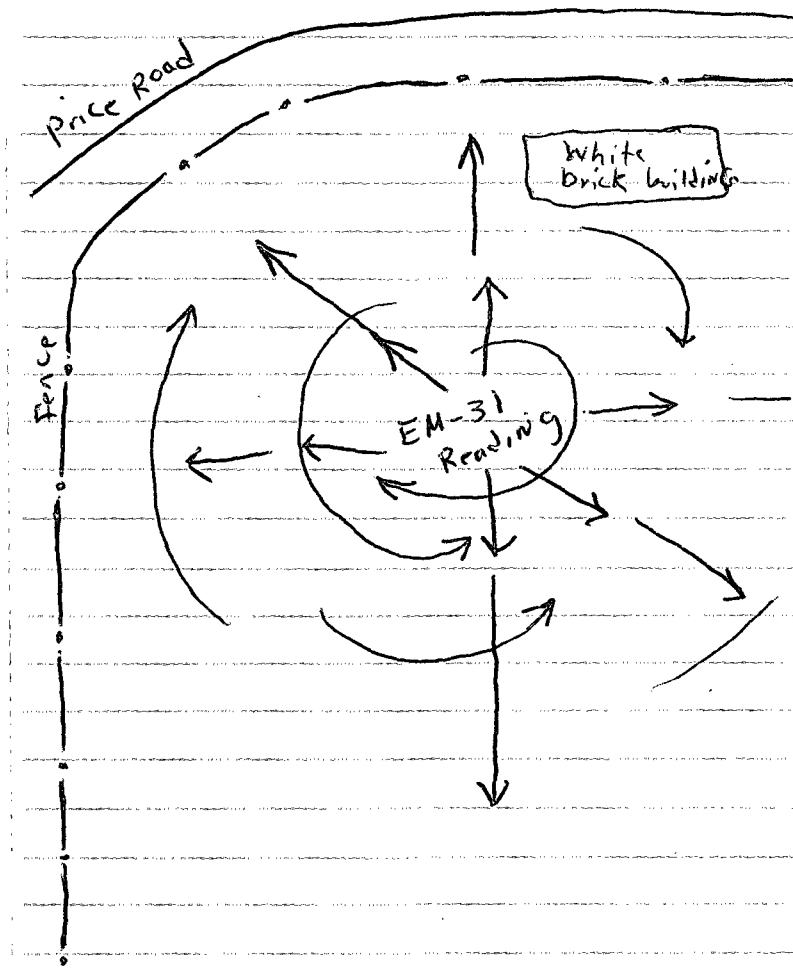
1025 TAT Member ErfanI is drawing a site sketch of the site. M-Erfani
