Field Report for Airborne Data Collected In Support of US EPA Region VI Intercontinental Terminals Company LLC Fire 22 March 2019

Data Results Flight 6 7, 8 and 9 22 March 2019

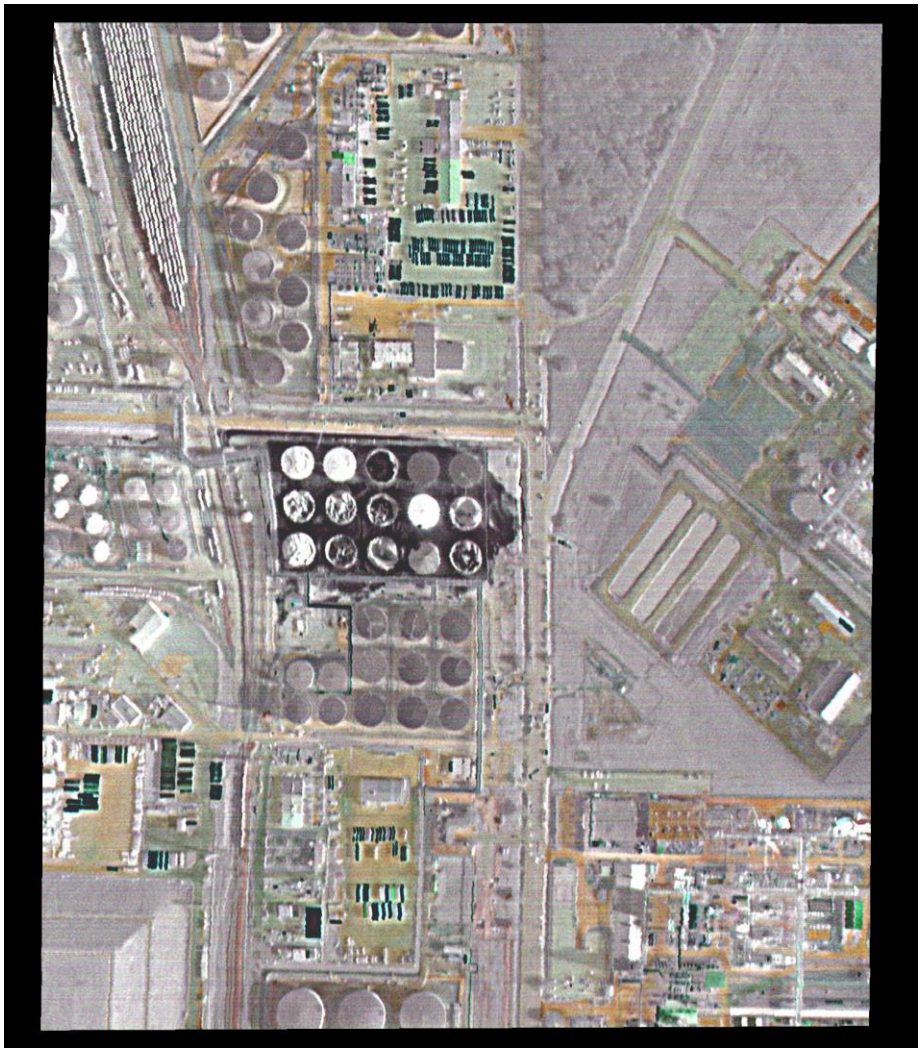
Figure 3: IR image of ITC data for 22 March 2019, Flight 7 Run 3

A total of 4 test and 17 data passes were made in the proximity of the impacted tank farm and also in extended areas surrounding the site and infrared line scanner images were generated for each pass. Figure 3 shows a typical 3-band infrared image obtained from data collected for Run 5. Examination of the IR image shows the tank farm with a black color within the secondary containment. This is actually white foam which is cooler than the surrounding oil and environment. A thermal analysis was conducted on a similar image with the results given in Figure 4 and tends to show that the tanks on the western end are actually the hottest with the NW tank consistently showing an elevated temperature remotely estimated to be about 70ºC.

Fights 8 and 9 were prompted by a report that secondary containment had failed at the tank farm. Figure 5 shows an image collected along the drainage channel leading the ship channel. A white signature substance can be seen being trapped at the confluence of

the drainage channel. Again the image is effectively showing a thermal signature so the while color is warmer than the black which is cooler; the oil is trapping solar radiation and heating up while the foam is reflective and cooler. Further analysis of the image shows that some material is leaking past the boom and entering the ship channel.

While the system was collecting data associated with the containment breach, a report was given that a fire restarted in the tank farm. Figure 6 is an example of IR imagery developed with the ASPECT night-vision thermal camera. Although this image is not calibrated, the content does show agreement with the thermal analysis conducted with data collected with line scanner. The image (which is flipped in direction) is showing the NW tank hotter than the surrounding but also is showing the tank south is hot around the edges and that a hot object is located further south and between the tanks.
