Field Report for Airborne Data Collected In Support of US EPA Region VI Intercontinental Terminals Company LLC Fire 20 March 2019

Data Results Flight 4, 20 March 2019

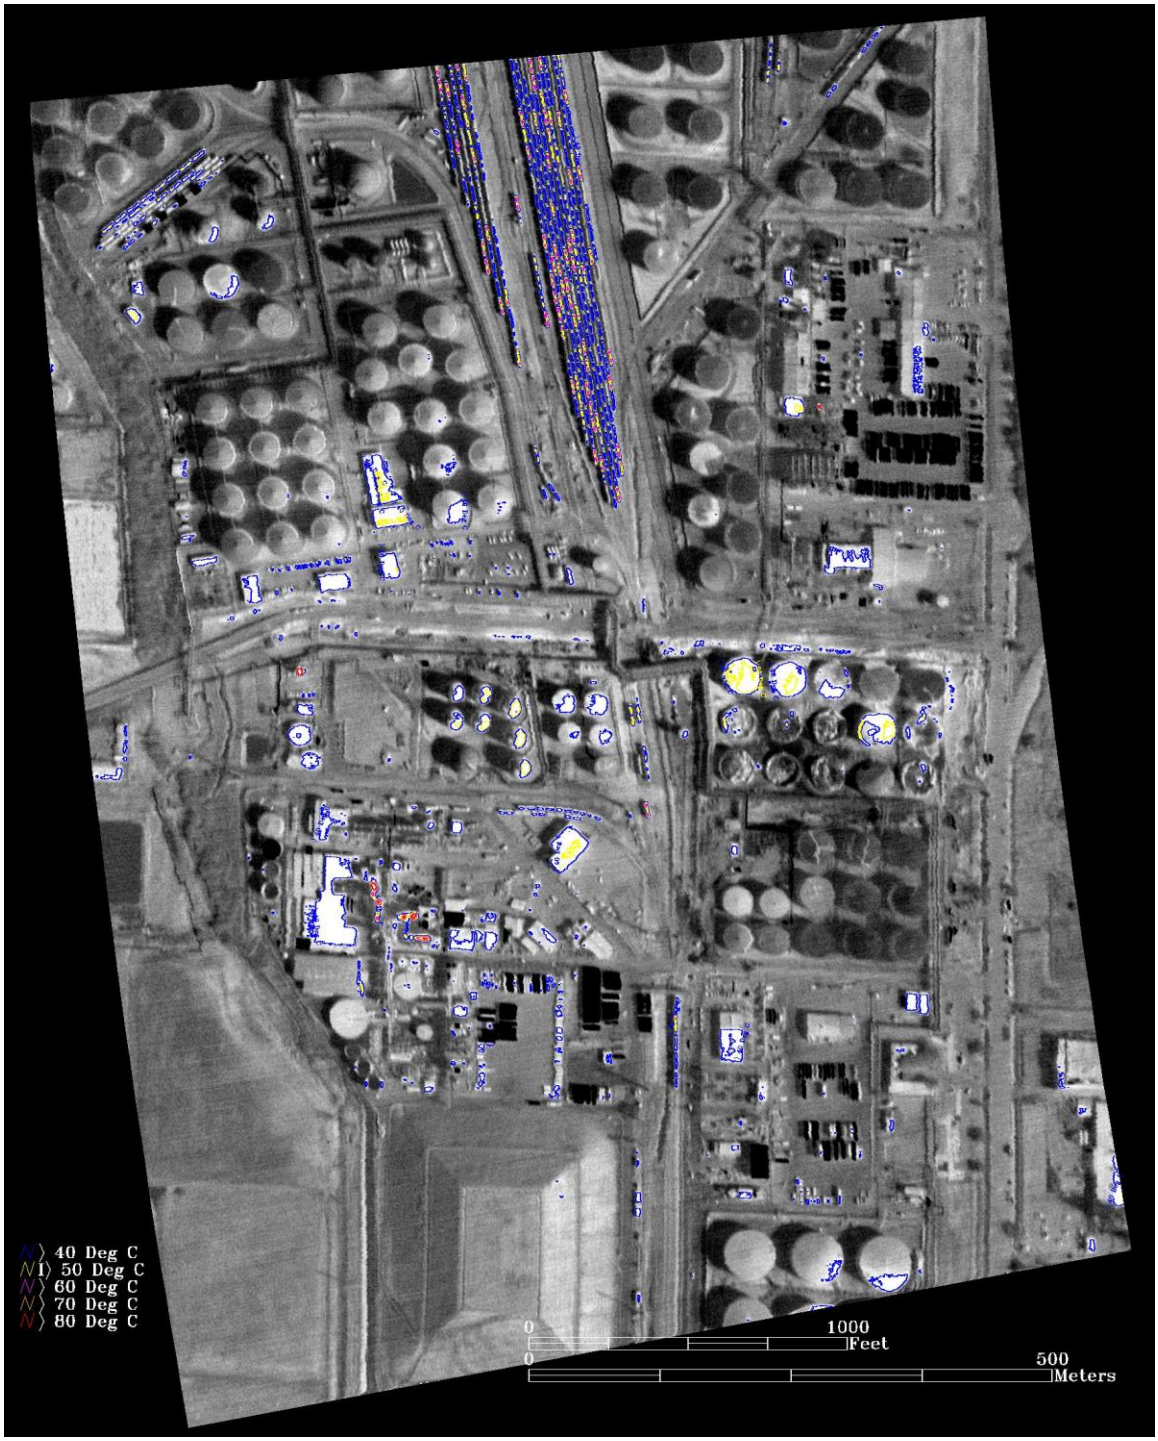
Figure 4: Thermal analysis of ITC data for 20 March 2019, Run 5

A total of 1 test and 8 data passes were made in the proximity of the site and an infrared line scanner images were generated for each pass. Figure 3 shows a typical 3-band infrared image obtained from data collected for Run 5. Examination of the IR image clearly shows that the fire is out due to the absence of any image saturation. Tanks on the NE corner of the farm and the center east tank do show some elevated temperature. A thermal analysis developed from the same pass of data does show that these tanks are elevated in temperature, showing an approximate temperature of about 60ºC as depicted by the yellow color (figure 4). It should be stressed that while these vessels are higher than the surrounding, there are other process related structures in the scene that are hotter which are shown as red. No plumes were detected in the image.

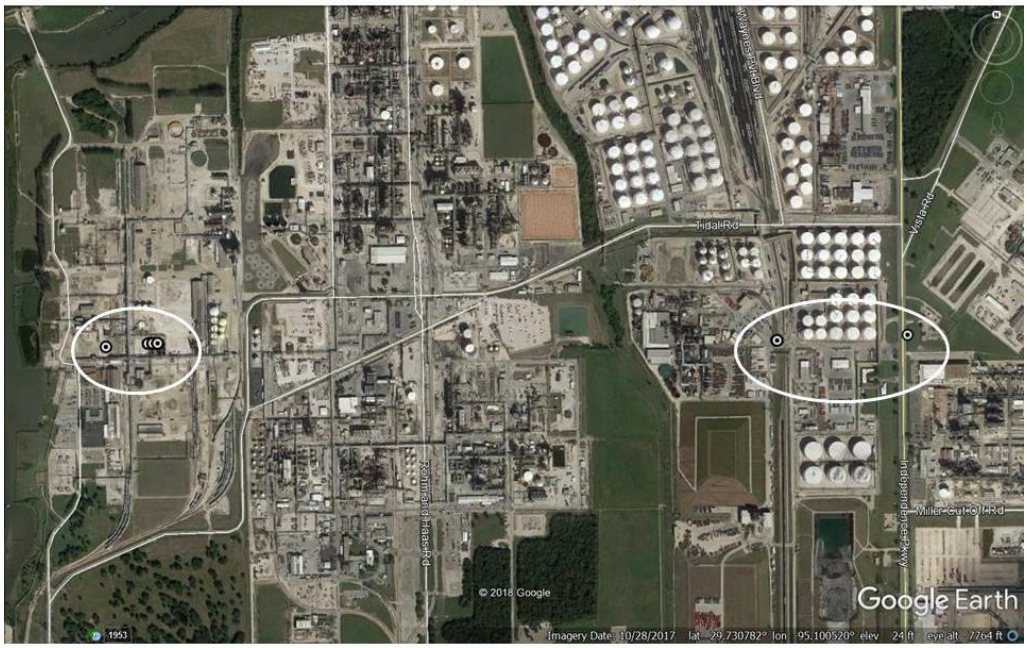
Figure 5: ITC Fire, Chemical Detection Locations – 20 March 2019

An examination of FTIR data collected on this mission showed low level detection west and south of the tank farm (Figure 5). Detections west of the farm include acetone (0.283ppm) and SO_2 (0.653 ppm). Based on the wind direction these detections are likely being transported into the area and are not associated with the former fire. Detections observed south of the tank farm include isobutylene (0.284 ppm) and isoprene (0.098 ppm) and may be associated with normal compounds in the urban air.
