Field Report for Airborne Data Collected In Support of US EPA Region 6 Intercontinental Terminals Company LLC Fire 3 April 2019

Data Results Flight 20, 3 April 2019

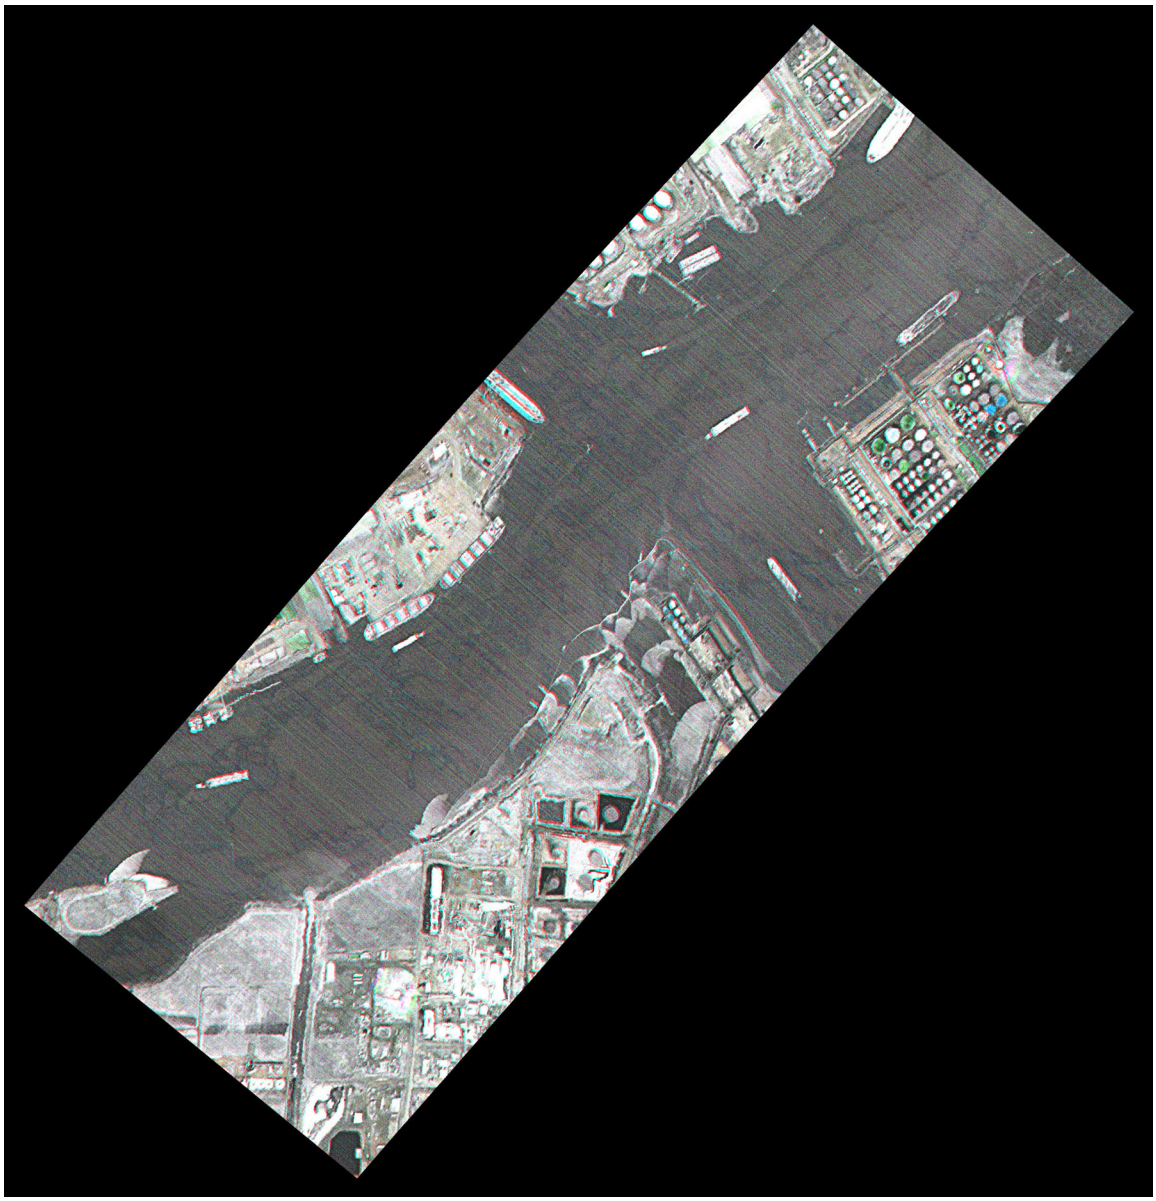
Figure 3: IR image of ITC data for 3 April 2019, Flight 20, Run 2

A total of 1 test and 5 data passes were made in the proximity of the impacted tank farm and also in extended areas surrounding the site and infrared line scanner images were generated for each pass. Figure 3 shows a typical 3-band infrared image obtained from data collected for Run 5. IR imagery of the tank farm indicates that all tanks are at ambient temperature other than IR solar heating on portions of the western structures.

An IR image of the confluence area is given in Figure 4. Product continues to be present within the boom structure. A small amount of sheen appears to be leaking in the northeast most structure.

Figure 4: IR Image of Contained Oil 3 April 2019, Fight 20, Run 6

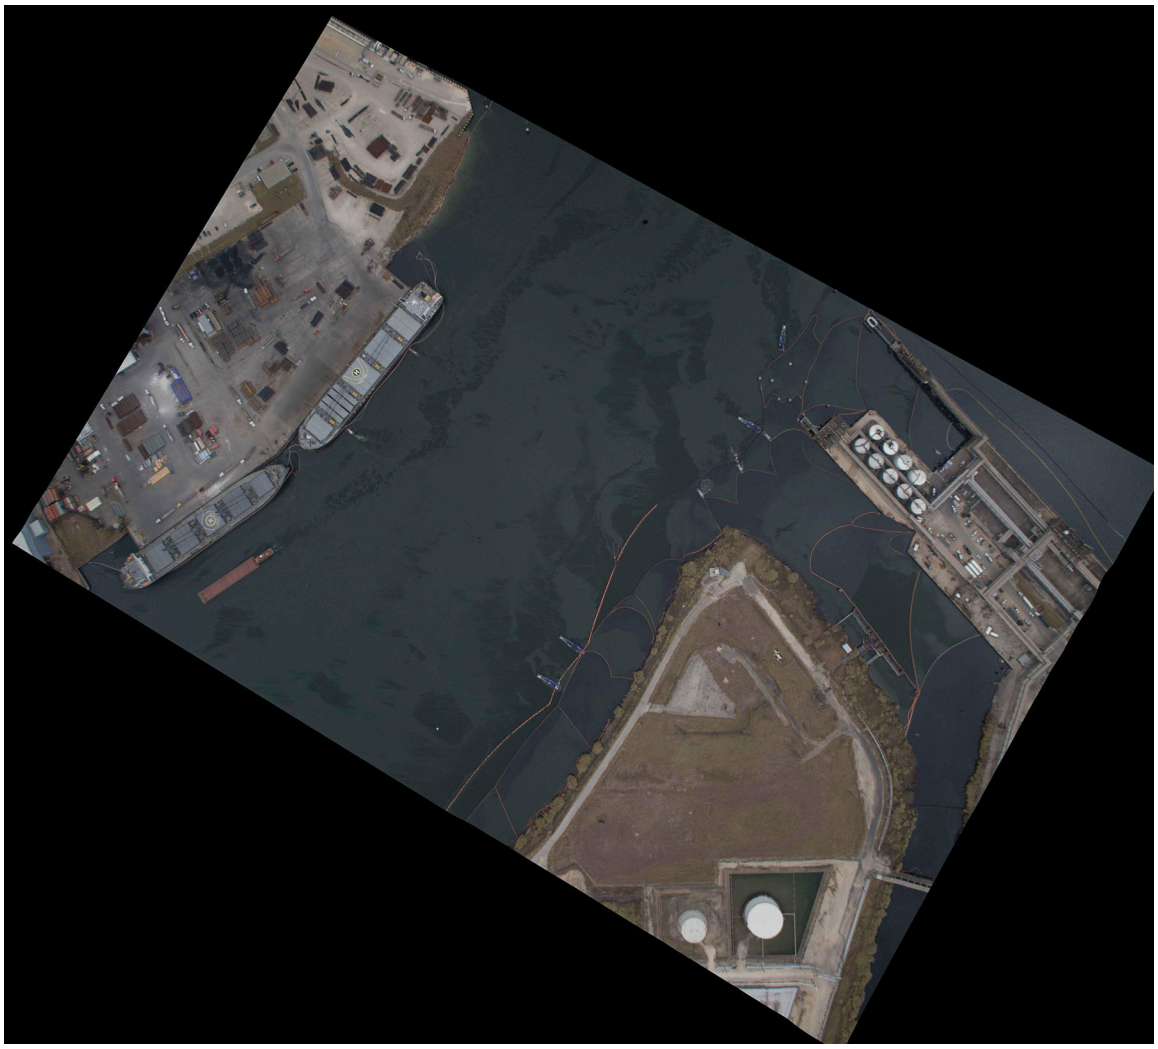
Figure 7: Aerial Image of the Ship Channel Boom Area, 3 April 2019, Flight 20

Figure 7 is an aerial image of the confluence area. As with prior flights, the boom network is clearly evident as is the trapped product behind the booms (visible as black material). There does not appear to be a significant change in the amount of trapped material from the previous mission. No significant leakage of product or sheen is present. An oblique of the same area confirms that most of the boom structure is holding product other than a small leakage of material in the northeast corner of the boomed area (Figure 8).
