Field Report for Airborne Data Collected In Support of US EPA Region 6 Intercontinental Terminals Company LLC Fire 27 March 2019

Data Results Flight 14, 27 March 2019

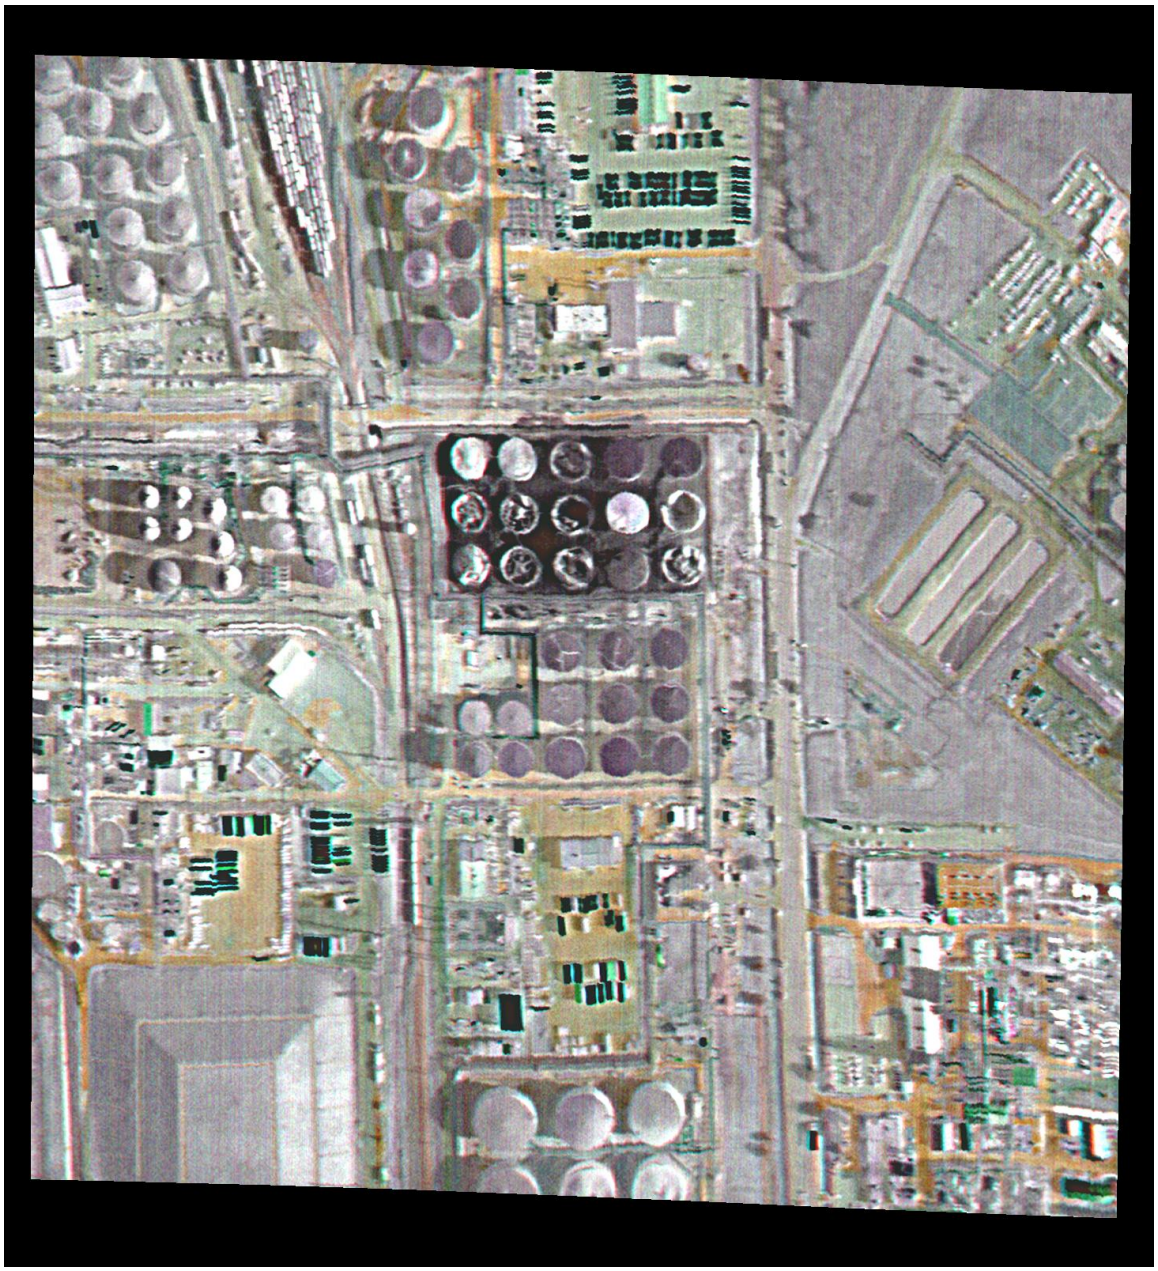
Figure 3: IR image of ITC data for 27 March 2019, Flight 14 Run 2

A total of 1 test and 7 data passes were made in the proximity of the impacted tank farm and also in extended areas surrounding the site and infrared line scanner images were generated for each pass. Figure 3 shows a typical 3-band infrared image obtained from data collected for Run 2. IR imagery is now showing fine detail on the tank surfaces and there is effectively no detector saturation. Figure 4 is a thermal image and which confirms the finding of the line scanner and shows tank surface features of tanks at ambient temperature (some solar heating is occurring). As with other thermal images, note that the bottom right in the image is the NW due to the image being inverted.

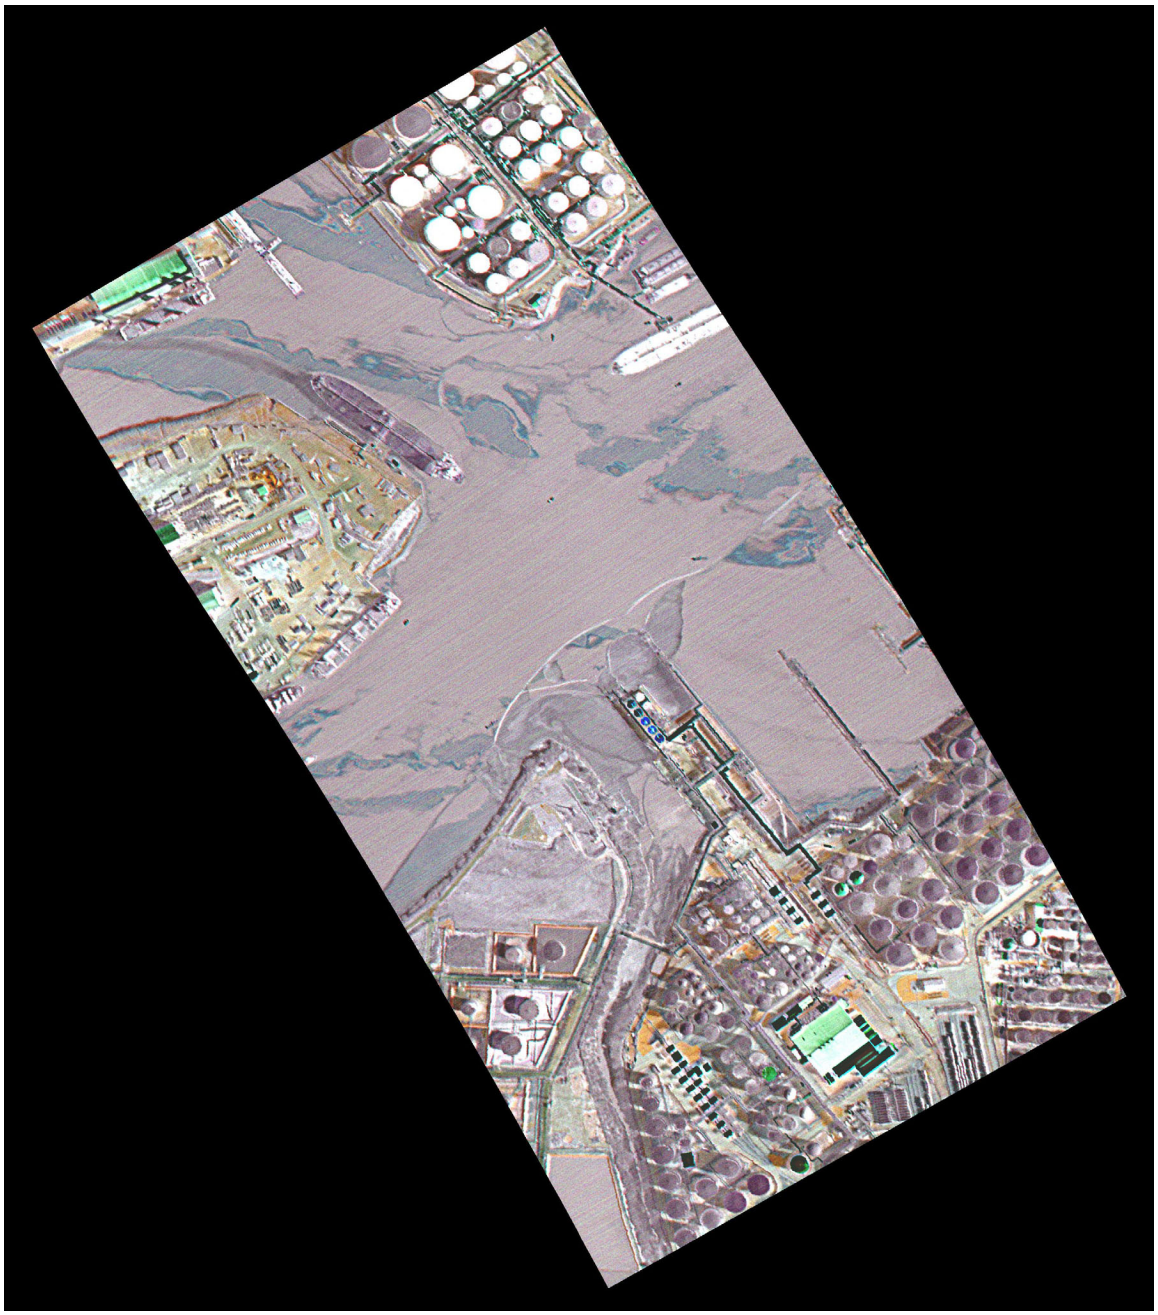
Figure 5: IR Image of Contained Oil 27 March 2019, Fight 14, Run 6

IR Run 5 was conducted over the confluence of the drainage creek into the ship channel with results similar to the prior mission. Containment boom (white due to solar heating)

continues to trap material with leakage can be seen across the channel mouth and also upstream within the drainage channel. Sheen leakage can be seen in the southwest edge of the boom (Figure 5). Figure 6 is a thermal image of the boom area and clearly shows the some boom leakage.

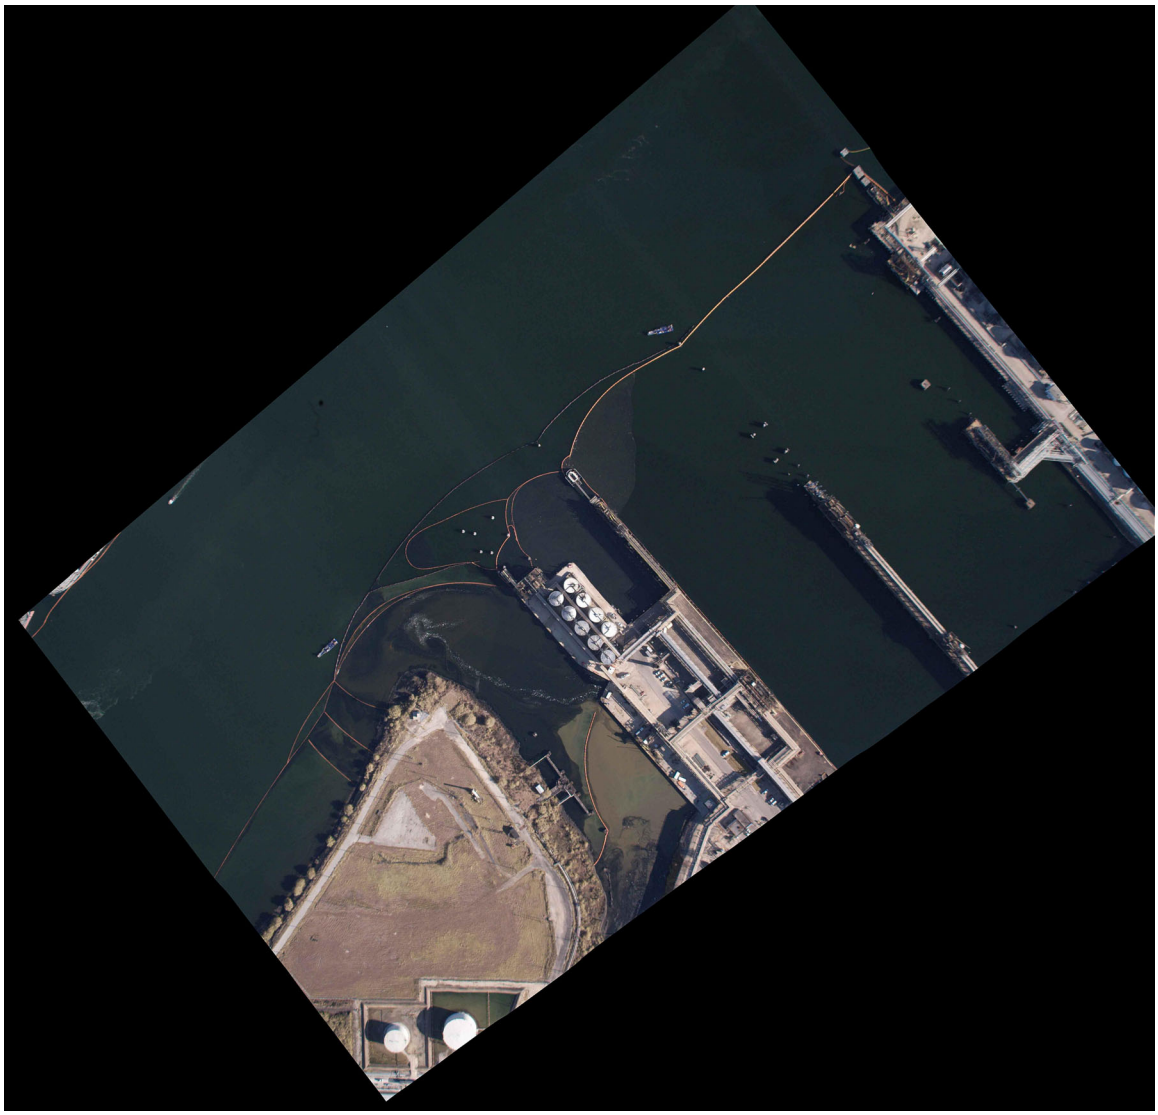
Figure 7: Aerial Image of the Ship Channel Boom Area, 27 March 2019, Flight 14

A full set of high resolution aerial digital photography was collected as part of the flight. Figure 7 shows a representative overhead image collected as part of each pass over the tank farm. There is effectively little new information that can be extracted for the tank farm. Figure 8 provides an overhead view of the confluence area. The amount of trapped product appears to be less than on prior missions. The image does not show boom leakage. The same area as viewed using the oblique camera downs more detail of the trapped product and does show some leakage from one boom layer to the next. Little leakage is evident from the main booms
