Field Report for Airborne Data Collected In Support of US EPA Region 6 Intercontinental Terminals Company LLC Fire 26 March 2019

Data Results Flight 13, 26 March 2019

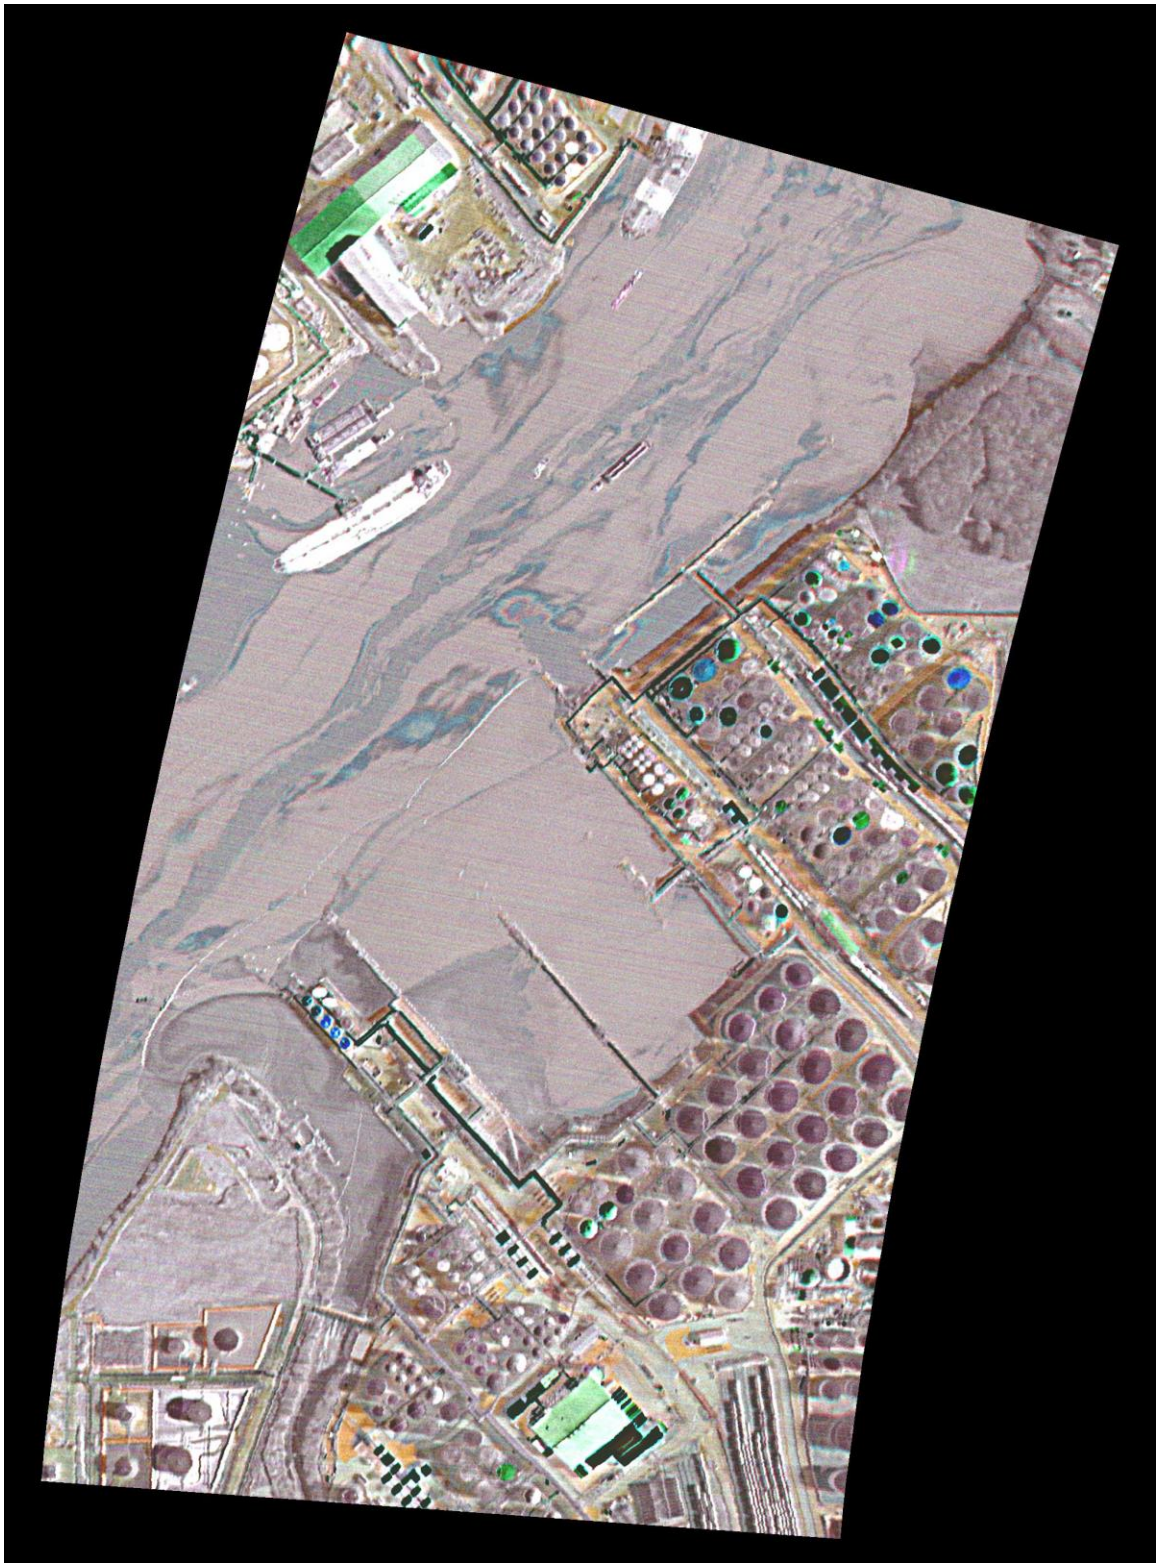
A total of 1 test and 7 data passes were made in the proximity of the impacted tank farm and also in extended areas surrounding the site and infrared line scanner images were generated for each pass. Figure 3 shows a typical 3-band infrared image obtained from data collected for Run 2. The image tends to show more surface detail on the tanks in the NM portion of the tank farm due to less detector saturation. This effect supports that the temperature of the tanks is close to ambient with heating likely due to solar radiation. A night vision thermal image supports this observation with clear surface details showing in the far NW tank and to a lesser degree that tank located to the east (bottom right in the image is the NW due to the image being inverted)(Figure 4).

IR Run 5 was conducted over the confluence of the drainage creek into the ship channel. Containment boom (white due to solar heating) can be seen across the channel mouth and also upstream within the drainage channel. Sheen leakage is very apparent in the image and is present in the entire field of view of the image (Figure 5).

Figure 3: IR image of ITC data for 26 March 2019, Flight 13 Run 2

Figure 4: IR Thermal Analysis 26 March 2019, Flight 13, Run 7

Figure 5: IR Image of Contained Oil 26 March 2019, Fight 13, Run 5

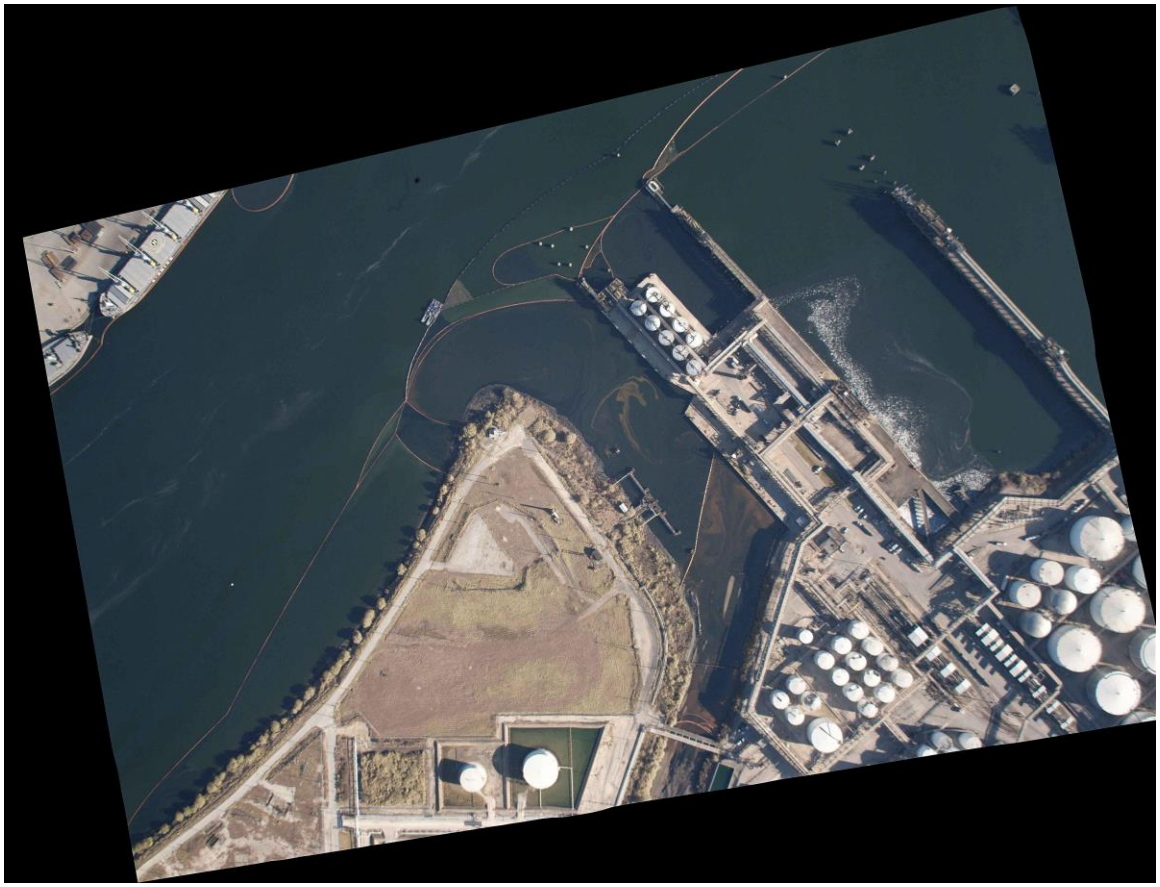
A full set of high resolution aerial digital photography was collected as part of the flight. Figure 6 shows a representative overhead image collected as part of each pass over the tank farm. Damage to the tanks is clearly evident as is the continued presence of white material in the secondary containment. Figure 7 provides an overhead view of the confluence area with the boom structure evident. Some product and sheen can be seen but differentiation of these materials is less apparent in the visible image as compared to the IR. Figure 8 shows the same area but from the perspective of an oblique image. Differentiation of project is more robust as compared to the overhead with limited evidence of sheen.

Figure 6: Aerial Image of the Tank Farm, 26 March 2019, Flight 13
