Field Report for Airborne Data Collected In Support of US EPA Region VI International Terminal Corporation Fire 18 March 2019

Data Results Flight 2 18 March 2019

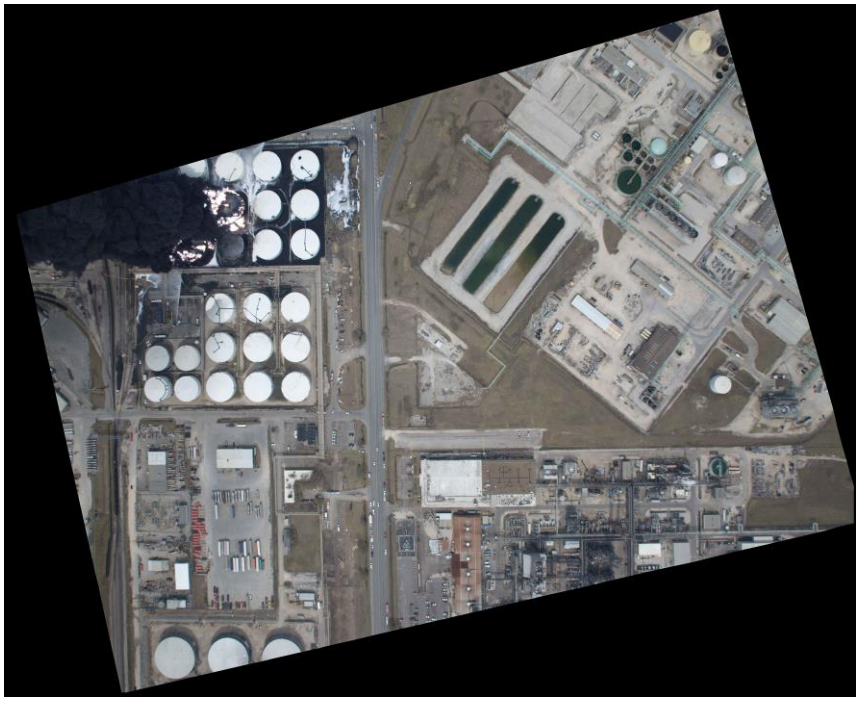
Figure 6: Aerial Image of the International Terminal Corporation Fire, Flt 2

A full set of high resolution aerial digital photography were collected as part of the flight. Figure 6 shows a representative image collected as part of each pass. As discussed in the IRLS Figure 7 shows a representative oblique collected from the copilot station. This image clearly shows the presence of fire in the center tank with additional fire surrounding the tank. The fire is generating a large amount of smoke which is rising nearly vertical. The low light conditions of the image are a result of the plume shading the area as the aircraft passed over the site.
