Field Report for Airborne Data Collected In Support of US EPA Region 6 Intercontinental Terminals Company LLC Fire 15 April 2019

Data Results Flight 26, 15 April 2019

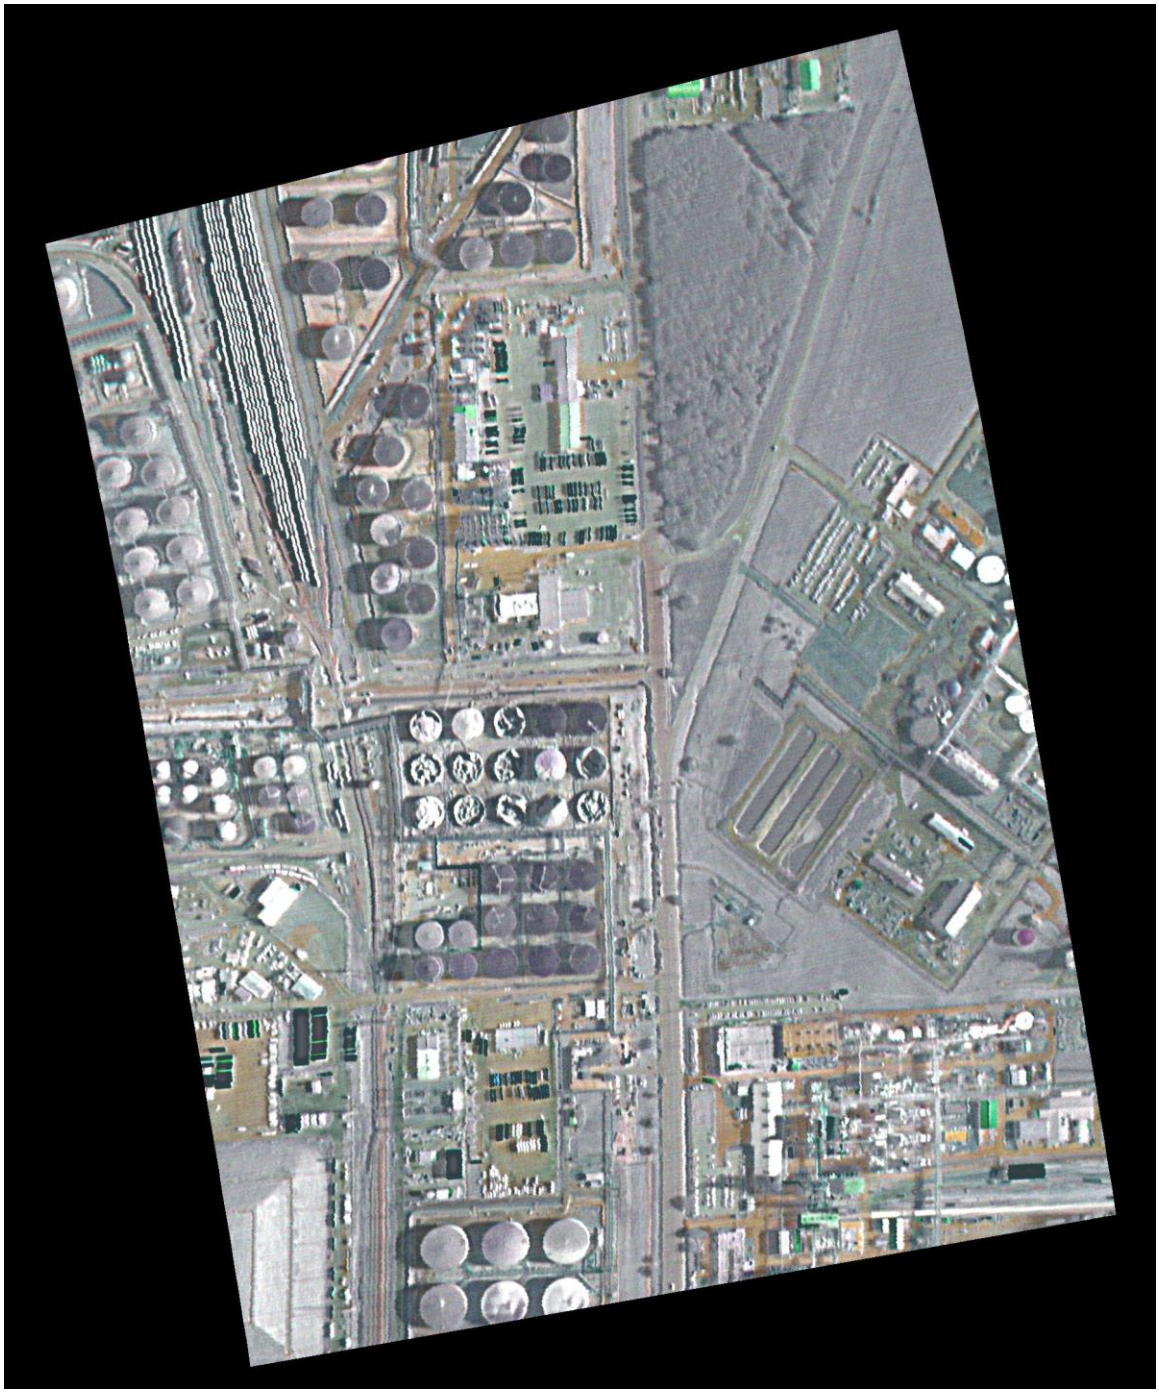
Figure 3: IR image of ITC data for 15 April 2019, Flight 26, Run 5

A total of 2 test and 5 data passes were made in the proximity of the impacted tank farm and also in extended areas surrounding the site and infrared line scanner images were generated for each pass. Figure 3 shows a typical 3-band infrared image obtained from data collected for Run 5. Analysis of the imagery shows no change in the tank farm area from Flight 25 conducted on 14 April 2019. All tanks show normal solar heating with the two tanks in the NE exhibiting cooler temperatures than the others.

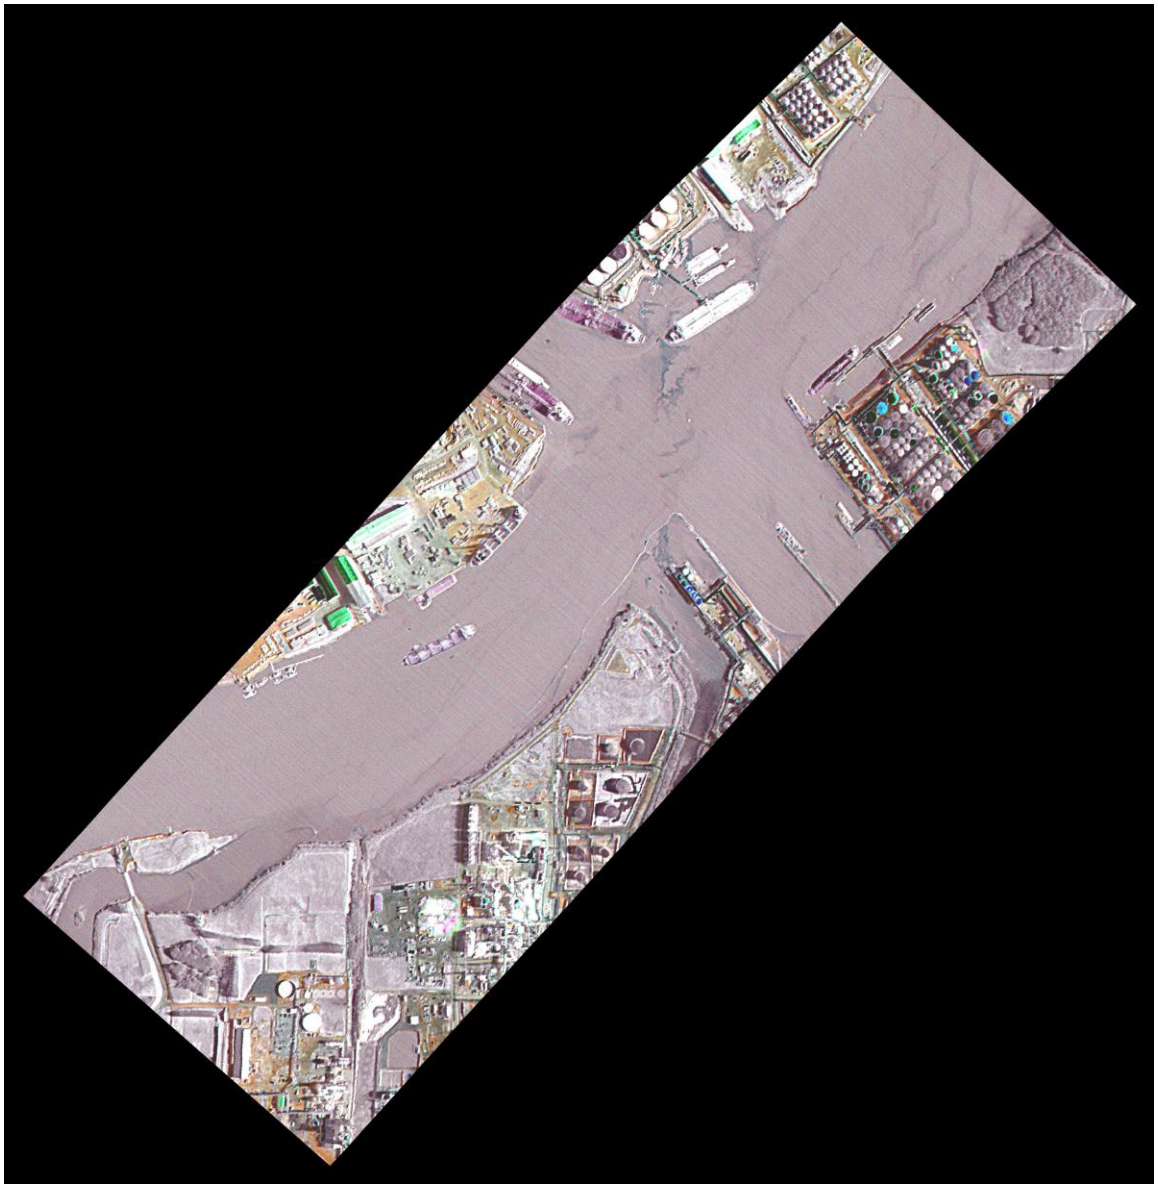
Figure 4: IR Image of Contained Oil 15 April 2019, Flight 26, Run 6

The confluence area is shown in Figure 4. Examination shows similarity to the imagery collected on 14 April 2019 namely that the channel water is relatively warm. The dark signature in the channel behind the ship is likely cooler water from the prop wash. Little

if any product is observable in the image. In addition, no sheen or leakage is evident in the image.

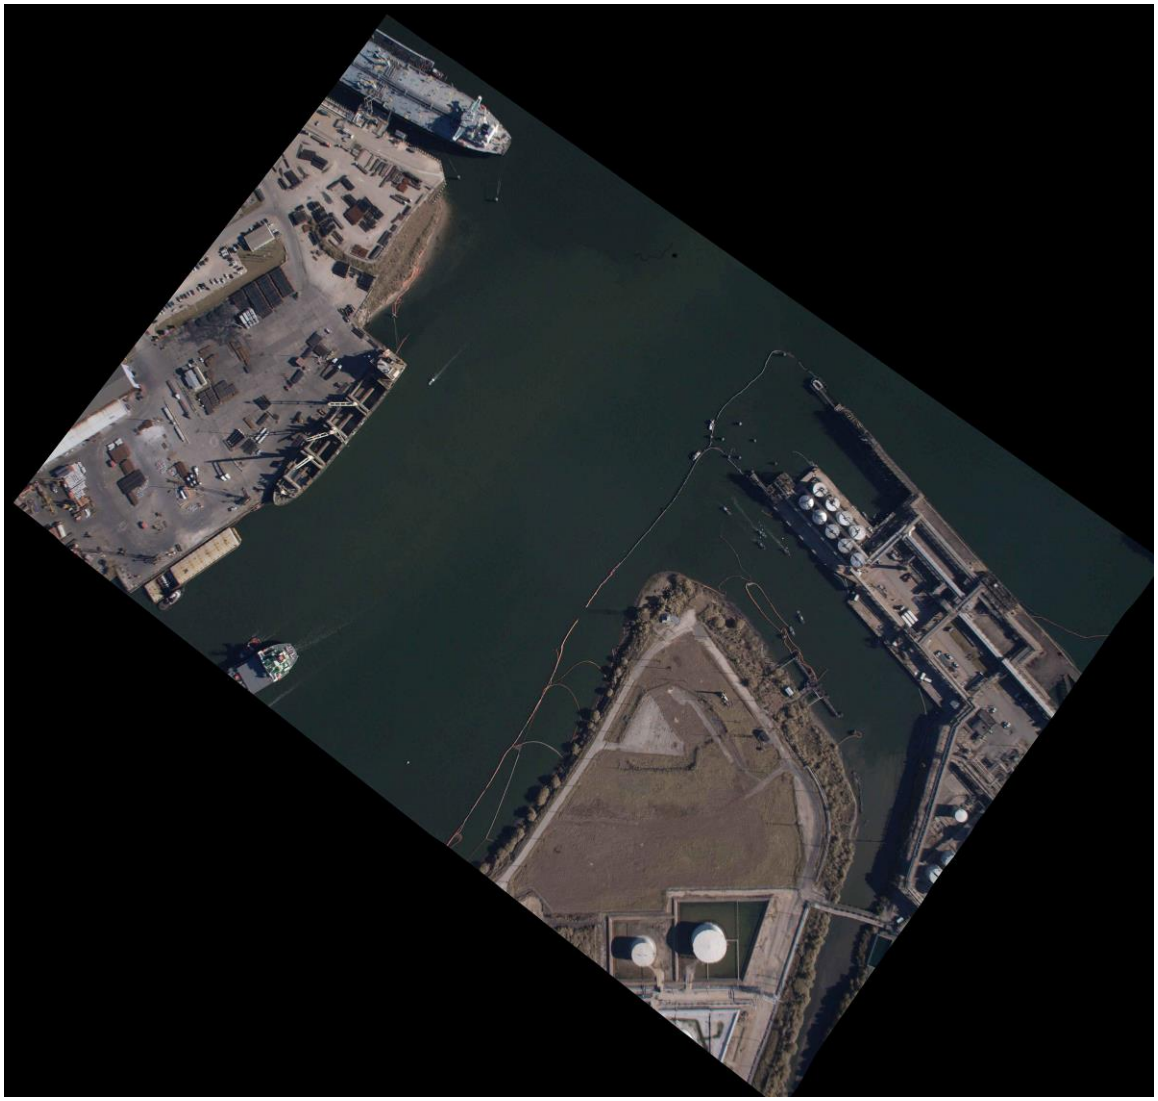
Figure 7: Aerial Image of the Ship Channel Boom Area, 15 April 2019, Flight 26

Figure 7 shows an overhead aerial image of the boomed area along the ship channel. A small dark area is present extending from the point of the drainage channel. Examination of this area and the same area shown in the oblique (Figure 8) suggest this is a shadow from a tower located near the shore and not product. No sheen is visible in either image perspective.
