Field Report for Airborne Data Collected In Support of US EPA Region 6 Intercontinental Terminals Company LLC Fire 8 April 2019

Data Results Flight 21, 8 April 2019

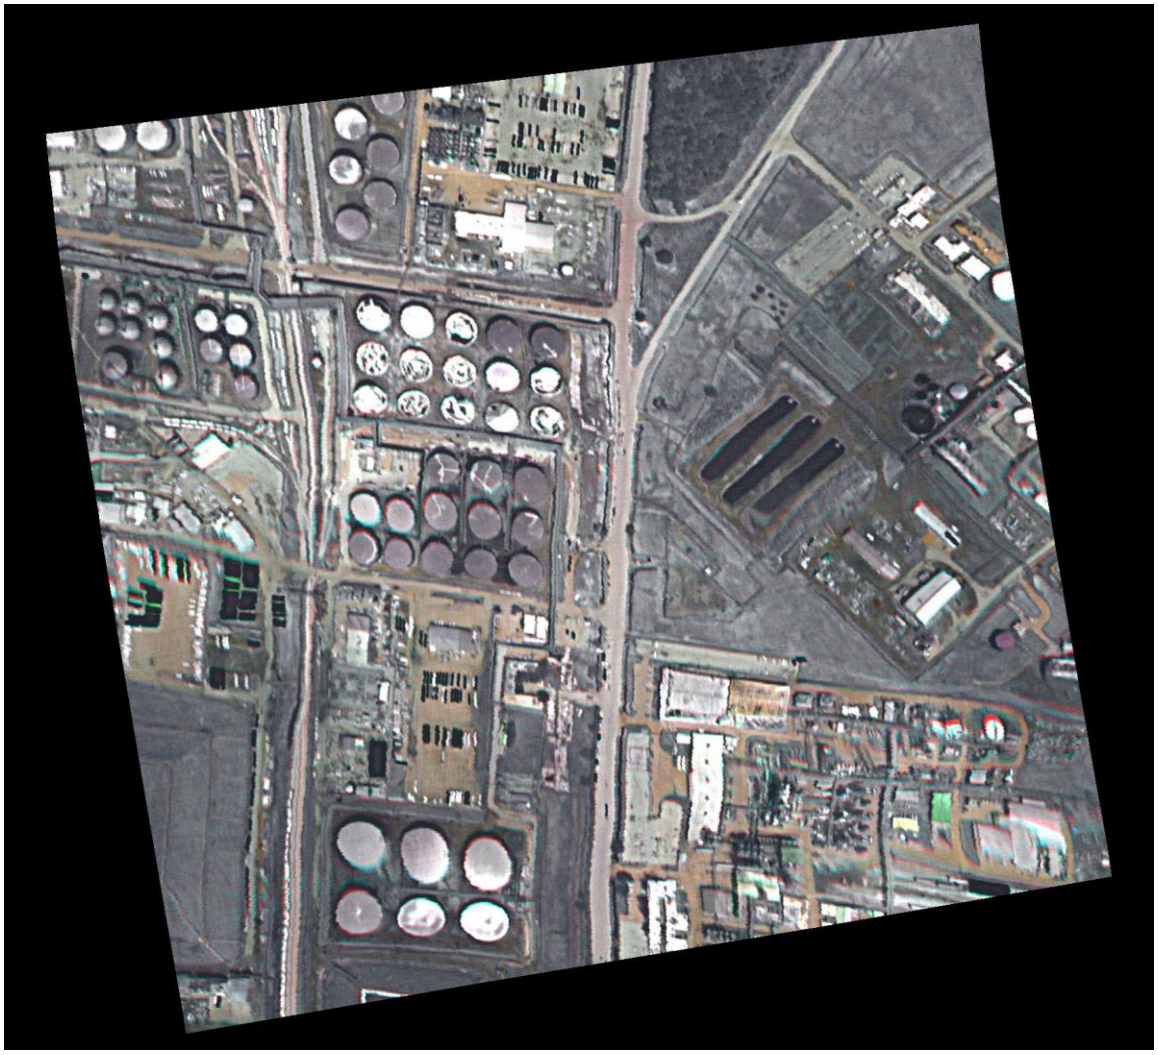
Figure 3: IR image of ITC data for 8 April 2019, Flight 21, Run 4

A total of 1 test and 5 data passes were made in the proximity of the impacted tank farm and also in extended areas surrounding the site and infrared line scanner images were generated for each pass. Figure 3 shows a typical 3-band infrared image obtained from data collected for Run 5. IR imagery of the tank farm indicates that the heavily damaged tanks show normal solar heating while the two tanks in the NE corner show minimal solar heating.

An IR image of the confluence area is given in Figure 4. A significant reduction in trapped product is evident. The remaining product seems to be along the southern booms on the ship channel with what appears to be some material pushed along the booms on

the channel side of the boom. Based on the IR imagery there appears to be no sheen leaking from the booms so the material on the outside of the booms may be channel debris.

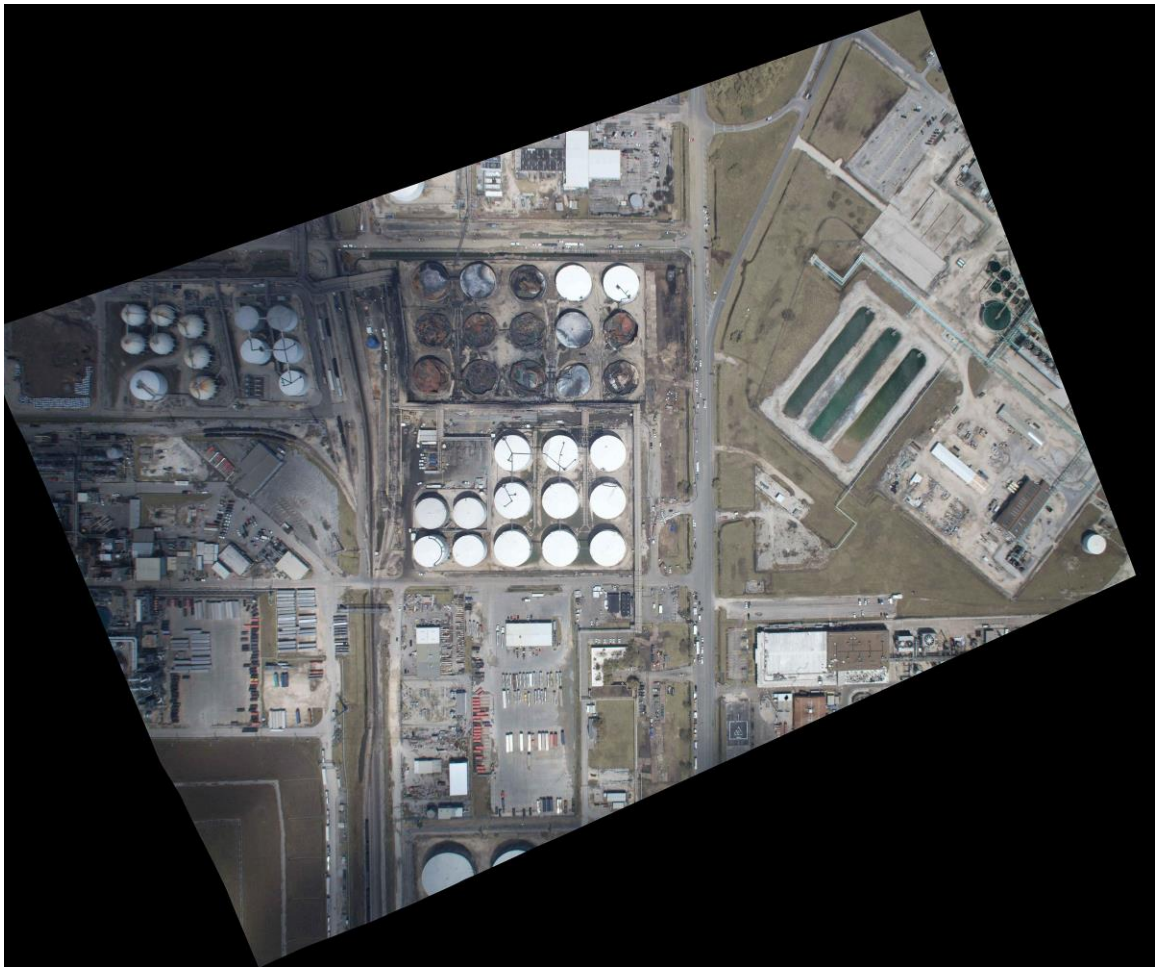
Figure 6: Aerial Image of the Tank Farm, 8 April 2019, Flight 21

A full set of high resolution aerial digital photography was collected as part of the flight. Figure 6 shows a representative overhead image collected as part of each pass over the tank farm. Analysis of the image shows no change from imagery collected on 3 April 2019. The dark hue on the left side of the image is a cloud shadow. Figure 7 shows an oblique image of the tank farm and confirms no change from the 3 April 2019 flight.

The confluence area aerial image is given in figure 9. Examination of the image shows a small amount of dark product trapped in the channel booms. No significant leakage of product or sheen is present. An oblique of the confluence area confirms that material is located on the outside of the channel booms (most likely pushed into position by the wind). No sheen is evident in the image.
