Field Report for Airborne Data Collected In Support of US EPA Region 6 Intercontinental Terminals Company LLC Fire 10 April 2019

Data Results Flight 23, 10 April 2019

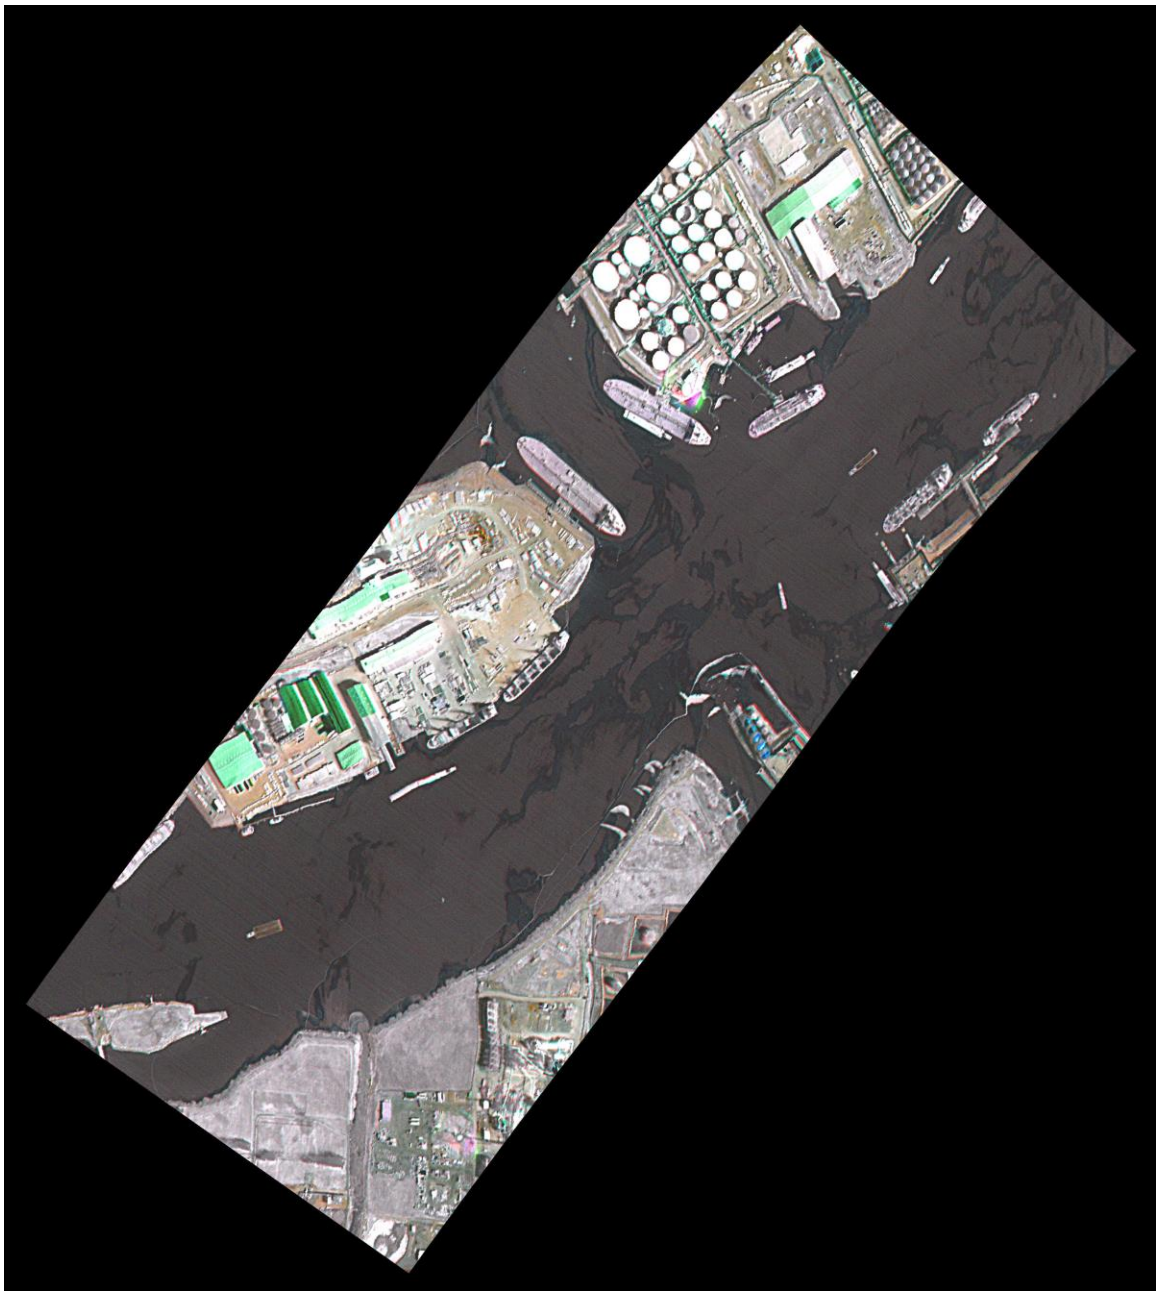
Figure 3: IR image of ITC data for 10 April 2019, Flight 23, Run 5

A total of 1 test and 5 data passes were made in the proximity of the impacted tank farm and also in extended areas surrounding the site and infrared line scanner images were generated for each pass. Figure 3 shows a typical 3-band infrared image obtained from data collected for Run 5. No significant difference was noted between this image and those collected on 9 April 2019.

Figure 4 provides an IR image of the confluence area. Some product (shown as white) can be observed within the boom structure namely product pushed to north by the wind. Little change in the apparent quantity of product is evident from the prior flight on 9 April 2019. Very light sheen or possibly prop wash (cooler upwelling water) is present in the channel with no significant leakage from the booms.

Figure 4: IR Image of Contained Oil 10 April 2019, Fight 23, Run 6

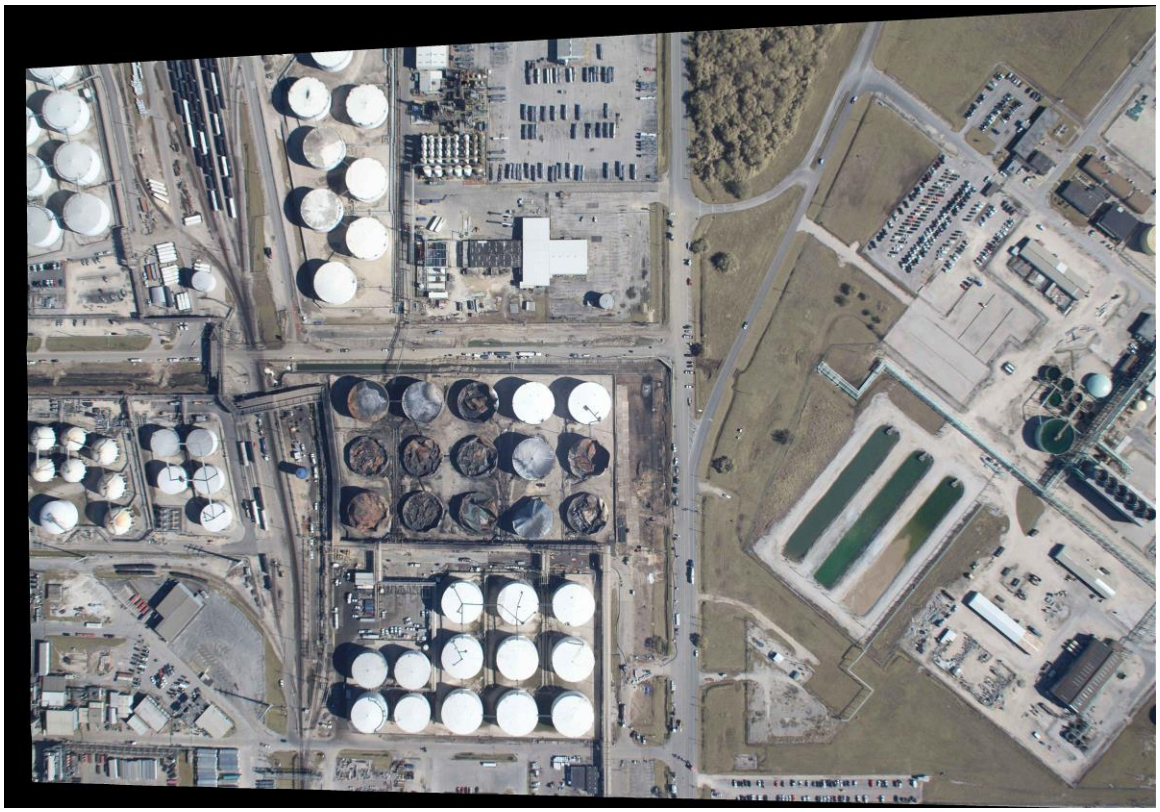
Figure 5: Aerial Image of the Tank Farm, 10 April 2019, Flight 23

A full set of high resolution aerial digital photography was collected as part of the flight. Figure 5 and 6 show representative overhead images collected as part of each pass over the tank farm. Examination of the image shows no change in the status of the tank farm from the previous flight on 9 April 2019. A similar conclusion can be reached by referring to the oblique image.

Figure 6: Oblique Image of the Tank Farm (looking south), 10 April 2019 Flight 23

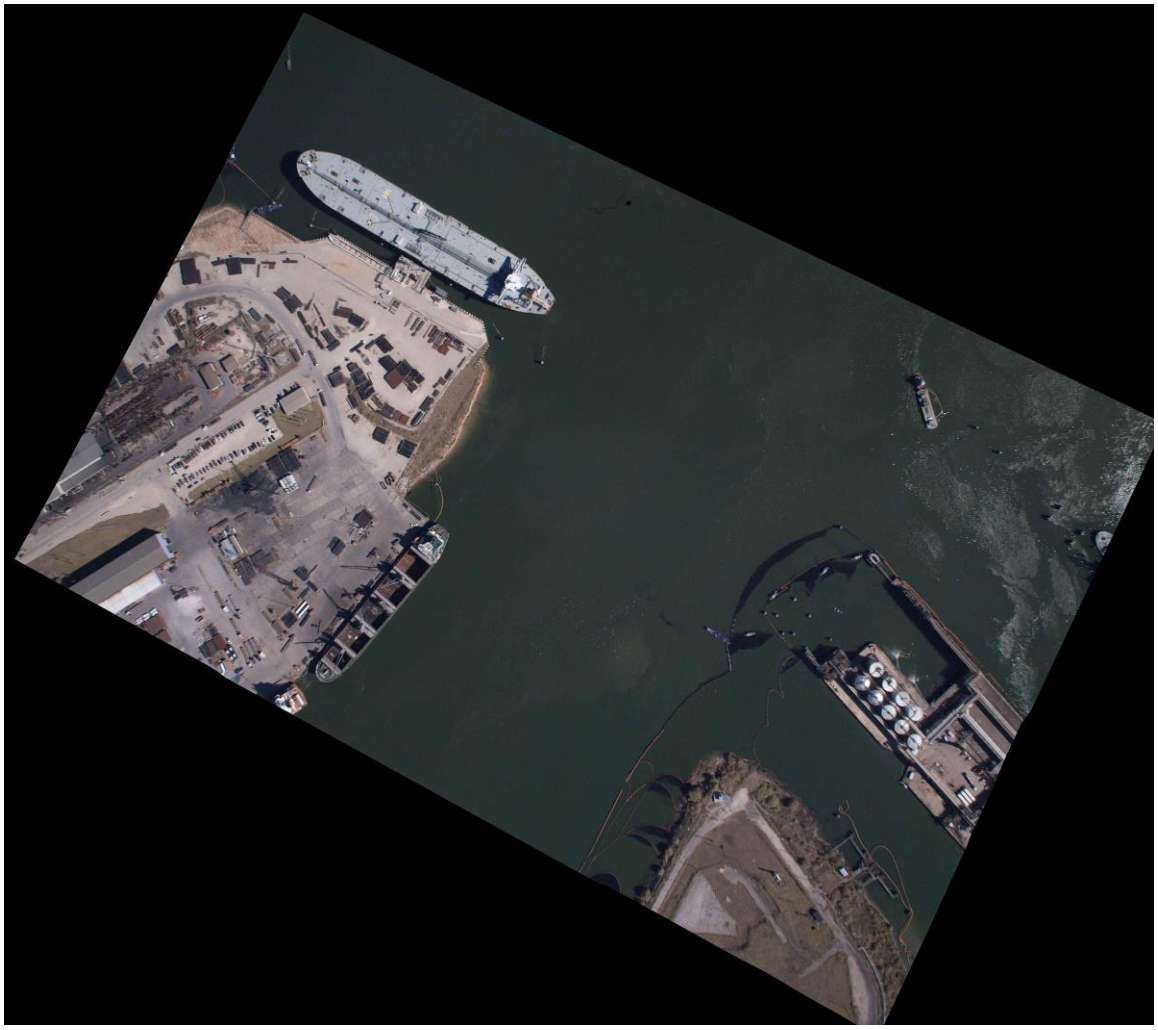
Figure 7: Aerial Image of the Ship Channel Boom Area, 10 April 2019, Flight 23

Figure 7 shows an aerial image collected over the confluence area. As observed in the IR image, trapped product has been pushed against the booms due to the southerly wind. Examination of the main channel shows what appears to be some product in the wake of the boom tug. The oblique image (Figure 8) also shows what appears to be a small amount of product in the main channel. No other leakage is evident. No sheen is present in the image.

Figure 8: Oblique Image of the Ship Channel Boom Area, 10 April 2019, Flight 23
