TCEQ Interoffice Memorandum

Subject: **Request for Region to Investigate F.J. Doyle Salvage Facility located at (b) (6) (b) (6) (905 N. Poplar Street), Leonard, Fannin County, Texas**
TCEQ SWR No. 80951; EPA ID No. TXD980865109; Customer No. CN600359095; Regulated Entity No. RN100649227

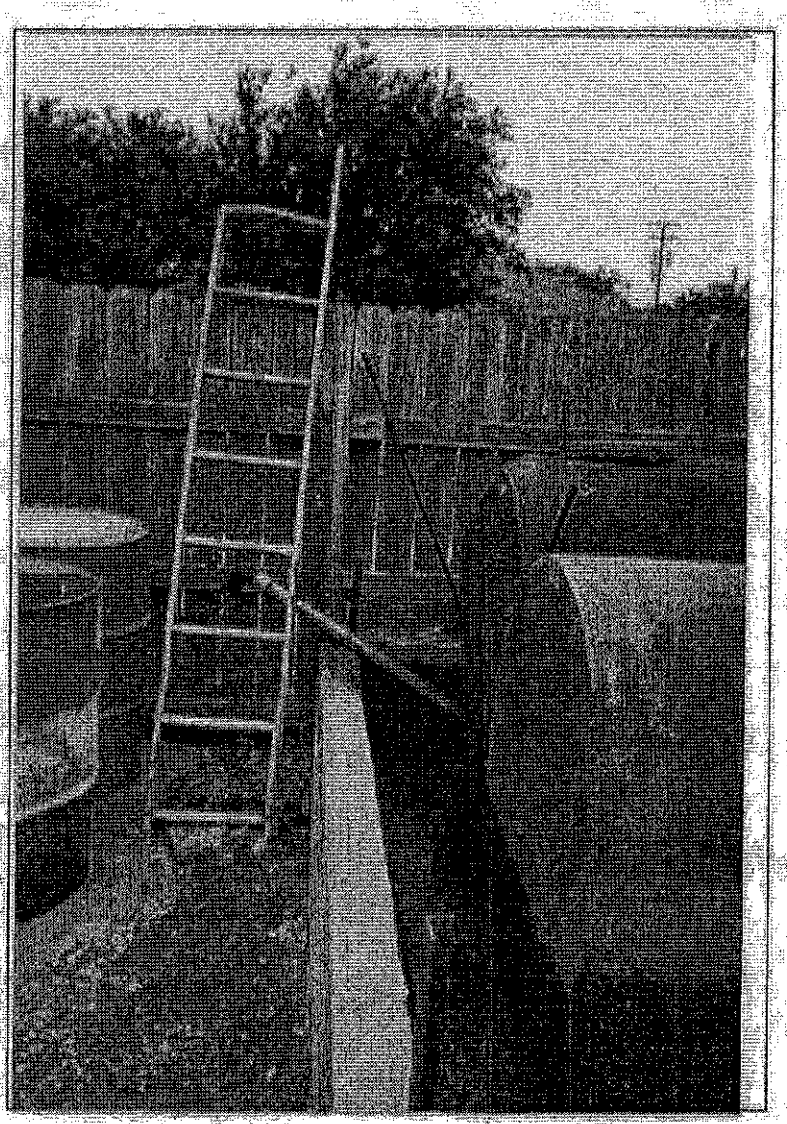
Photo No.
12

Photographer/Witness W. Bigley/ K. Westberry
Date: 05/20/97 Time 10:25 Direction North
Description Waste oil containment structure. Also shown is the location of waste collection for off-site disposal.

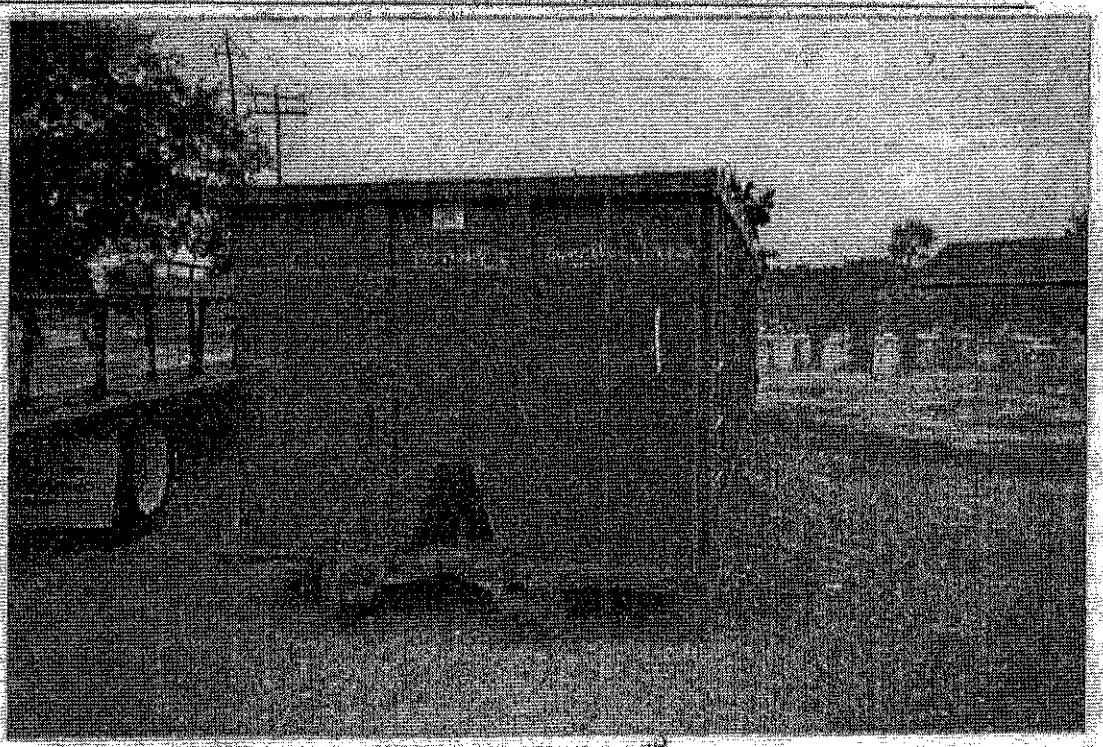
Photo No. 15

Description A 20 yard dumpster used to store general refuse.
