Field Report for Airborne Data Collected In Support of US EPA Region VI South 4 Group Fire 27 November 2019

Background

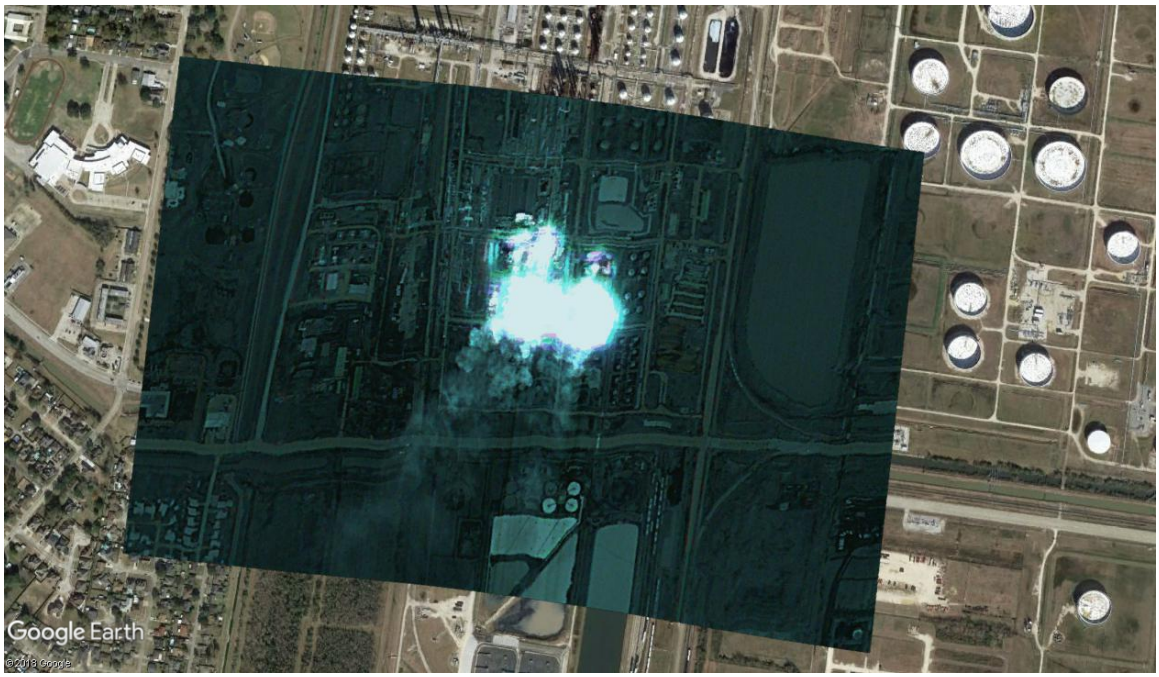
Figure 3: – 3 band IR image, Run 5, TPC Group Fire

A total of 1 test and 11 data collection passes were made in the proximity of the fire and an infrared line scanner image was generated for each pass. Figure 3 shows a typical 3-band infrared image obtained from data collected for Run 2. This image was generated by flying approximately 100 meters downwind of the facility. The white area within the image is the hot signature of the fire. A thermal plume can be seen being emitted from the active fire location within the facility perimeter with no evidence of a chemical plume being generated by the fire.

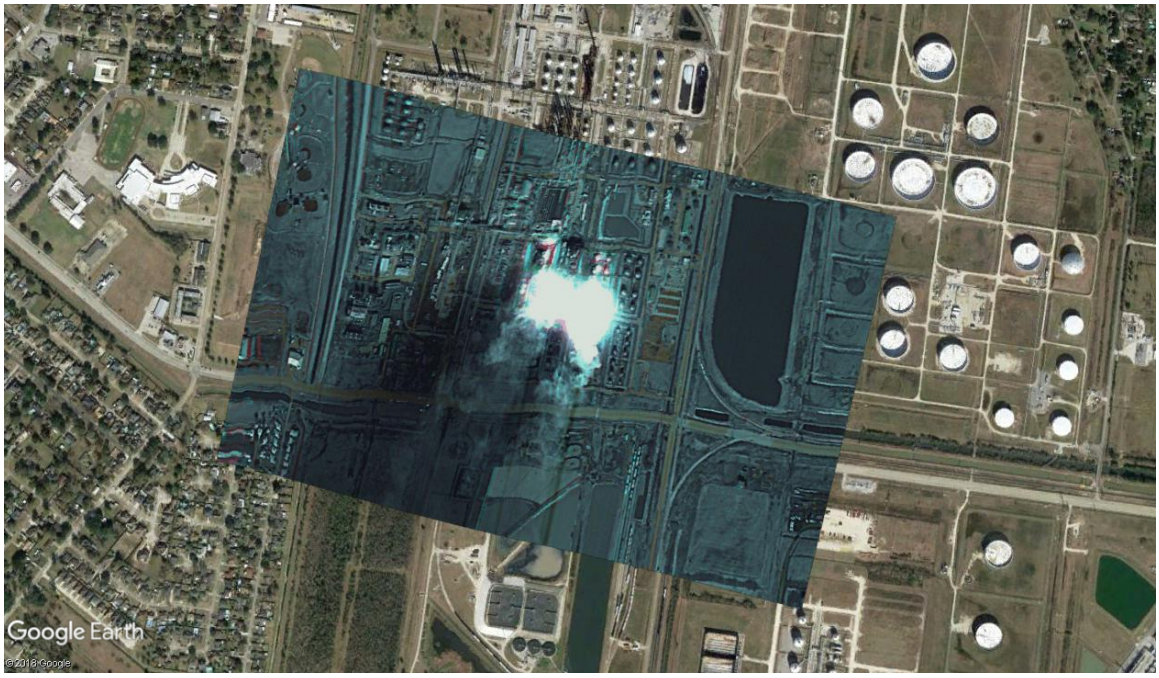
Figure 7: – 3 band IR image TPC Group Fire, Flight 2, Run 3

A total of 2 test and 2 data passes were made in the proximity of the fire and an infrared line scanner image was generated for each pass. In a similar fashion to data collected on flight 1, line scanner data continues to show a very hot environment due to the fires in the facility.

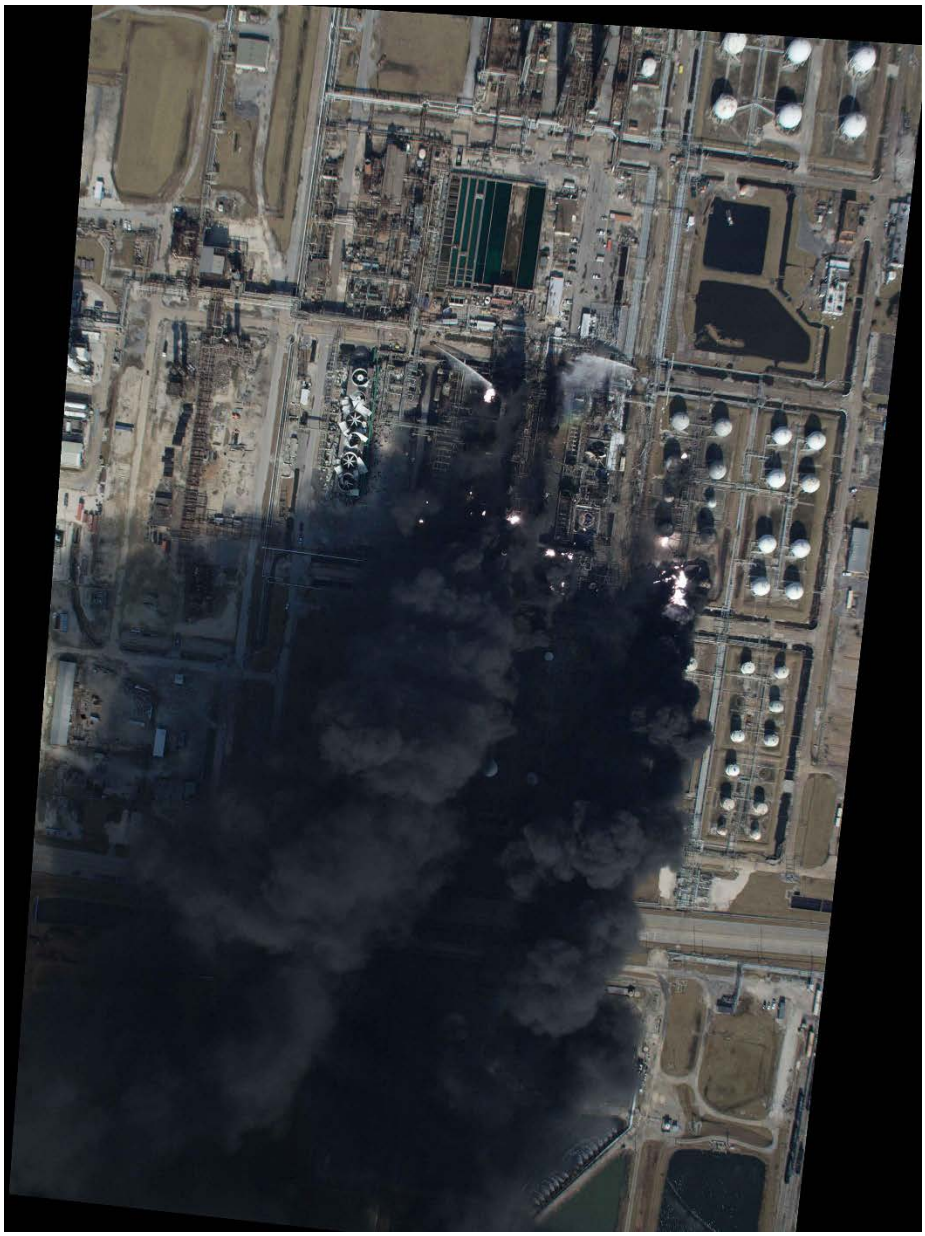
Figure 8: Aerial Image of the TCP Group Fire, Flight 2

A full set of high resolution aerial digital photography were collected as part of the flight. Figure 8 shows a representative image collected as part of each pass. The image illustrates that several fires continue to burn in the area, but the intensity of the smoke appears to be somewhat diminished. Figure 9 shows confirms that several fires are present with some indication that the number of individual fires has expanded.
