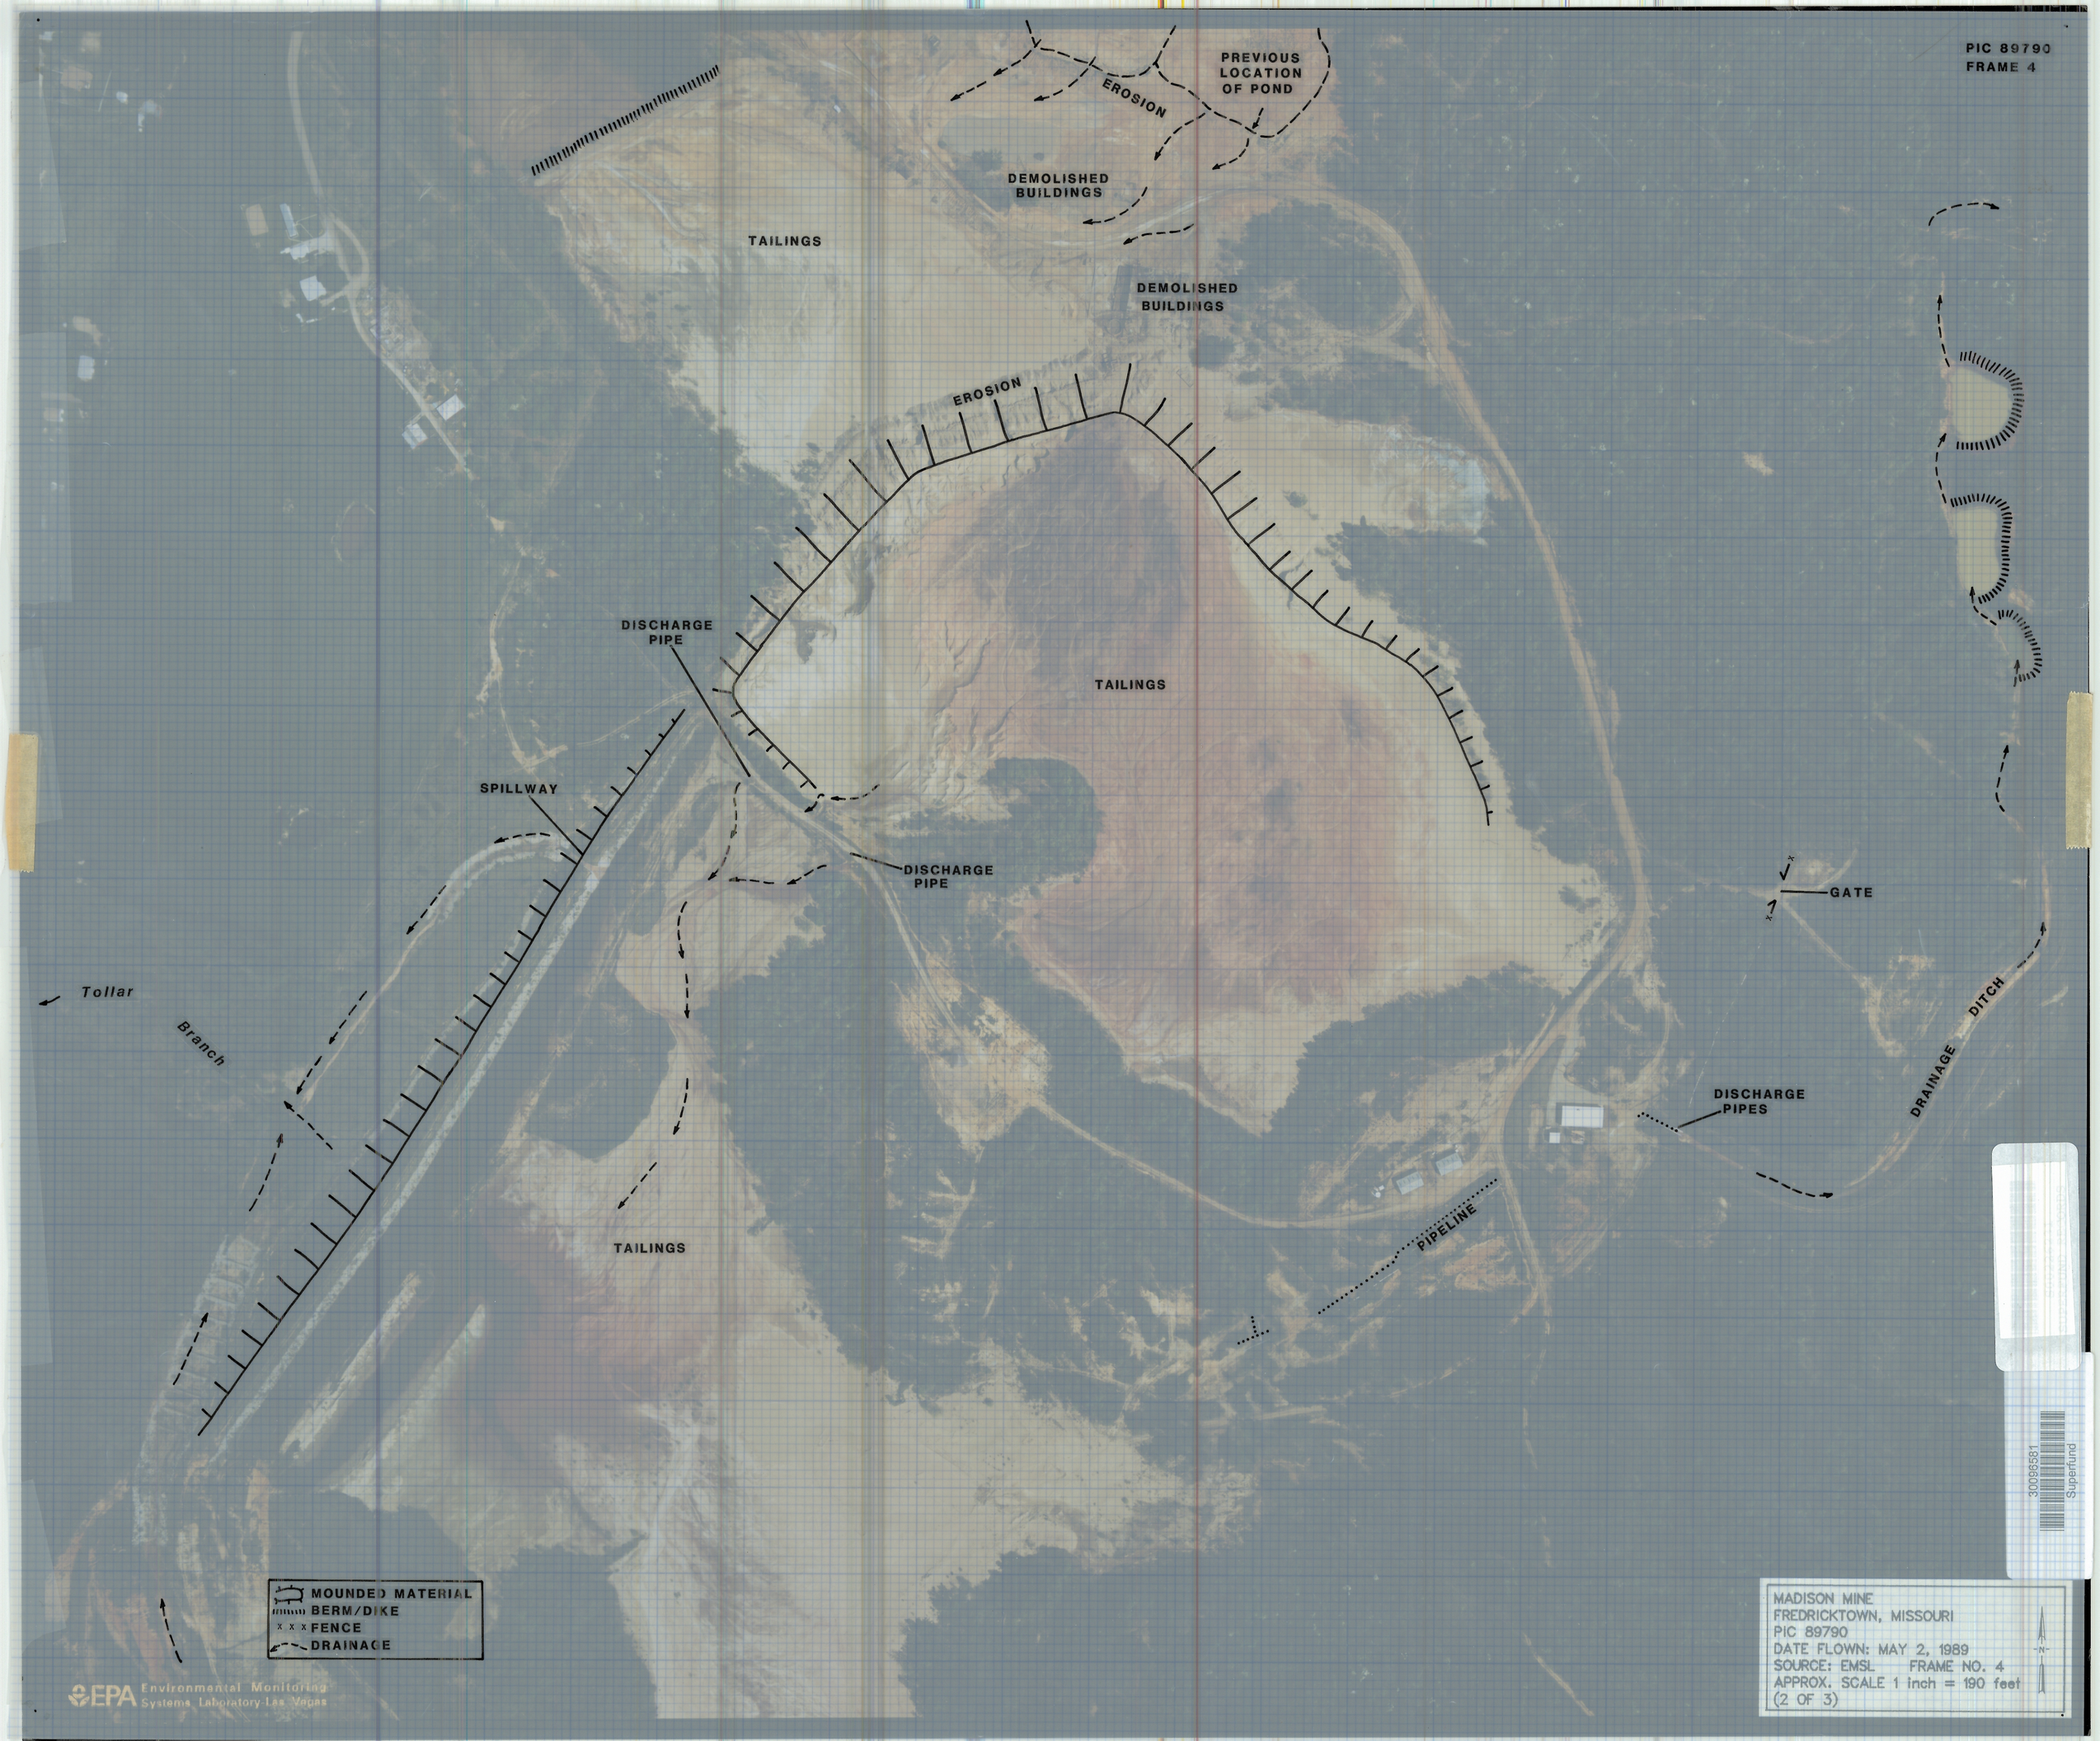
PIC 89790
FRAME 4
PREVIOUS LOCATION OF POND
EROSION
DEMOLISHED BUILDINGS
TAILINGS
DEMOLISHED BUILDINGS
EROSION
DISCHARGE PIPE
TAILINGS
SPILLWAY
DISCHARGE PIPE
GATE
Tollar
Branch
DRAINAGE DITCH
DISCHARGE PIPES
PIPELINE
TAILINGS
MOUNDED MATERIAL
BERM/DIKE
FENCE
DRAINAGE
EPA Environmental Monitoring Systems Laboratory-Las Vegas
MADISON MINE
FREDRICKTOWN, MISSOURI
PIC 89790
DATE FLOWN: MAY 2, 1989
SOURCE: EMSL FRAME NO. 4
APPROX. SCALE 1 inch = 190 feet
(2 OF 3)
N
30096581
Superfund
