Re Transmittal of Draft Site Specific Environmental Baseline Survey Report
for the St Louis Army Ammunition Plant St Louis MO
Contract No DACW41 96 D 8014 Task Order No 0019

DISTRIBUTION LIST
DRAFT SITE SPECIFIC ENVIRONMENTAL BASELINE SURVEY REPORT

ST LOUIS ARMY AMMUNITION PLANT
ST LOUIS, MISSOURI

CONTRACT NO DACW41 96 D 8014
TASK ORDER NO 0019

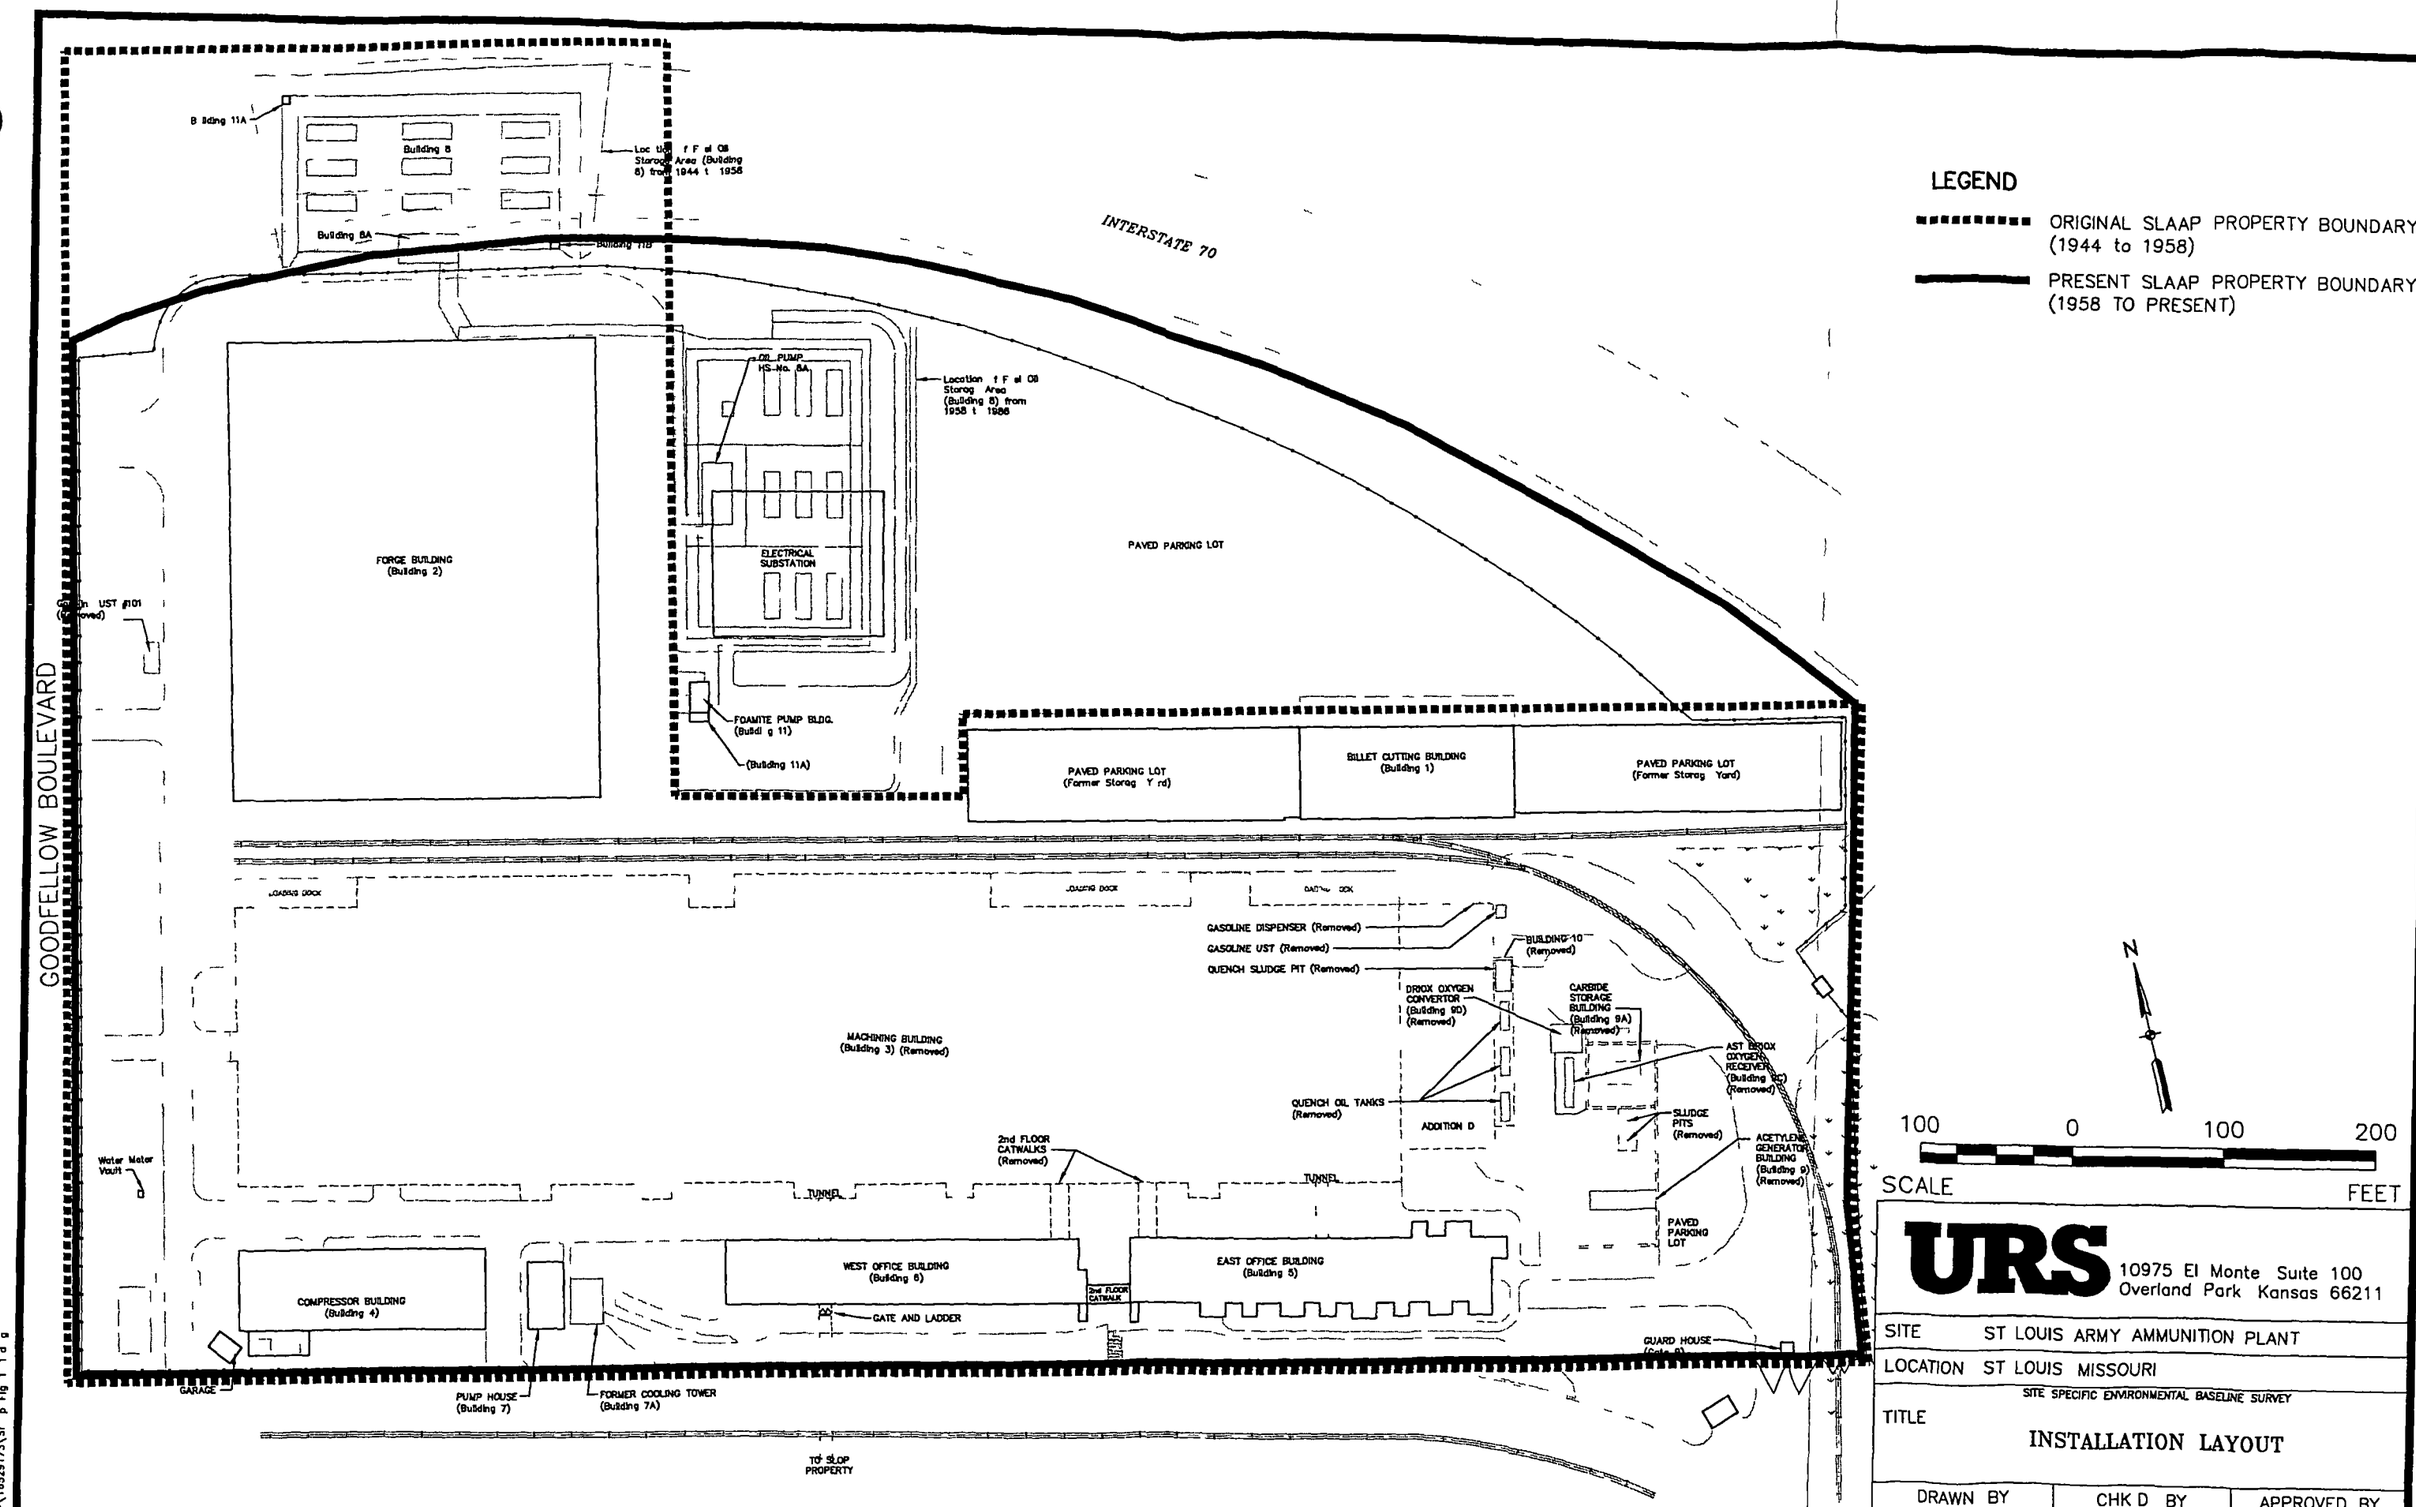
DRAWN BY	CHK D BY	APPROVED BY
R A D	M R P	R F S
JOB NO	DATE	FIG NO
16529173	8/29/03	1-1

SLOP was constructed in 1941 as a 276 acre small arms ordnance plant that produced 30 and 50 caliber munitions In 1944 21 05 acres in the northeast portion of SLOP were converted from small arms munitions production to 105 mm Howitzer shell production and this portion was designated as SLAAP Additional land was acquired on the north side of SLOP (see **Appendix A, Figure 6 1**) Currently the SLAAP property contains seven unoccupied buildings that were used to house SLAAP s main operating processes See **Figure 1 1** for original and present site boundaries

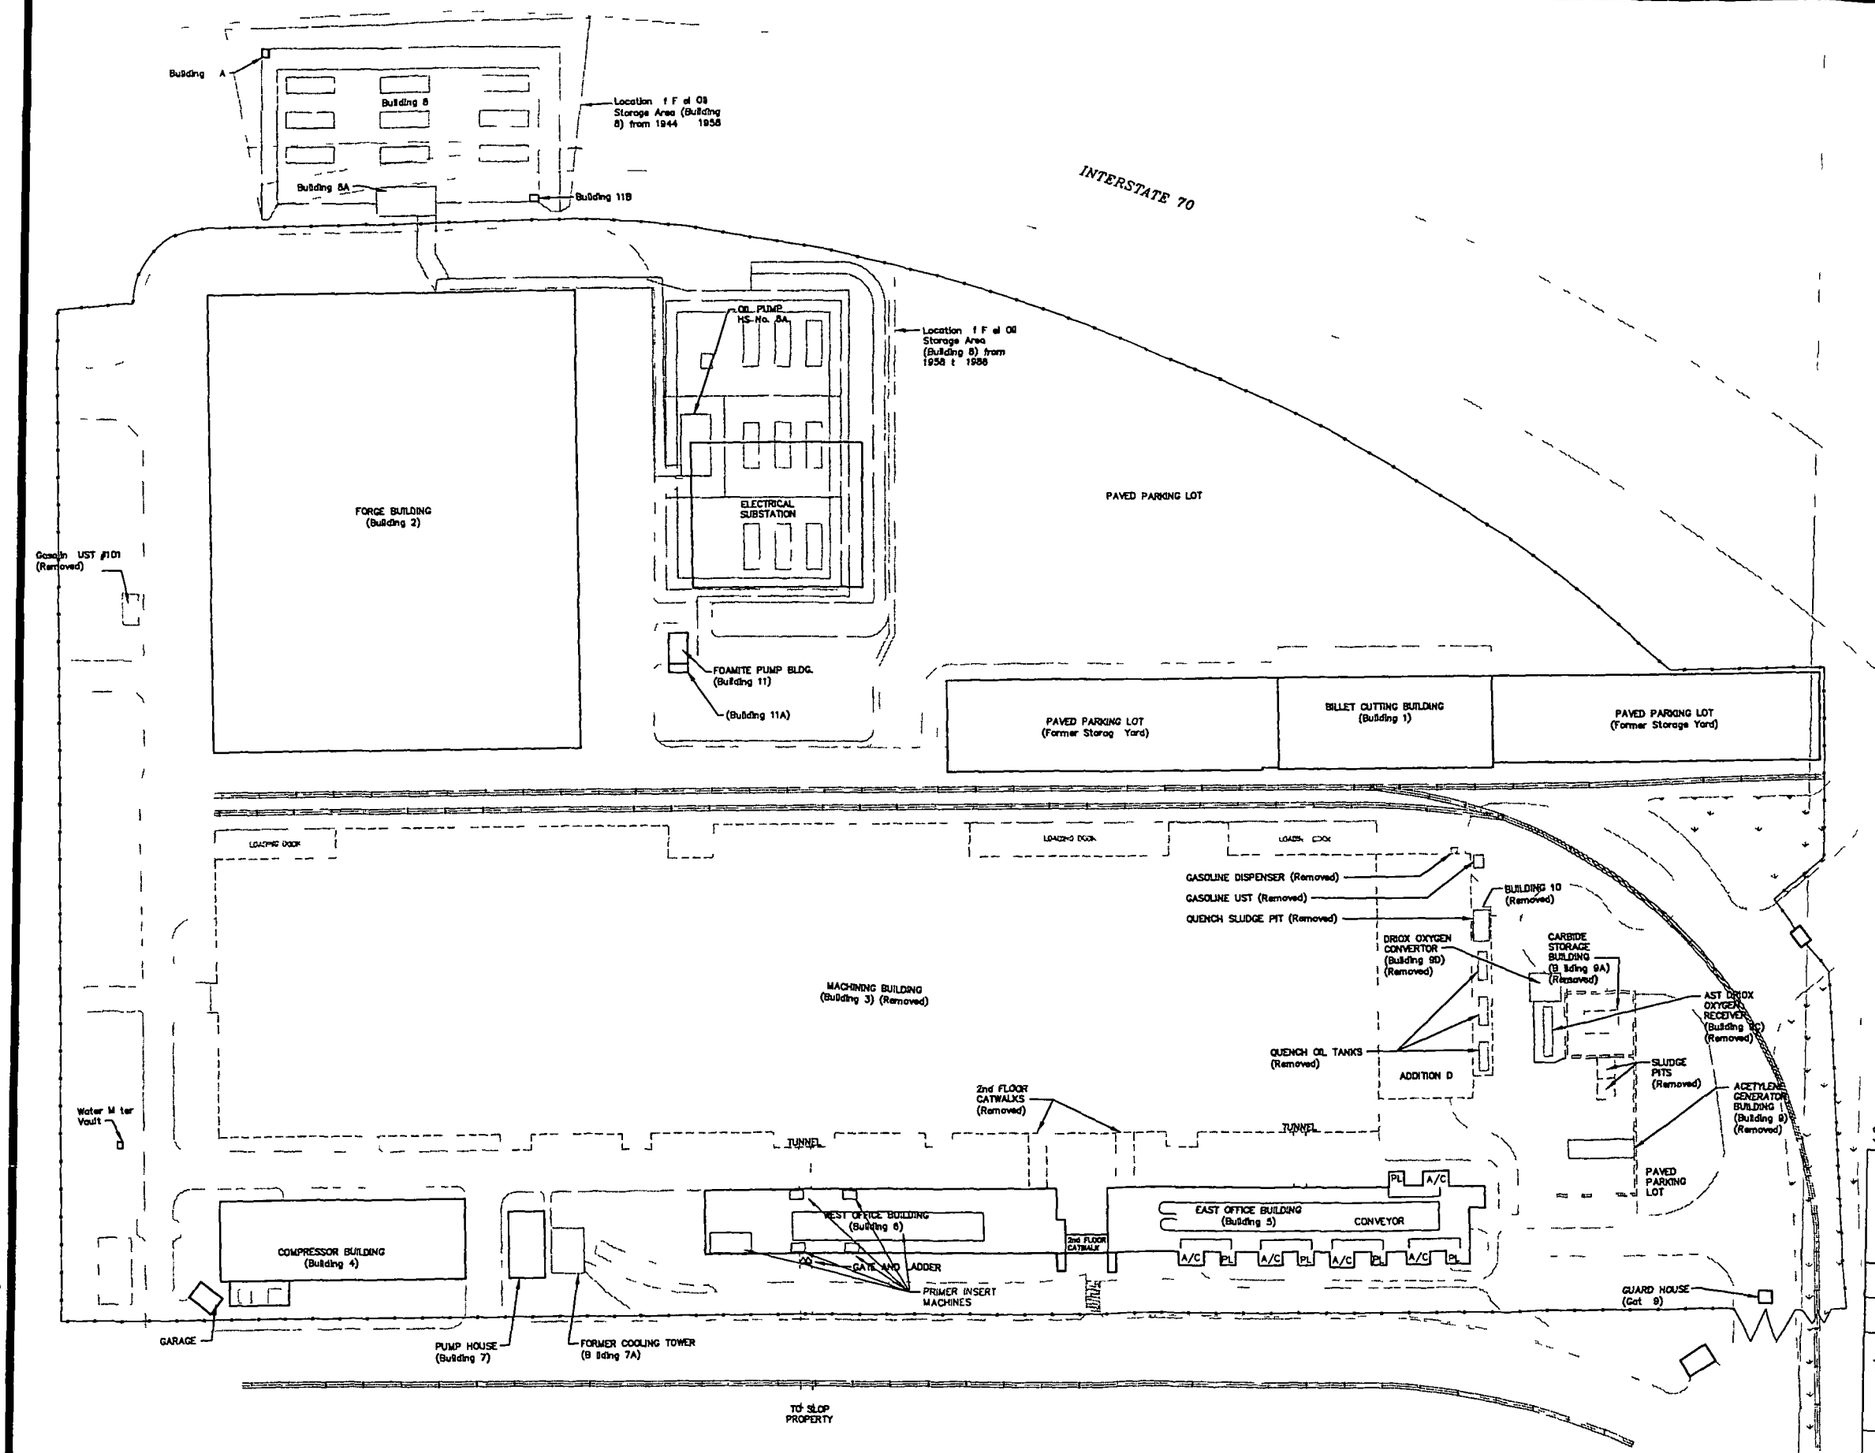
DRAWN BY	CHK D BY	APPROVED BY
R A D	M R P	R F S
JOB NO	DATE	FIG NO
16529173	8/29/03	1-2

Appendix A, Figures 6 2 and **6 3** show the areas in Building 3 where specific 30 caliber ammunition manufacturing operations took place on the first and second floors respectively **Appendix A, Figure 6 4** shows the locations of manufacturing operations within Building 5 and 6 Each of these process areas as well as those support processes conducted in Buildings 202 F J and K are discussed in detail in **Section 1 4** General areas of manufacturing processes are shown in **Figure 1 2**

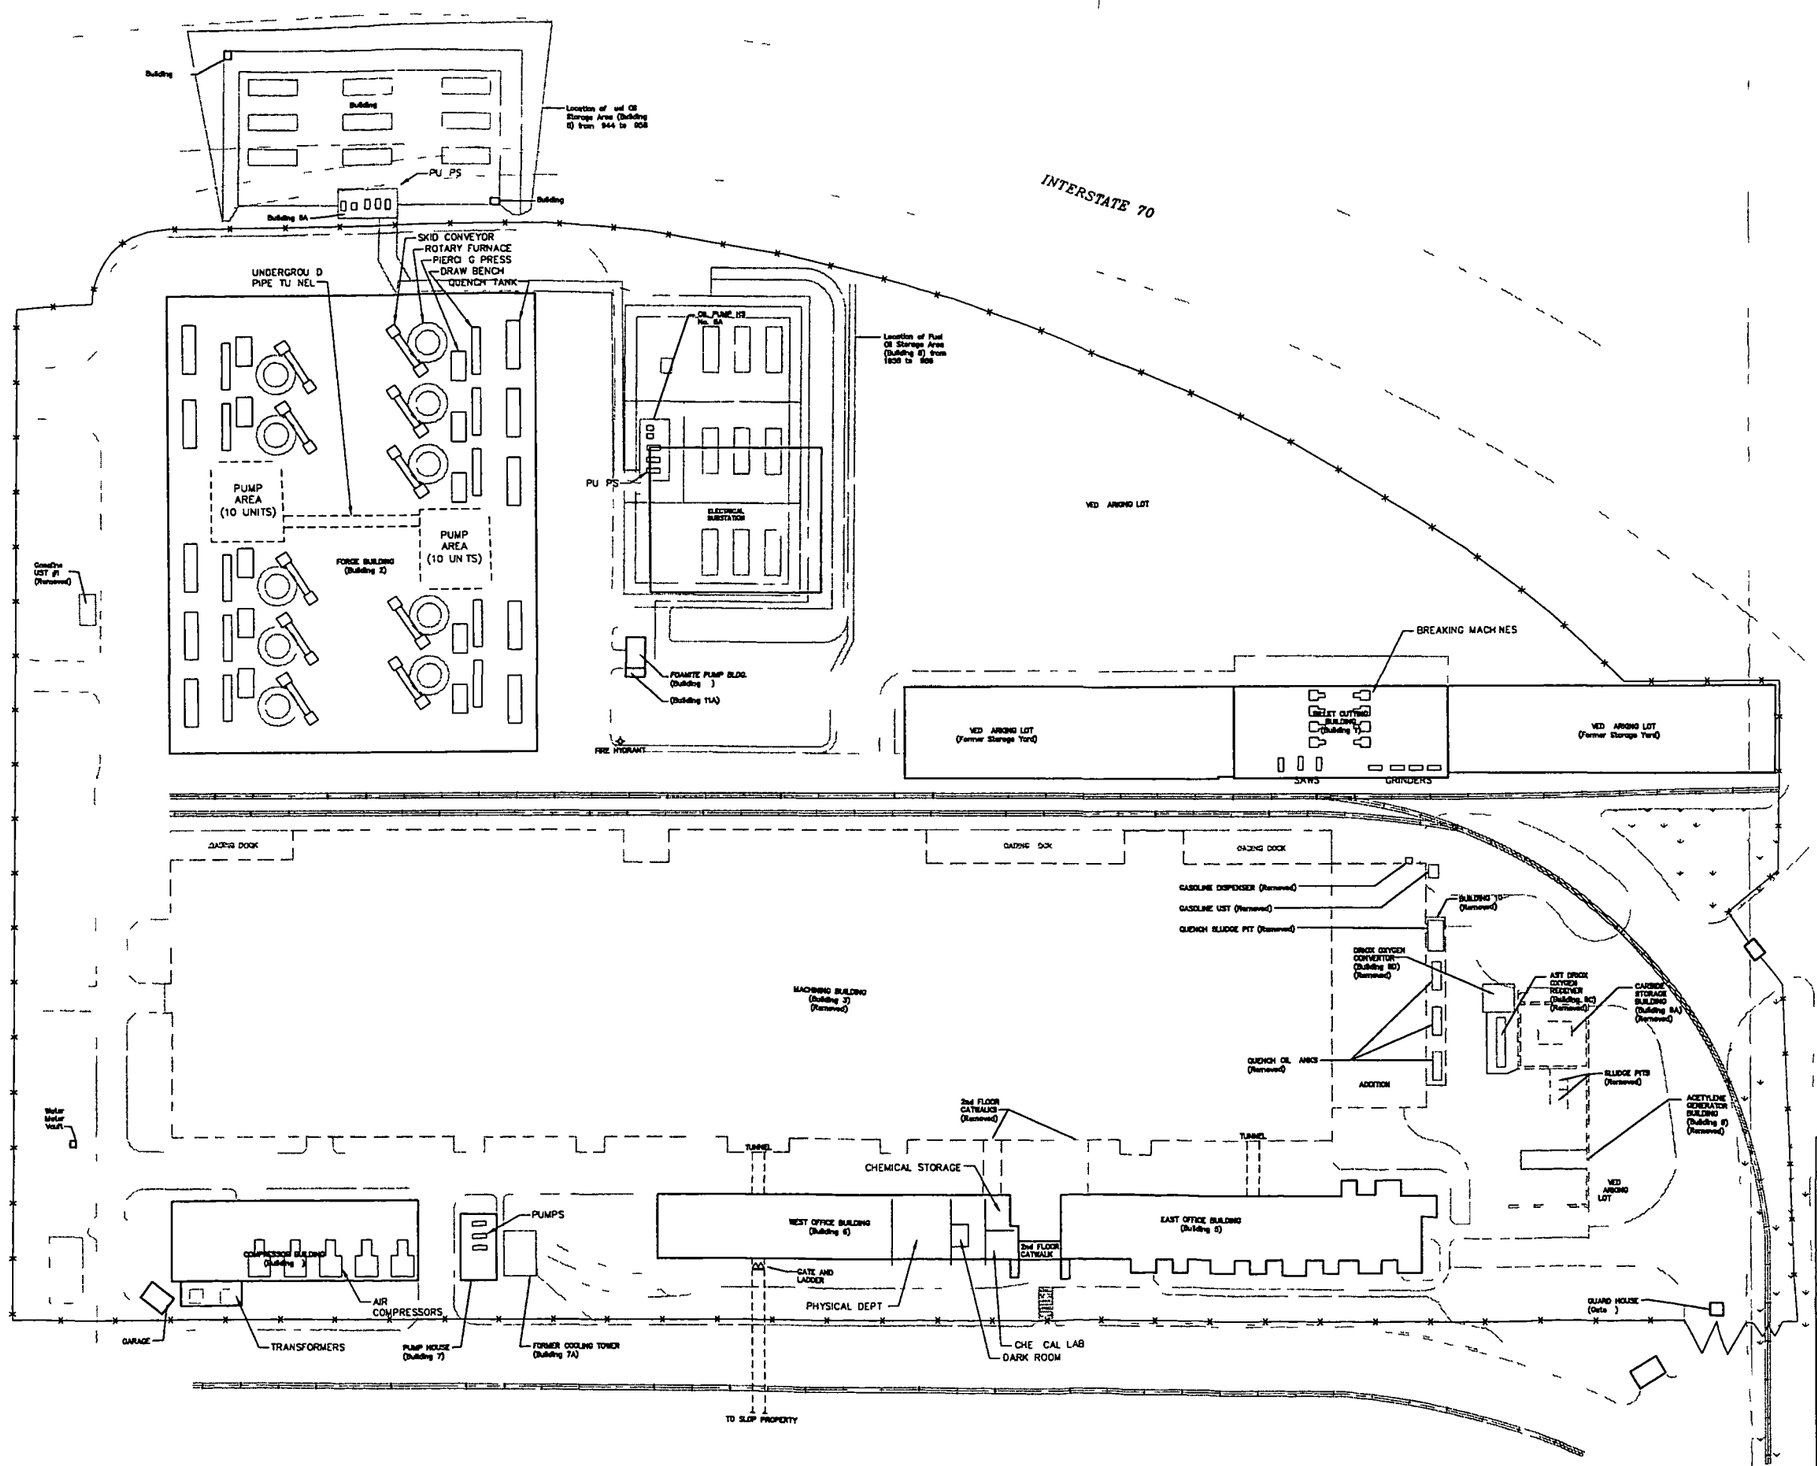
g 1 28 2003 3 03 47 pm (rad)
J \SLAAP\16529173\SI p Fig 1 3 dwg

Appendix A, Figures 6 5 through **6 13** show the locations of major equipment areas in Buildings 1 through 8A and 11 11A and 11B associated with 105 mm Howitzer shell production Existing Buildings 202 ABC 202 D 202 E 202 F and 202H were retrofitted to accommodate 105 mm Howitzer shell production and were designated Buildings 3 5 6 and 9 (202 F and 202 H) respectively In addition Buildings 1 2 4 7 7A 8 8A 10 11 11A and 11B were built in 1944 to support 105 mm Howitzer shell production Equipment layout after 1944 is shown in **Figure 1 3** for all existing buildings

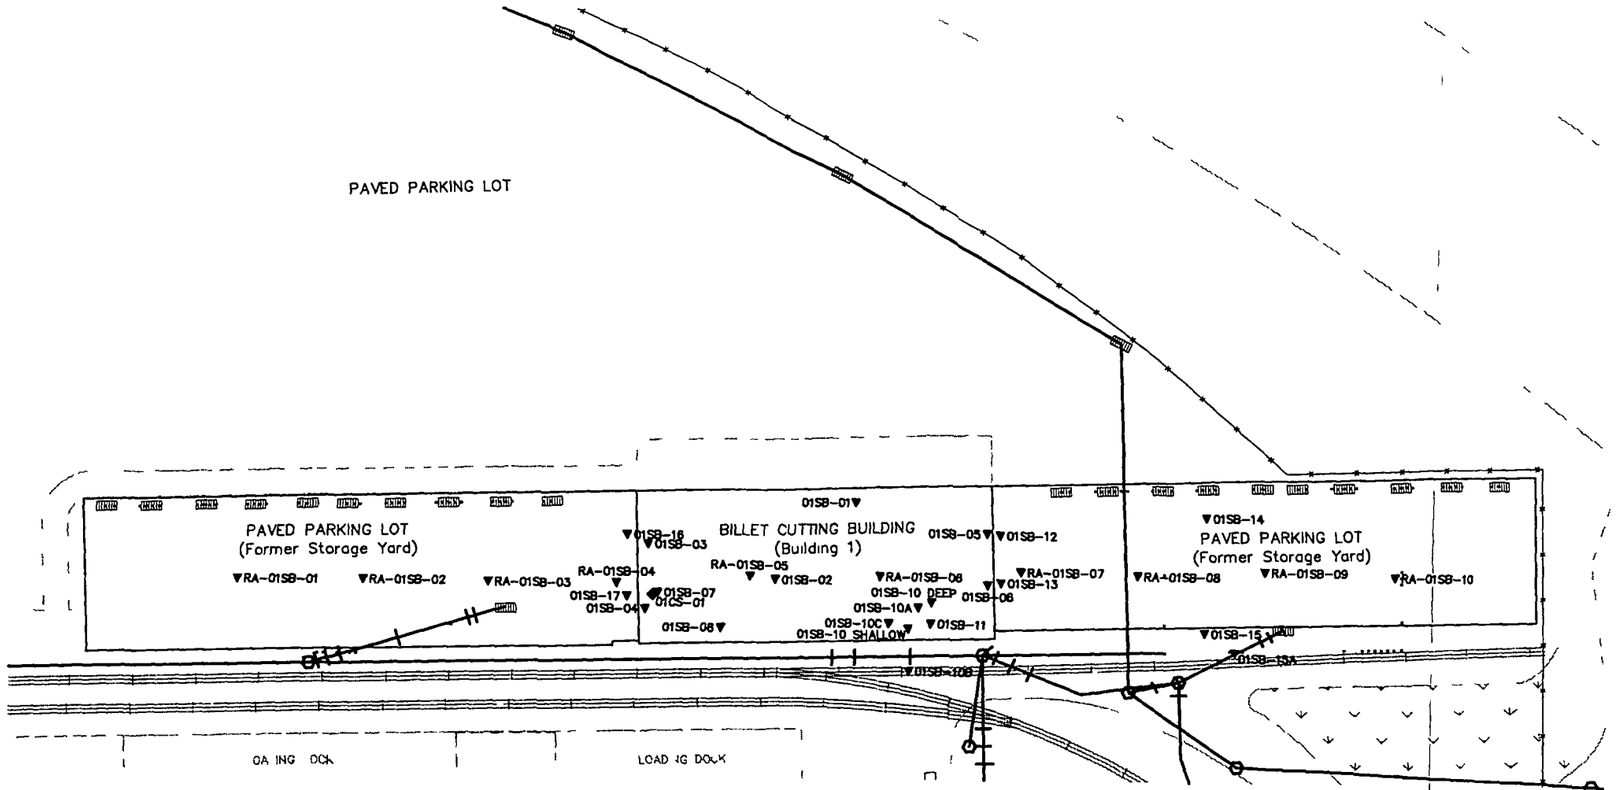
DRAWN BY	CHK D BY	APPROVED BY
R A D	M R P	R F S
JOB NO	DATE	FIG NO
16529173	8/29/03	2-2

One concrete sample location (01CS 01) was planned in Building 1 in an oil spot on the floor near the southwest corner This oil spot was wipe sampled during the Comprehensive EBS investigation and found to contain PCBs Concrete samples were collected at this location from 0 1 inch and from 2 3 inches using a hammer drill and analyzed for PCBs

Seventeen Geoprobe® soil borings (01SB 01 through 01SB 17) were planned to assess areas potentially impacted by historic industrial activities in and around Building 1 Eleven of these borings (01SB 01 through 01SB 11) were planned within the footprint of the building and the other six were located in the parking areas (former billet yards) to the east (01SB 12 through 01SB 15) and west (01SB 16 and 01SB 17) of the building Conditions at several boring locations within Building 1 required the following modifications from the FSP

- Boring 01SB-09 was intended to investigate a second sump along the south wall of the building however a second sump was not identified during sample layout activities so this boring was eliminated
- Several boring locations (01SB 08 01SB 10 and 01SB 11) were offset adjacent to sumps instead of in them because these locations were inaccessible for the concrete coring machine and the Geoprobe® could not penetrate the concrete bottom of the sump Samples were still collected at the designated depths relative to the bottom of the sumps
- Boring 01SB 10 was advanced using a stainless steel hand auger due to overhanging structures blocking access for the Geoprobe® However the hand auger met refusal at 5 5 feet after collection of samples 01SB 10(0 0 5) 0802 and 01SB 10(04 05) 0802

- Borings 01SB 04 and 01SB 07 were proposed to be located within five feet of each other As a result 01SB 07 was located and sampled as planned (in an oil stained area) and 01SB 04 was relocated within an open sump found in the southwest corner of the building The operational purpose of this sump was not known

Three additional soil borings (01SB 10A 01SB 10B and 01SB 10C) were advanced to define the extent of the PCBs detected above the screening level at 01SB 10 Samples were collected from all three borings from 0 to 0 5 feet bgs using the Geoprobe® rig except 01SB 10A which was sampled with a stainless steel hand auger due to overhead obstructions blocking rig access to the location Samples from 01SB 10A 01SB 10B and 01SB 10C were analyzed for PCB 1254 The eastern extent is defined by sample location 01SB 11

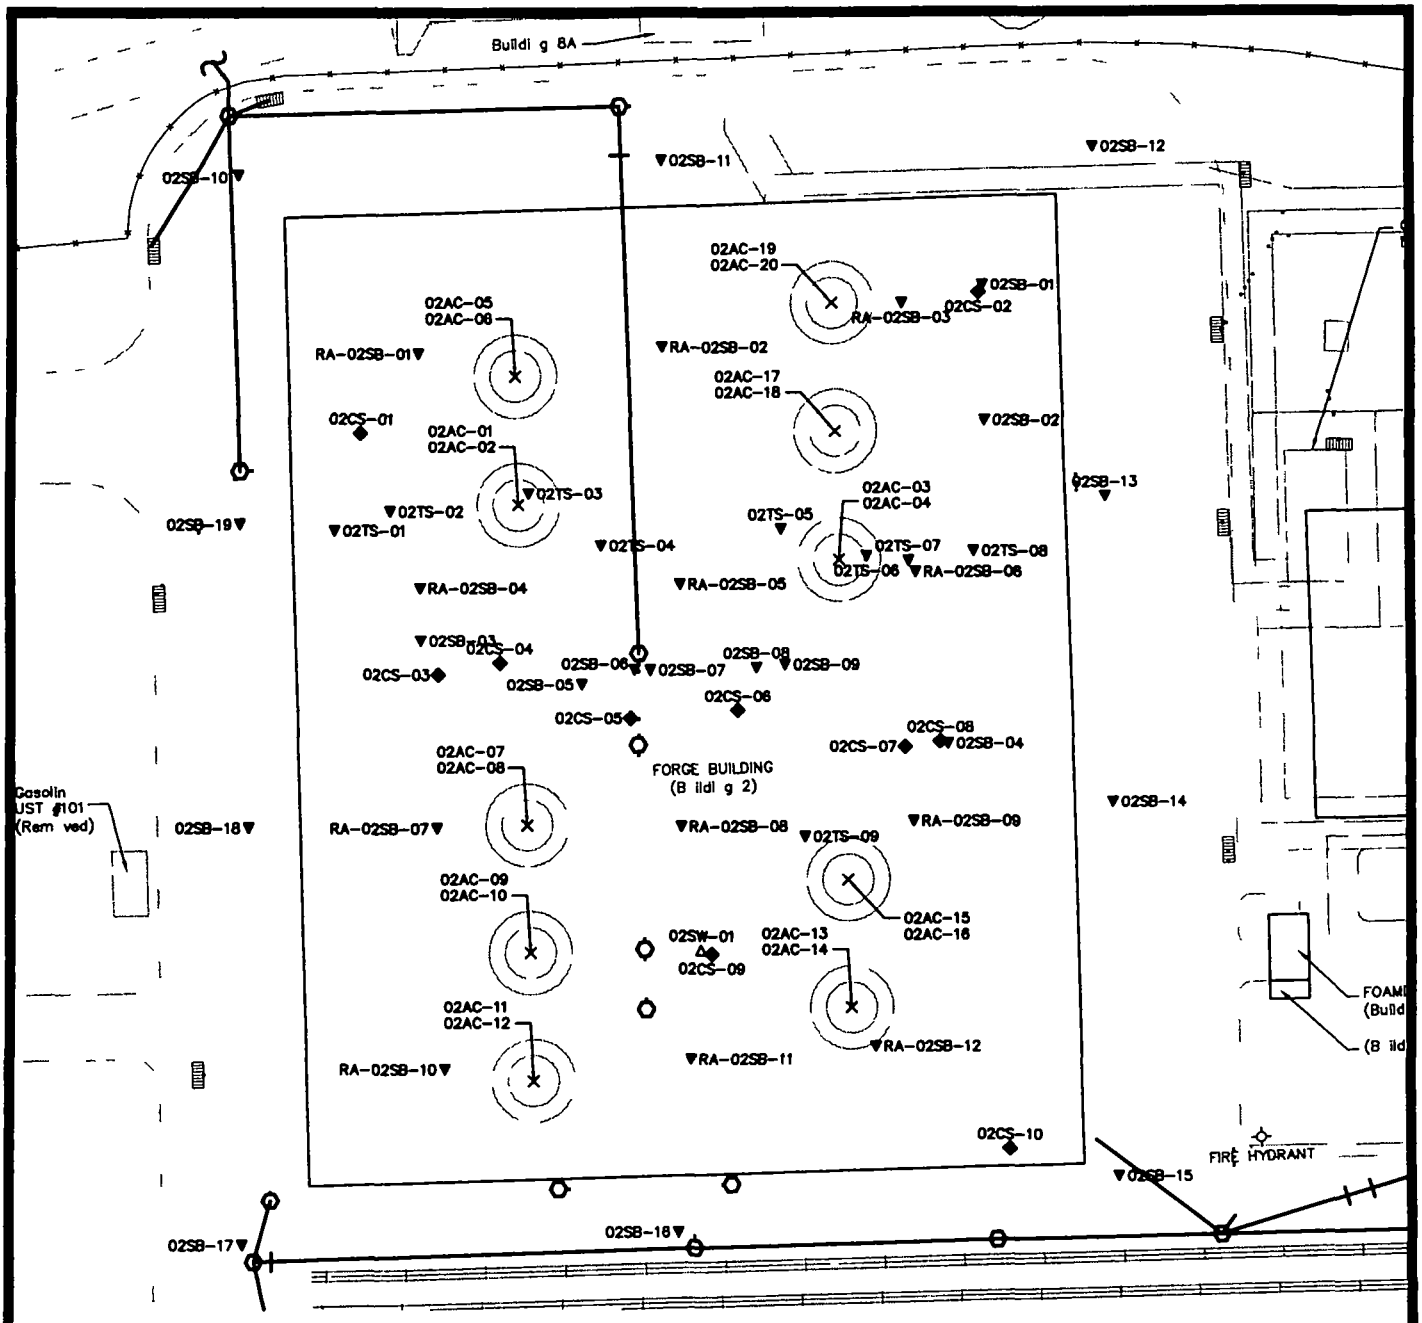
DRAWN BY	CHK D BY	APPROVED BY
R A D	M R P	R F S
JOB NO	DATE	FIG NO
16529173	8/29/03	2-3

Twenty refractory brick samples were collected from the debris piles in the forge furnace foundations in Building 2 Two types of refractory bricks were identified and one sample of each type was collected from each foundation for asbestos fiber analysis

The FSP did not include concrete sampling in Building 2 however significant oil staining was observed on the floor and therefore ten concrete sampling locations (02CS 01 through 02CS 10)

Four small tanks with conduits containing a black substance were also observed in the western mezzanine One of these tanks was opened and a product sample (02PD 02) was collected and analyzed for PCBs

Nine soil borings (02SB 01 through 02SB 09) were planned within the footprint of Building 2 in areas that may have been impacted by historic industrial activities Borings 02SB 01 and 02SB 02 were located in oil stained areas in the northeast corner of the building Two other borings were located in oil stained areas of the pump stations in Building 2 (02SB 03 in the west and 02SB 04 in the east pump station) Borings 02SB 05 through 02SB 09 were located at the bottom of the central pipe trench connecting the pump stations All of these borings were advanced using the Geoprobe® rig and analyzed for PCBs (and dioxins if PCBs were detected) Samples from borings 02SB 01 through 02SB 04 were also analyzed for TPH

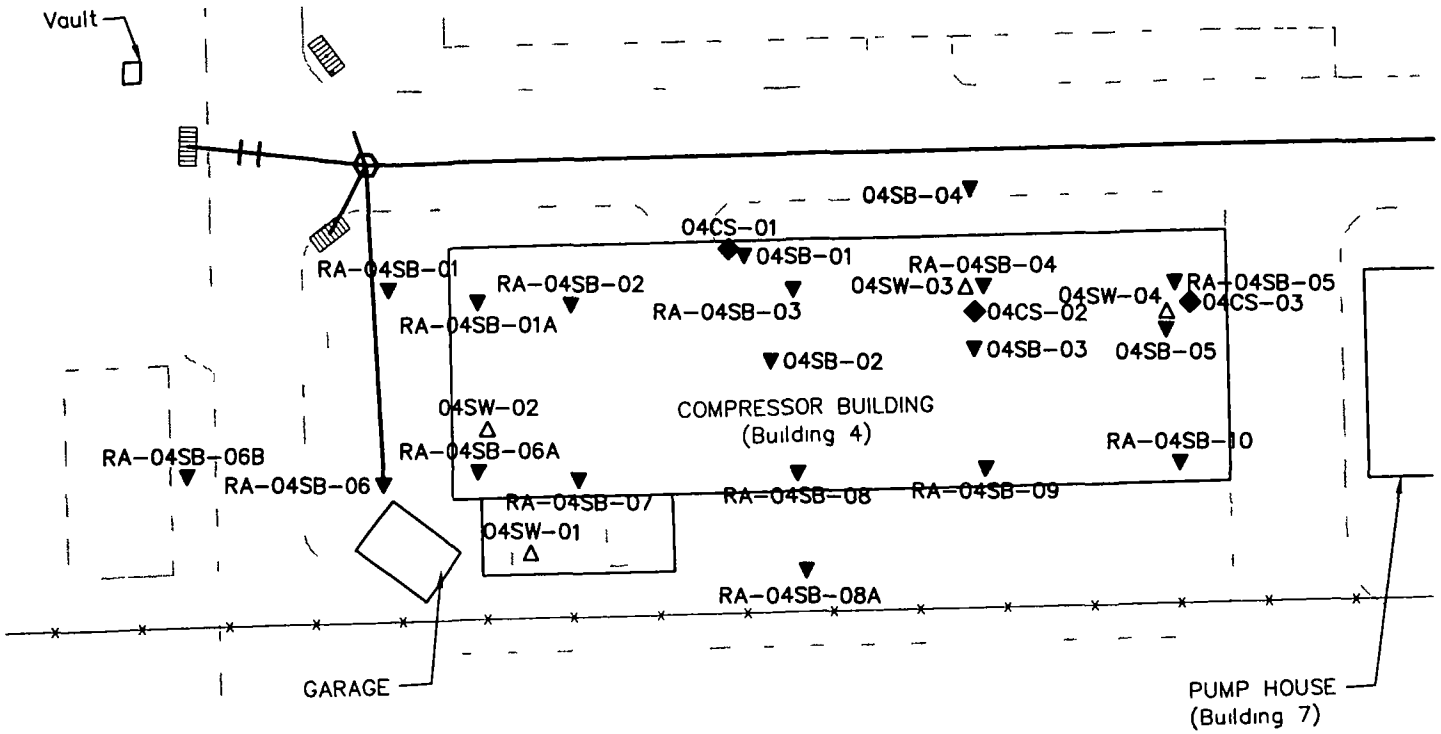
SITE	ST LOUIS ARMY AMMUNITION PLANT
LOCATION	ST LOUIS MISSOURI
	SITE SPECIFIC ENVIRONMENTAL BASELINE SURVEY
TITLE	**BUILDING 4 SAMPLING LOCATIONS**

During sample layout activities an oily residue was observed in the bottom of the utility trenches that were located to the north of the air compressor pits Two additional concrete samples (04CS 02 and 04CS 03) were located in these trenches and analyzed for PCBs These concrete samples were collected from 0 1 inch only using a hammer drill

There were three soil borings (04SB 01 through 04SB 03) advanced to assess potentially impacted soils due to industrial activities in Building 4 Boring 04SB 01 was located underneath a transformer in an area of PCB contaminated oil staining Samples were collected from three depths (0 to 0 5 feet 4 to 5 feet and 6 to 7 feet bgs) using a stainless steel hand auger prior to encountering refusal and analyzed for PCBs Borings 04SB 02 and 04SB 03 were collected from beneath two randomly selected concrete equipment pits inside Building 4 Samples were collected from three depths (0 to 0 5 feet 4 to 5 feet and 9 to 10 feet bgs) using a stainless steel hand auger and analyzed for PCBs and TPH Two additional borings (RA 04SB 01 and RA 04SB 06) will also be used to assess potentially impacted soils to the west of Building 4 As discussed below these borings were originally intended to be risk assessment borings and were analyzed for metals PAHs PCBs pesticides and VOCs

Four additional soil borings were advanced in and around Building 4 during the contingency sampling event Two of these (04SB 04 and 04SB 05) were located in trenches in the vicinities of concrete samples 04CS 02 and 04CS 03 which had detected concentrations of PCBs above the screening level Samples were collected from 04SB 05 with a stainless steel hand auger at depths of 0 to 0 5 and 2 to 3 feet below the concrete bottom of the trench Due to the thickness

During sample layout activities an oily residue was observed in the bottom of the utility trenches that were located to the north of the air compressor pits As a result two additional surface wipe samples (04SW 03 and 04SW 04) were collected in these trenches and analyzed for PCBs These surface wipe samples were co located with concrete samples 04CS-02 and 04CS 03 respectively

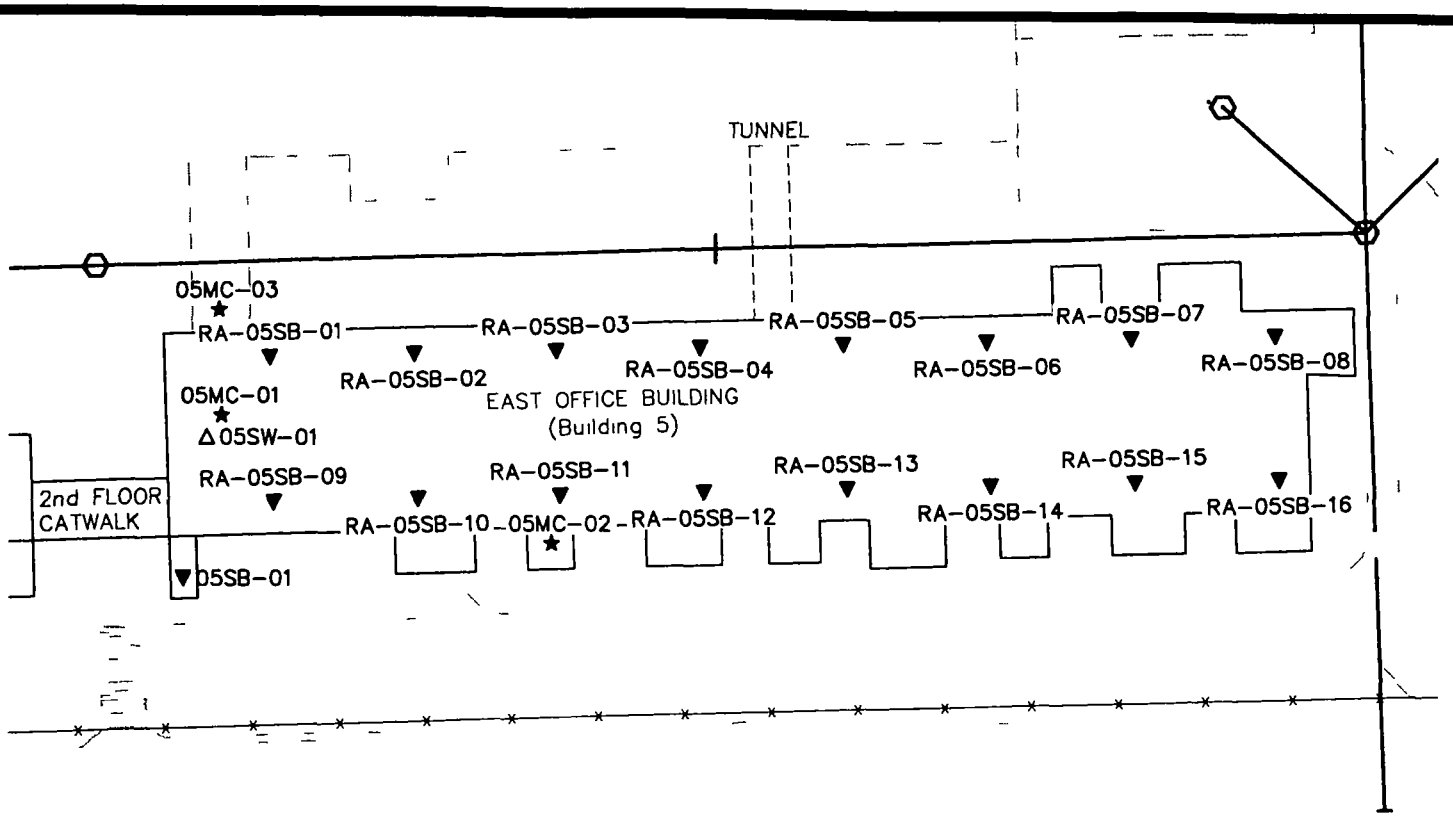
TITLE **BUILDING 5 SAMPLING LOCATIONS**

There were sixteen risk assessment borings (RA 05SB 01 through RA 05SB 16) advanced using a stainless steel hand auger within the basement of Building 5 Two samples were collected

One surface wipe sample (05SW 01) was collected from an oil stained area in the southeastern corner of the elevator shaft This sample was analyzed for PCBs

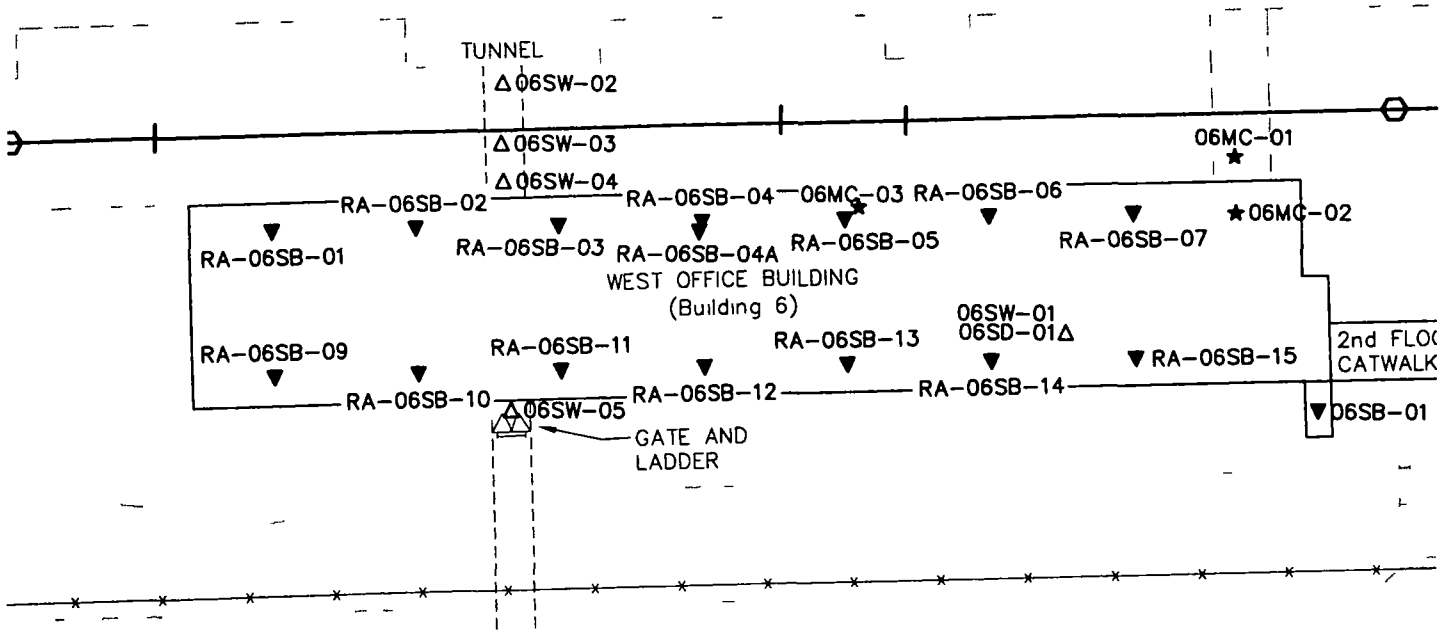
TITLE **BUILDING 6 SAMPLING LOCATIONS**

One sediment sample (06SD 01) was collected from the heating duct found in the hearth room on the first floor of Building 6 This sediment sample was analyzed for metals SVOCs and VOCs

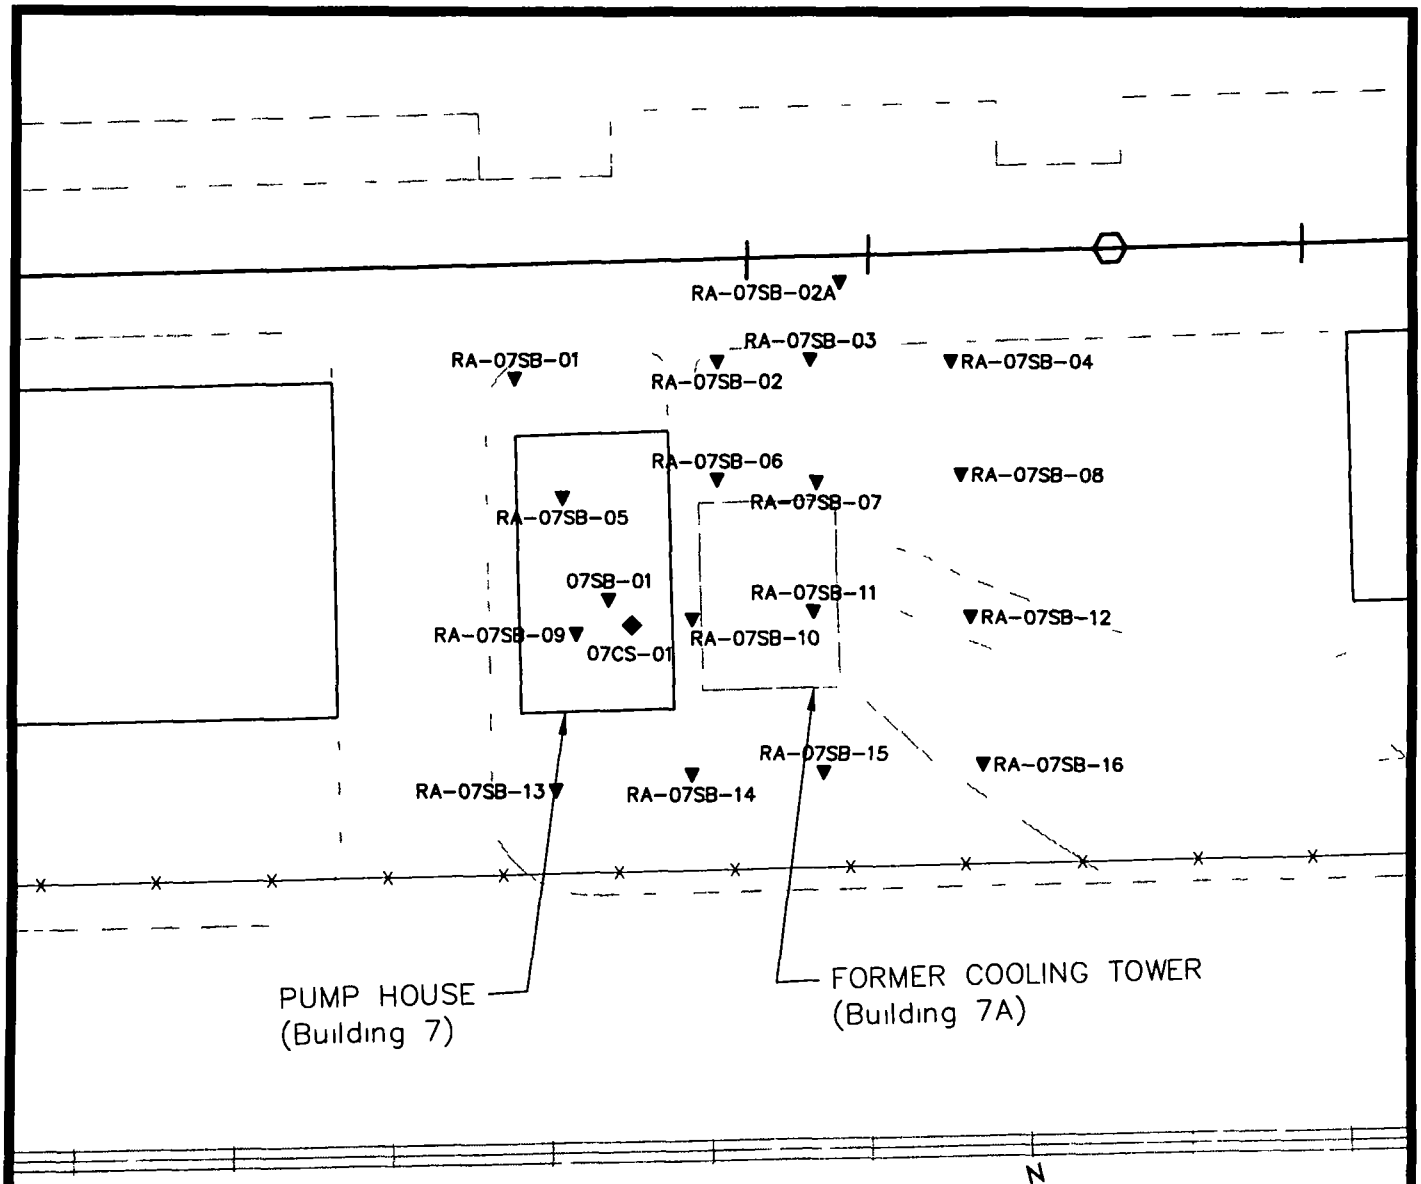
DRAWN BY	CHK D BY	APPROVED BY
R A D	M R P	R F S
JOB NO	DATE	FIG NO
16529173	8/29/03	2-7

One concrete sample (07CS 01) was collected from an oil stained area on the concrete floor of Building 7 using a hammer drill This concrete sample was analyzed for TPH
