FINAL
OU-1 QUARTERLY GROUNDWATER MONITORING REPORT
OCTOBER 2013 SAMPLING EVENT
THE FORMER ST. LOUIS ORDNANCE PLANT
ST. LOUIS, MISSOURI

REGIONAL LTO/LTM FOR SEVEN INSTALLATIONS

June 2014

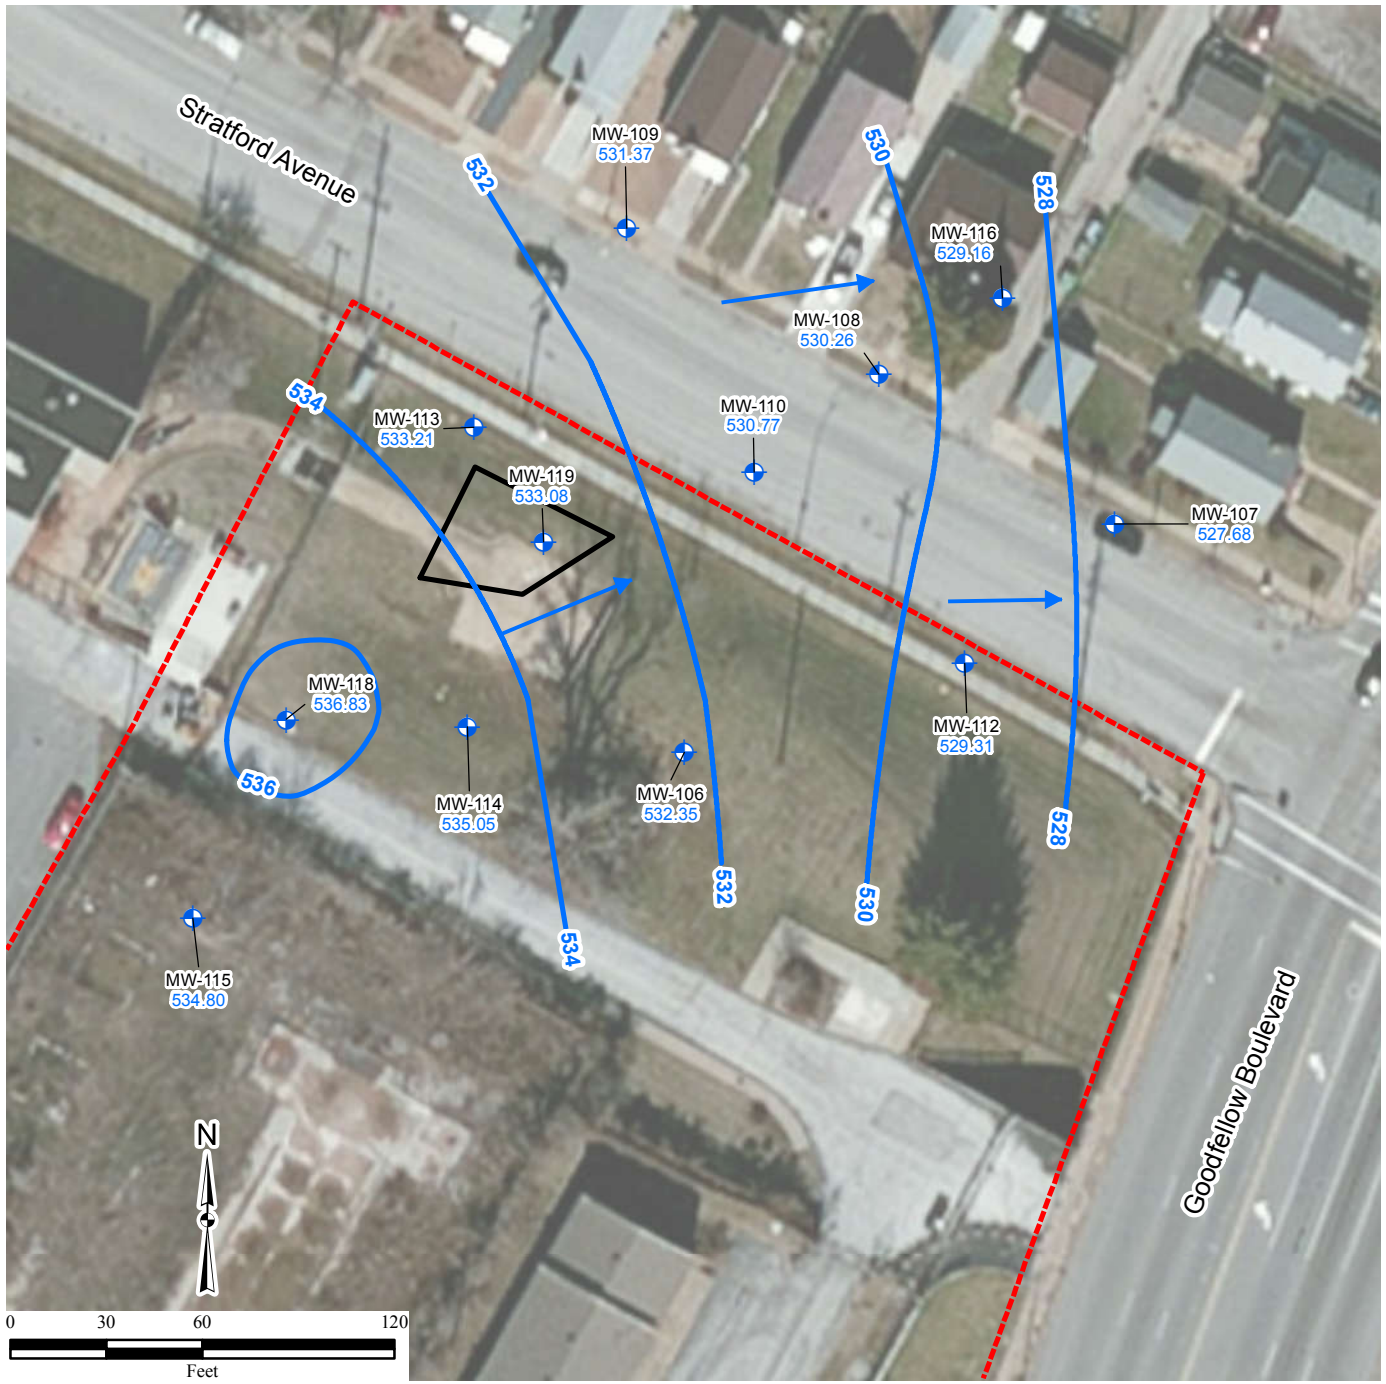
Figure 3.1
Potentiometric Surface Map
The Former St. Louis Ordnance Plant
October 2013

Figure 3.1 shows the potentiometric surface for October 2013. The groundwater elevation data indicates that the groundwater flow direction is to the northeast away from the topographic high on the southwest corner of the site. During each of the post-RA sampling rounds, the same general trend of a groundwater high at MW-118 with groundwater flow to the northeast was observed.

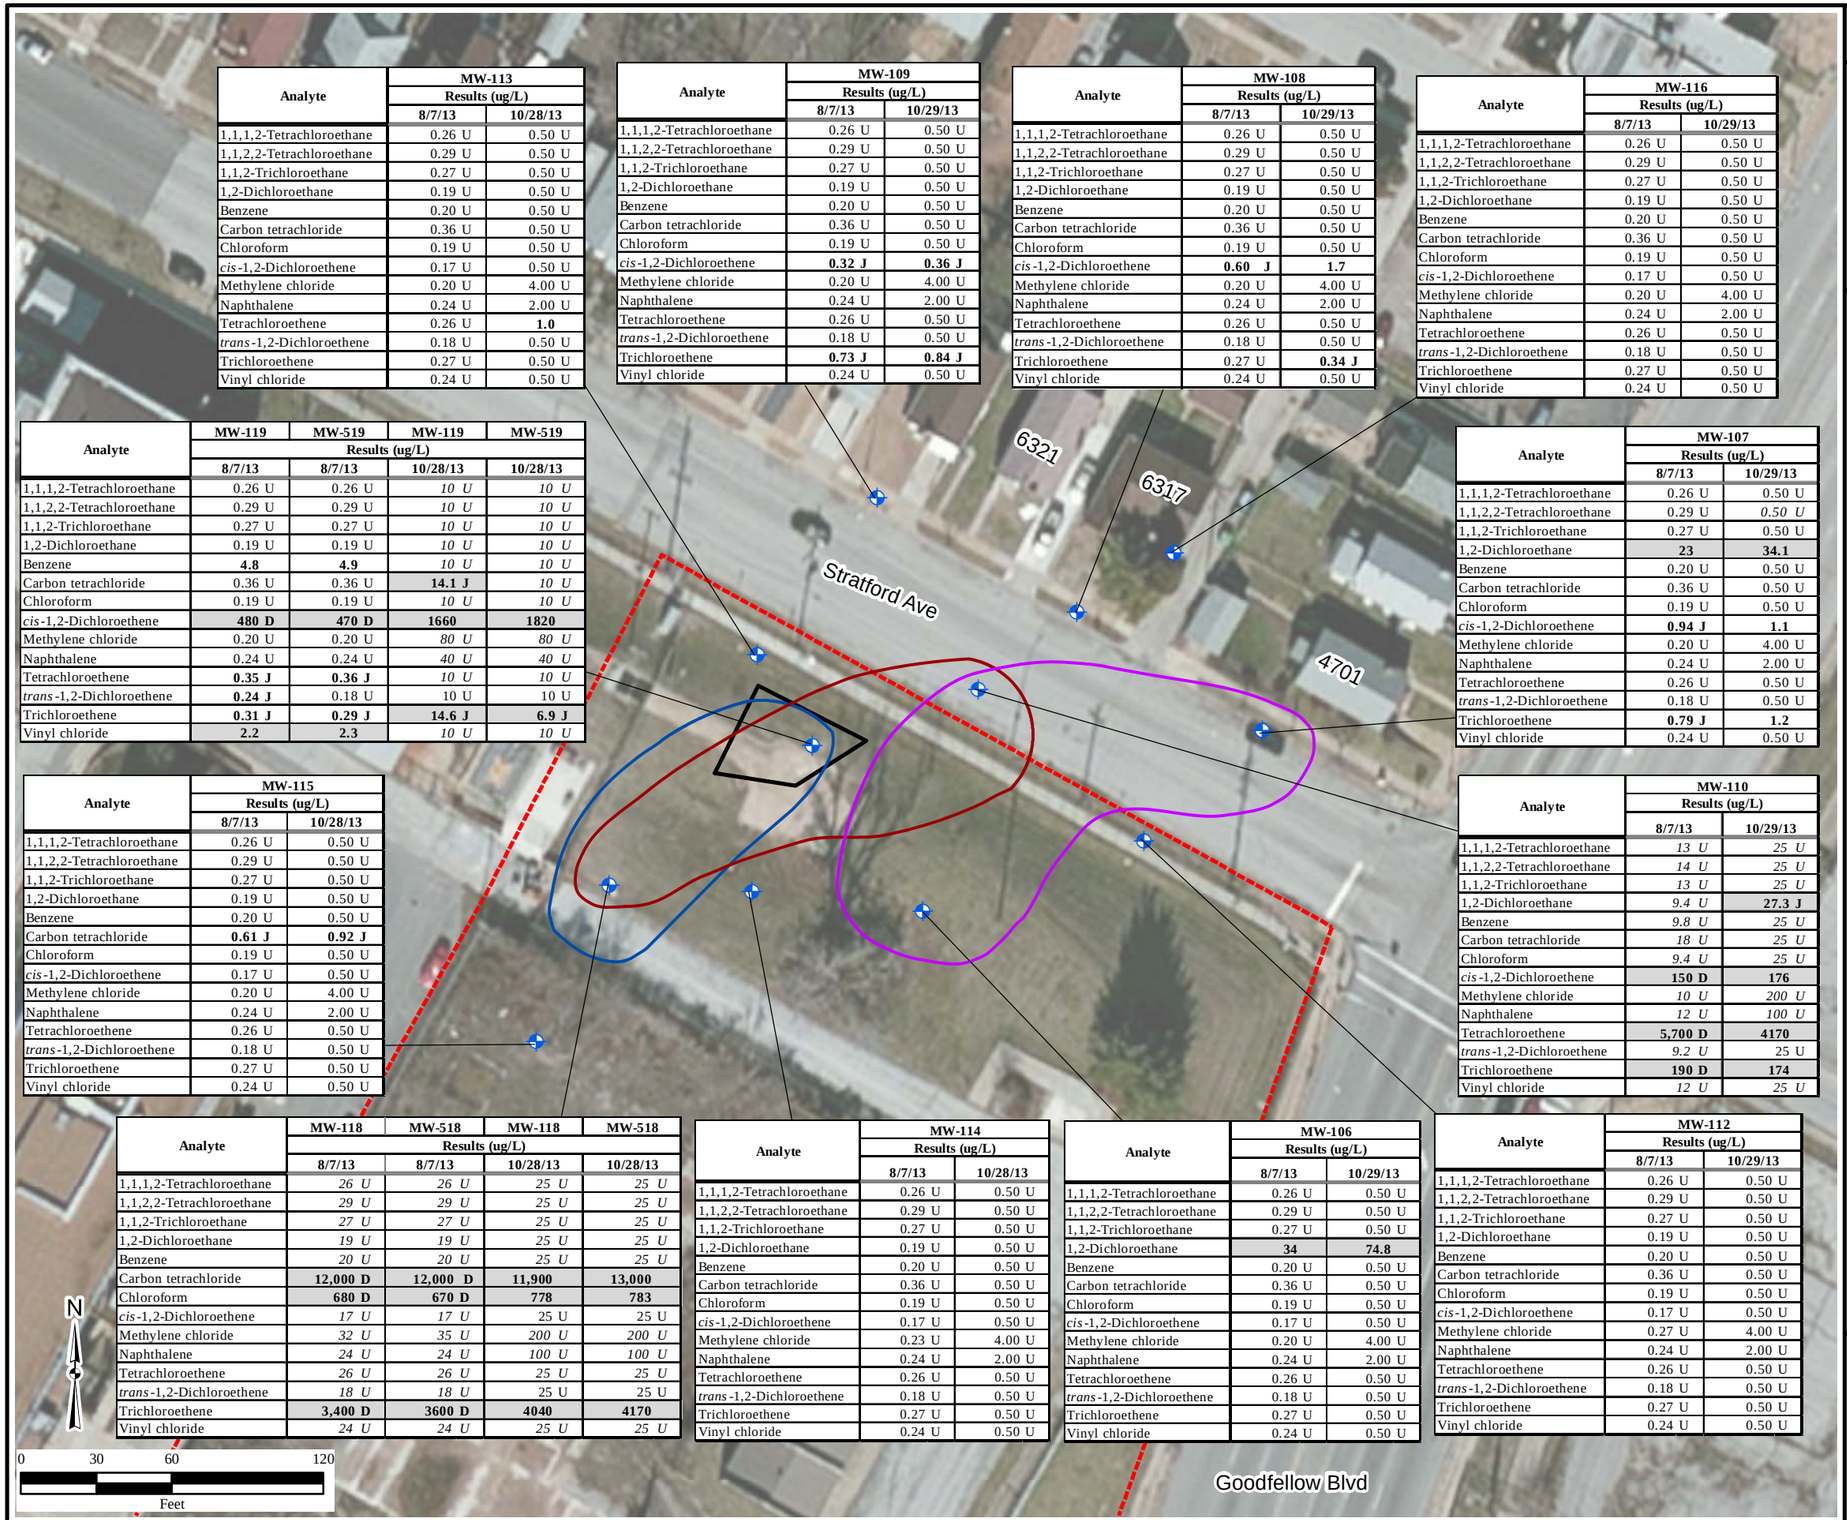
Figure 3.2
Groundwater VOC Data
The Former St. Louis Ordnance Plant
August/October 2013

The extent of Plume A, Plume B, and Plume C are shown on Figure 3.2. Table 3.3 presents cumulative site groundwater monitoring data for the COCs, along with the screening levels and remediation goals. Figure 3.2 shows groundwater LTM data for August 2013 and October 2013. The annual report for 2014 will include discussion and trend graphs for the network monitoring wells for PCE and degradation products; CT and degradation products; and 1,1,1,2-TeCA and degradation products.
