First Half 2019
Operations and Monitoring Report
Remedial Action Pilot Study

Former J.H. Baxter & Co. Wood Treating Facility
Arlington, Washington

August 2019

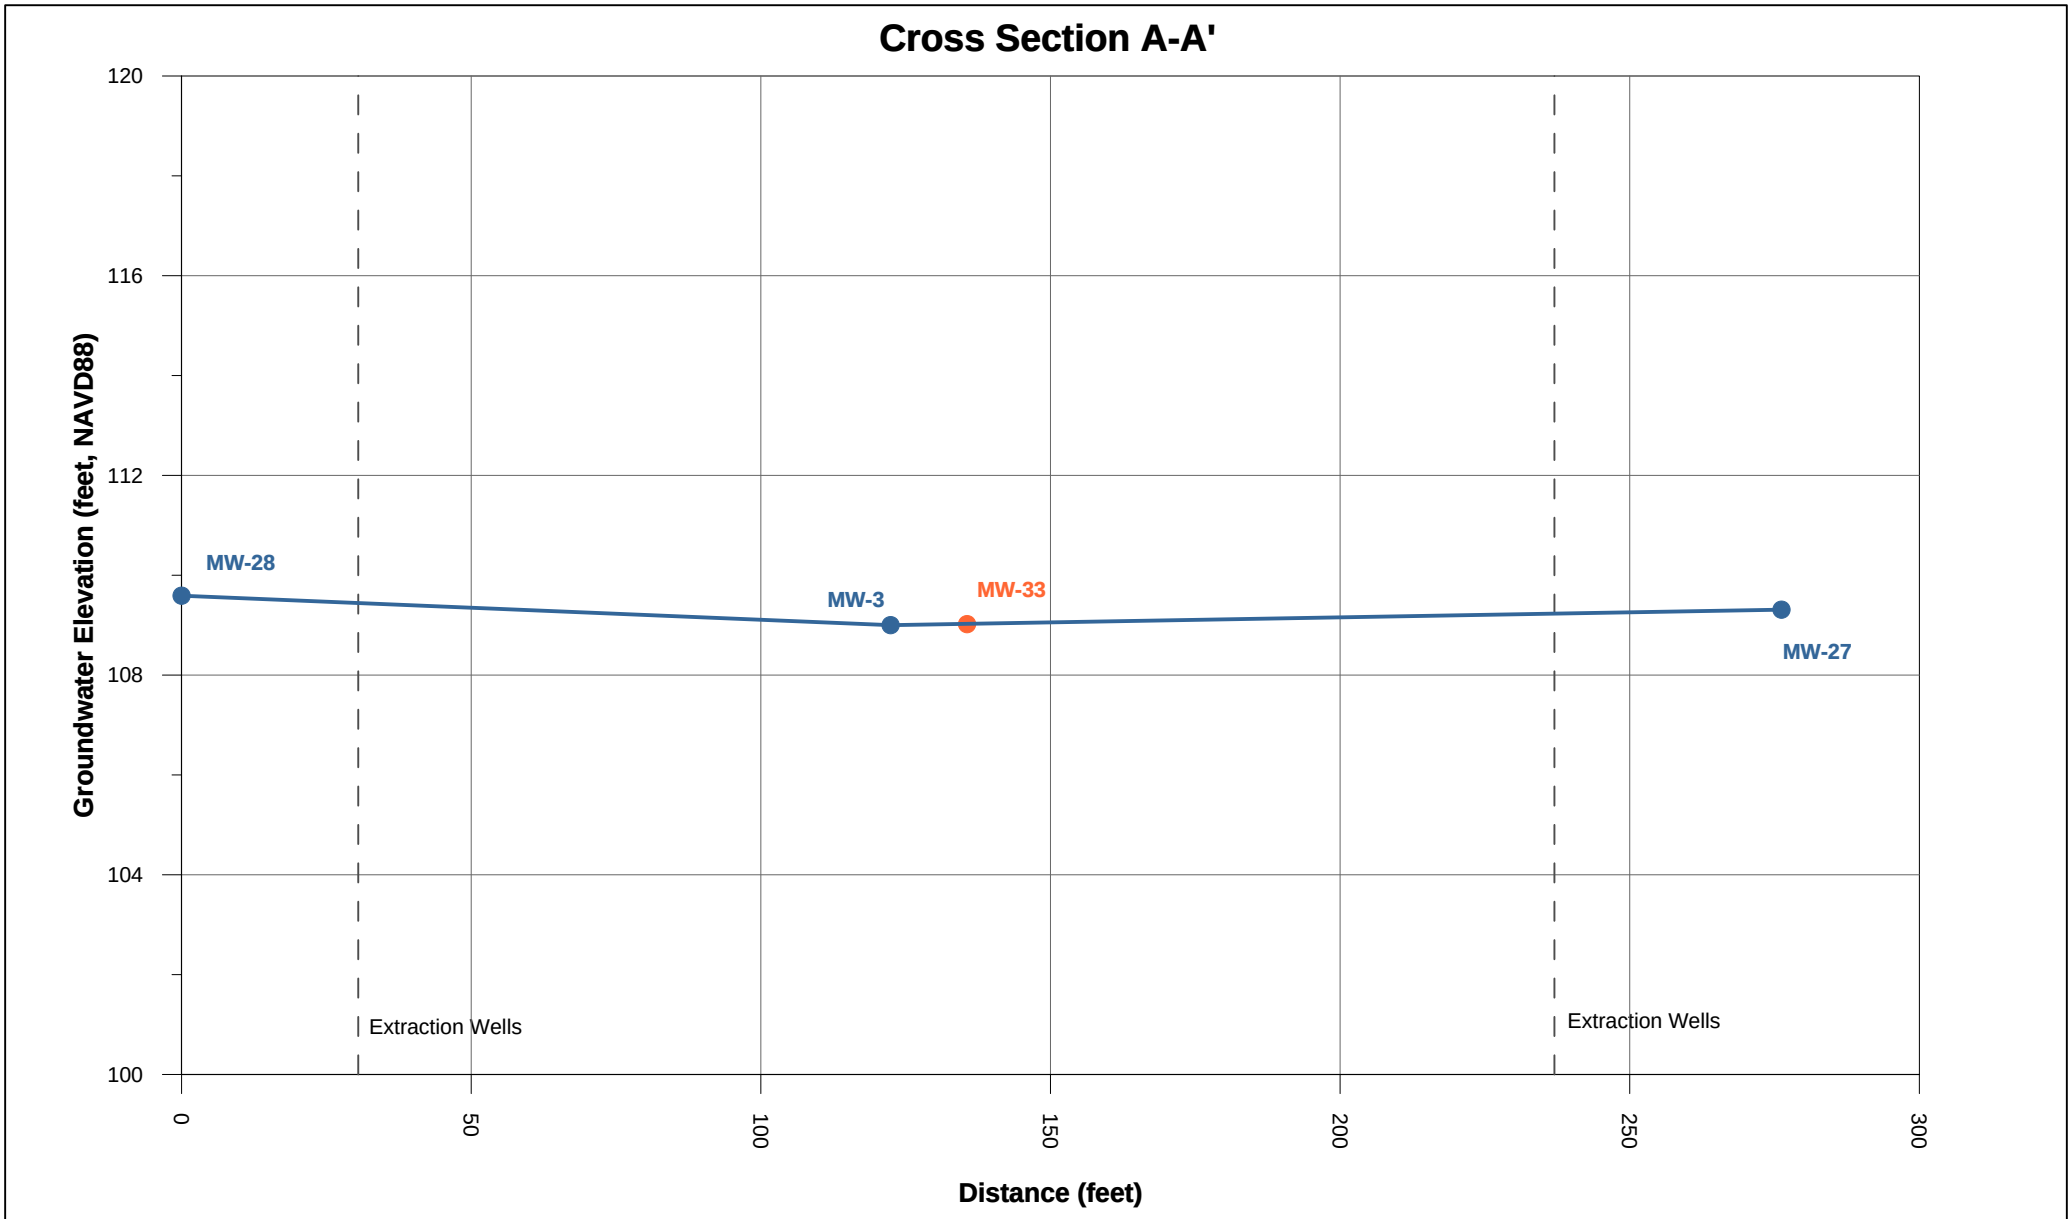
FIGURE A-2
First Quarter 2019 Groundwater Elevation
Cross Section A-A'
Former J.H. Baxter Wood Treating Facility
Arlington, Washington

gradient indicates an upward trend and a positive gradient indicates a downward trend. In Appendix A, Figures A-2 through A-5 display the vertical gradients for select well pairs. Figures A-4 and A-5 show that water levels in the shallow zone, where the extraction and infiltration occurred, were generally higher in the area of infiltration and lower in the area of extraction, as would be expected. The MW-25/MW-32 well pair (Figure 5) shows a downward gradient that is consistent with past trends and is to be expected near the infiltration trench, where shallow water levels are elevated because of the infiltrating groundwater. In between the infiltration trench and extraction wells, at well pair MW-3/MW-33, an upward vertical gradient was observed during the first quarter of 2019. Second quarter 2019 was not measured for MW-3. A downward vertical gradient between the deep zone and shallow zone near the extraction wells (MW-29/MW-38 well pair) was observed in the first half of 2019. Downgradient of the recirculation system, there is little vertical gradient between the shallow, intermediate, and deep zones with the exception of the upward gradient at the distal well cluster MW-37/MW-41 between the intermediate and deep zones observed in the first half of 2019.

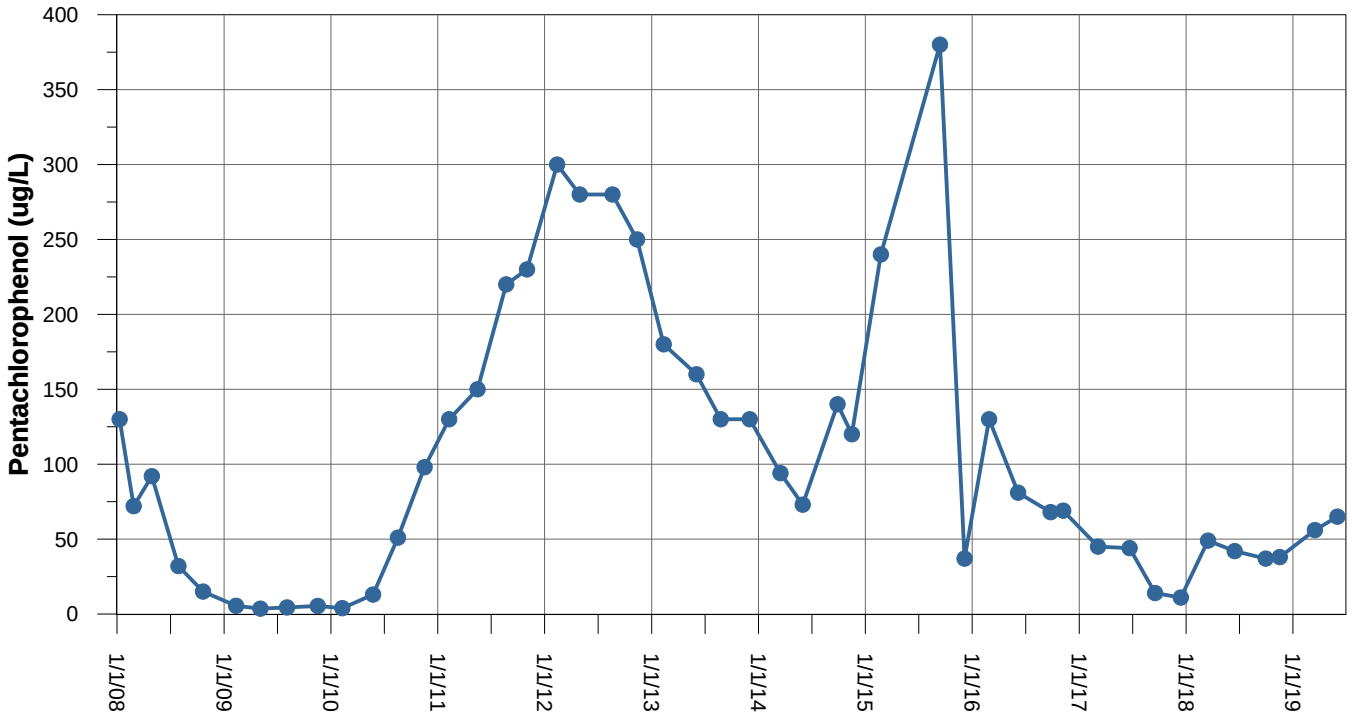
- **MW-22 (Figure C-3)**: Since September 2015, the PCP concentration has generally declined in MW-22 from 130 µg/L in the first quarter of 2016. Concentrations increased slightly during the first half of 2019 relative to 2018 but still shows a general overall decline in PCP concentration. This well is located upgradient of extraction well EW-1, which has been continuously operated since August 2015.

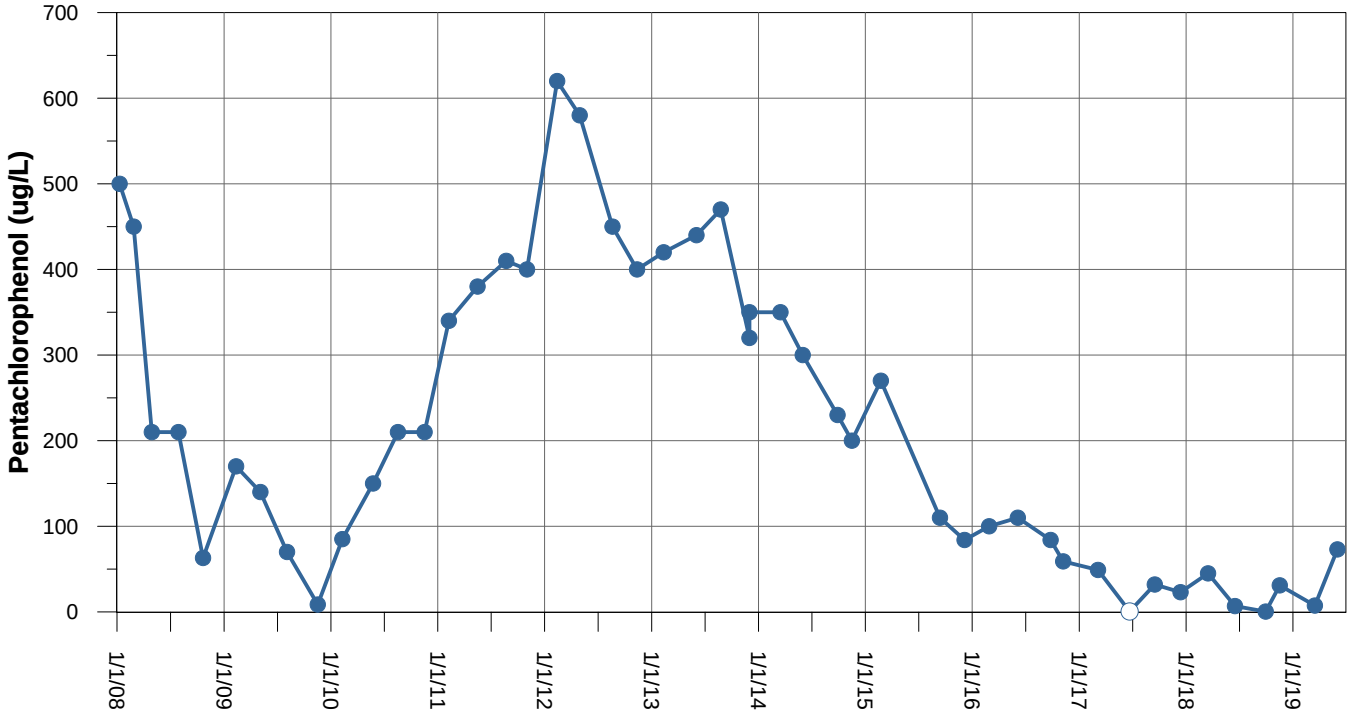
MW-23

- **MW-23 (Figure C-4)**: Since 2009, the PCP concentration has shown a mid-year increase every year but has overall declined significantly from 2012. This well is located upgradient of extraction well EW-2, which has been continuously operated since August 2015.

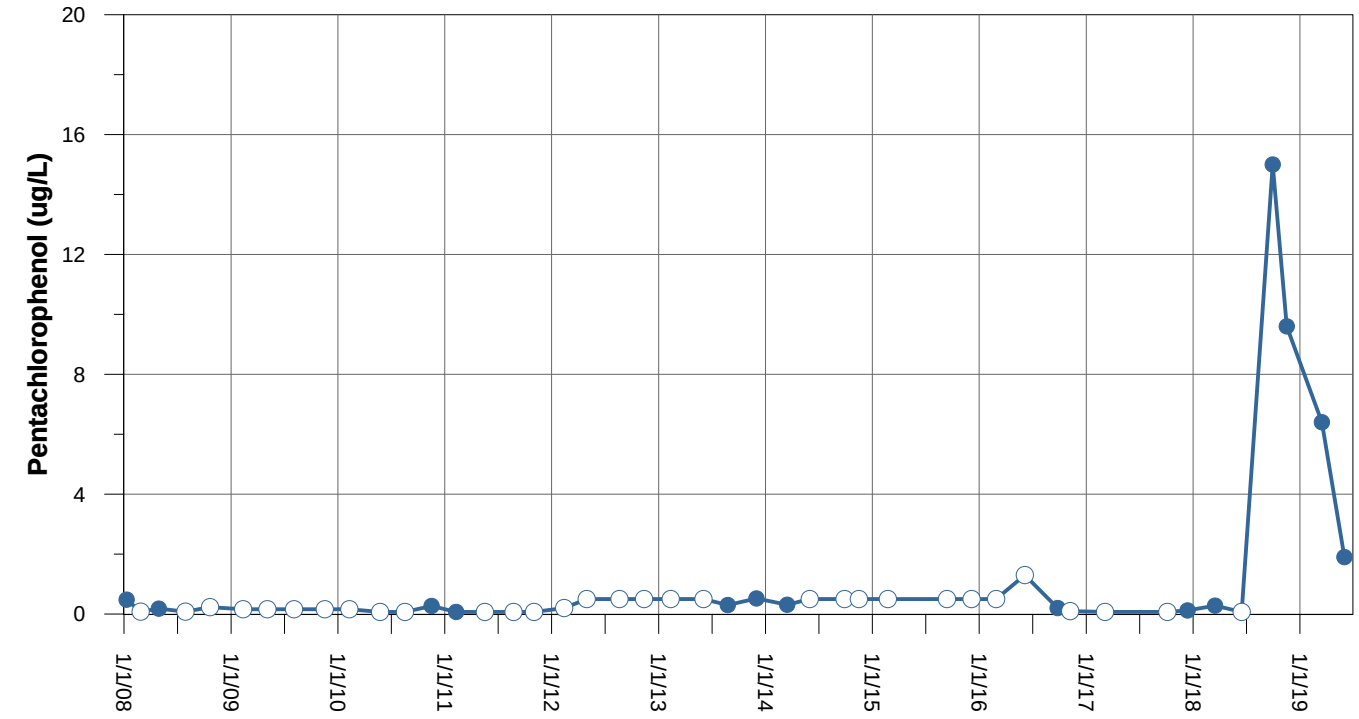
MW-27

- **MW-27 (Figure C-5)**: PCP concentrations during the third quarter of 2018 were detected at their highest levels since monitoring has begun at this well. However, concentrations were still relatively low at 15 µg/L. Concentrations have been declining towards non-detect values since that time. This well is located cross-gradient from the extraction wells.
