VIDEO SURVEY KEY

UPLAND SOURCE CONTROL
BOEING PLANT 2
SEATTLE, WASHINGTON

STORMWATER STRUCTURES INVESTIGATION
SOLIDS SAMPLE PCBs RESULTS

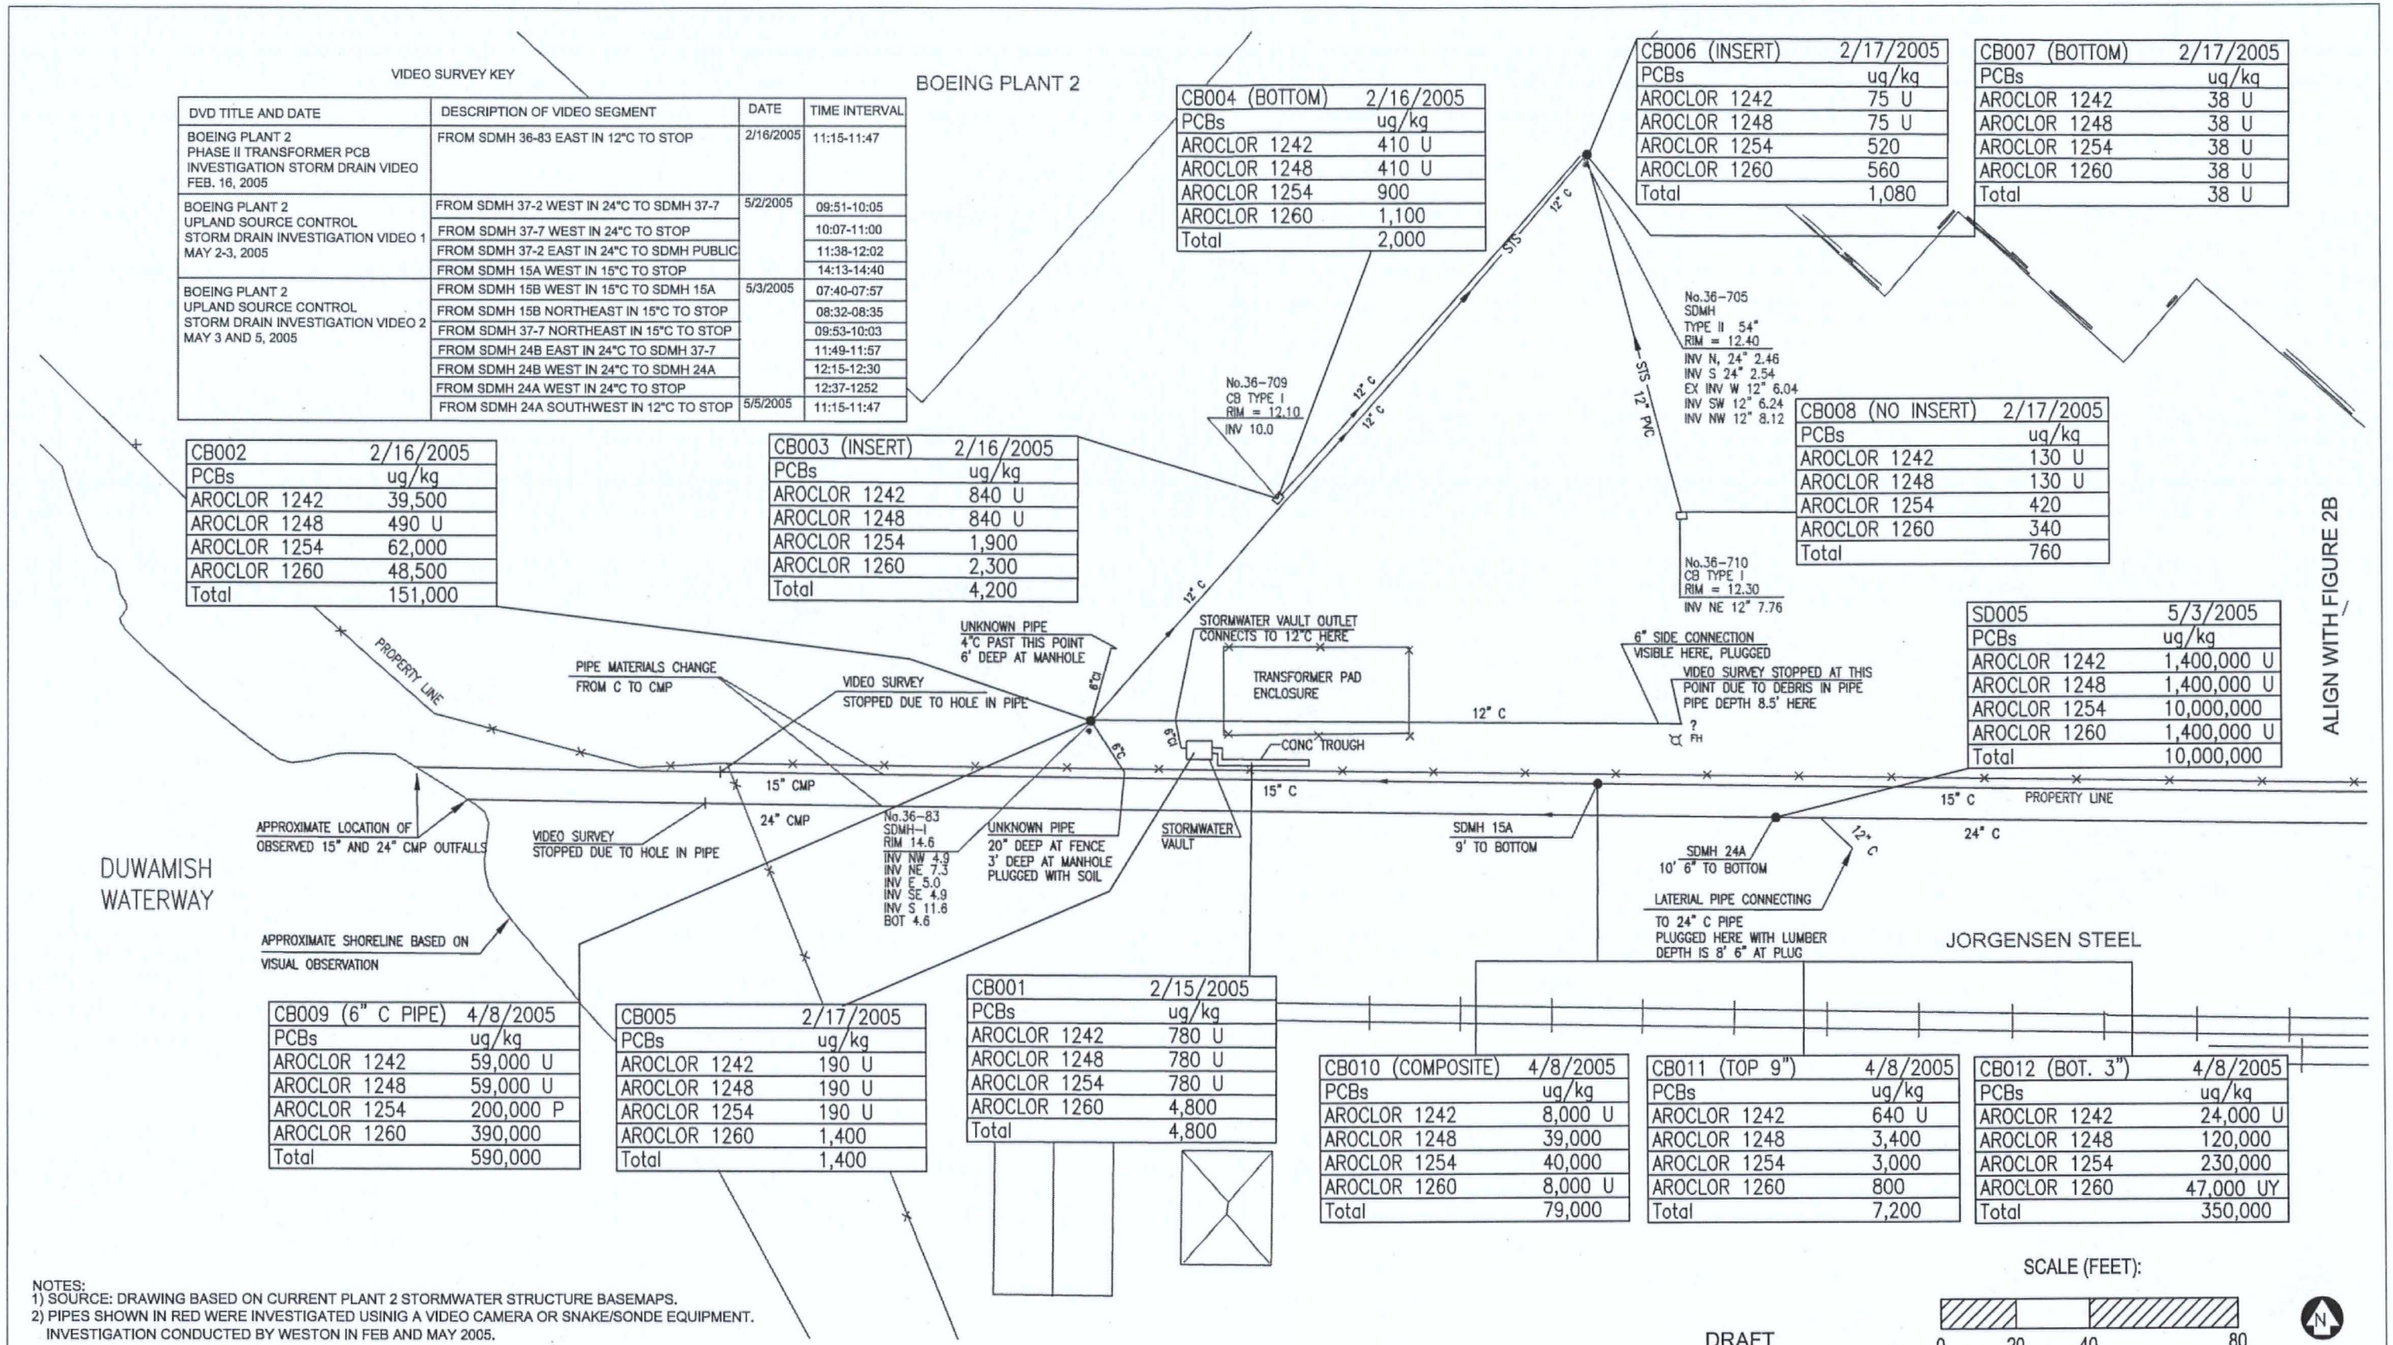
DRAWN	DATE	DWG. NO.	REV. NO.
DLD	JUNE 10, 2005	FIGURE - 2A	0
SCALE 1" = 50'	W.O. NO. 03709-034.600.0008 RFW NO. 05-0031	SHT. 1 OF 1

CB004 (BOTTOM)	2/16/2005
PCBs	ug/kg
AROCLOR 1242	410 U
AROCLOR 1248	410 U
AROCLOR 1254	900
AROCLOR 1260	1,100
Total	2,000

CB006 (INSERT)	2/17/2005
PCBs	ug/kg
AROCLOR 1242	75 U
AROCLOR 1248	75 U
AROCLOR 1254	520
AROCLOR 1260	560
Total	1,080

CB007 (BOTTOM)	2/17/2005
PCBs	ug/kg
AROCLOR 1242	38 U
AROCLOR 1248	38 U
AROCLOR 1254	38 U
AROCLOR 1260	38 U
Total	38 U

CB008 (NO INSERT)	2/17/2005
PCBs	ug/kg
AROCLOR 1242	130 U
AROCLOR 1248	130 U
AROCLOR 1254	420
AROCLOR 1260	340
Total	760

CB002	2/16/2005
PCBs	ug/kg
AROCLOR 1242	39,500
AROCLOR 1248	490 U
AROCLOR 1254	62,000
AROCLOR 1260	48,500
Total	151,000

CB003 (INSERT)	2/16/2005
PCBs	ug/kg
AROCLOR 1242	840 U
AROCLOR 1248	840 U
AROCLOR 1254	1,900
AROCLOR 1260	2,300
Total	4,200

SD005	5/3/2005
PCBs	ug/kg
AROCLOR 1242	1,400,000 U
AROCLOR 1248	1,400,000 U
AROCLOR 1254	10,000,000
AROCLOR 1260	1,400,000 U
Total	10,000,000

CB009 (6" C PIPE)	4/8/2005
PCBs	ug/kg
AROCLOR 1242	59,000 U
AROCLOR 1248	59,000 U
AROCLOR 1254	200,000 P
AROCLOR 1260	390,000
Total	590,000

CB005	2/17/2005
PCBs	ug/kg
AROCLOR 1242	190 U
AROCLOR 1248	190 U
AROCLOR 1254	190 U
AROCLOR 1260	1,400
Total	1,400

CB001	2/15/2005
PCBs	ug/kg
AROCLOR 1242	780 U
AROCLOR 1248	780 U
AROCLOR 1254	780 U
AROCLOR 1260	4,800
Total	4,800

CB010 (COMPOSITE)	4/8/2005
PCBs	ug/kg
AROCLOR 1242	8,000 U
AROCLOR 1248	39,000
AROCLOR 1254	40,000
AROCLOR 1260	8,000 U
Total	79,000

CB011 (TOP 9")	4/8/2005
PCBs	ug/kg
AROCLOR 1242	640 U
AROCLOR 1248	3,400
AROCLOR 1254	3,000
AROCLOR 1260	800
Total	7,200

CB012 (BOT. 3")	4/8/2005
PCBs	ug/kg
AROCLOR 1242	24,000 U
AROCLOR 1248	120,000
AROCLOR 1254	230,000
AROCLOR 1260	47,000 UY
Total	350,000

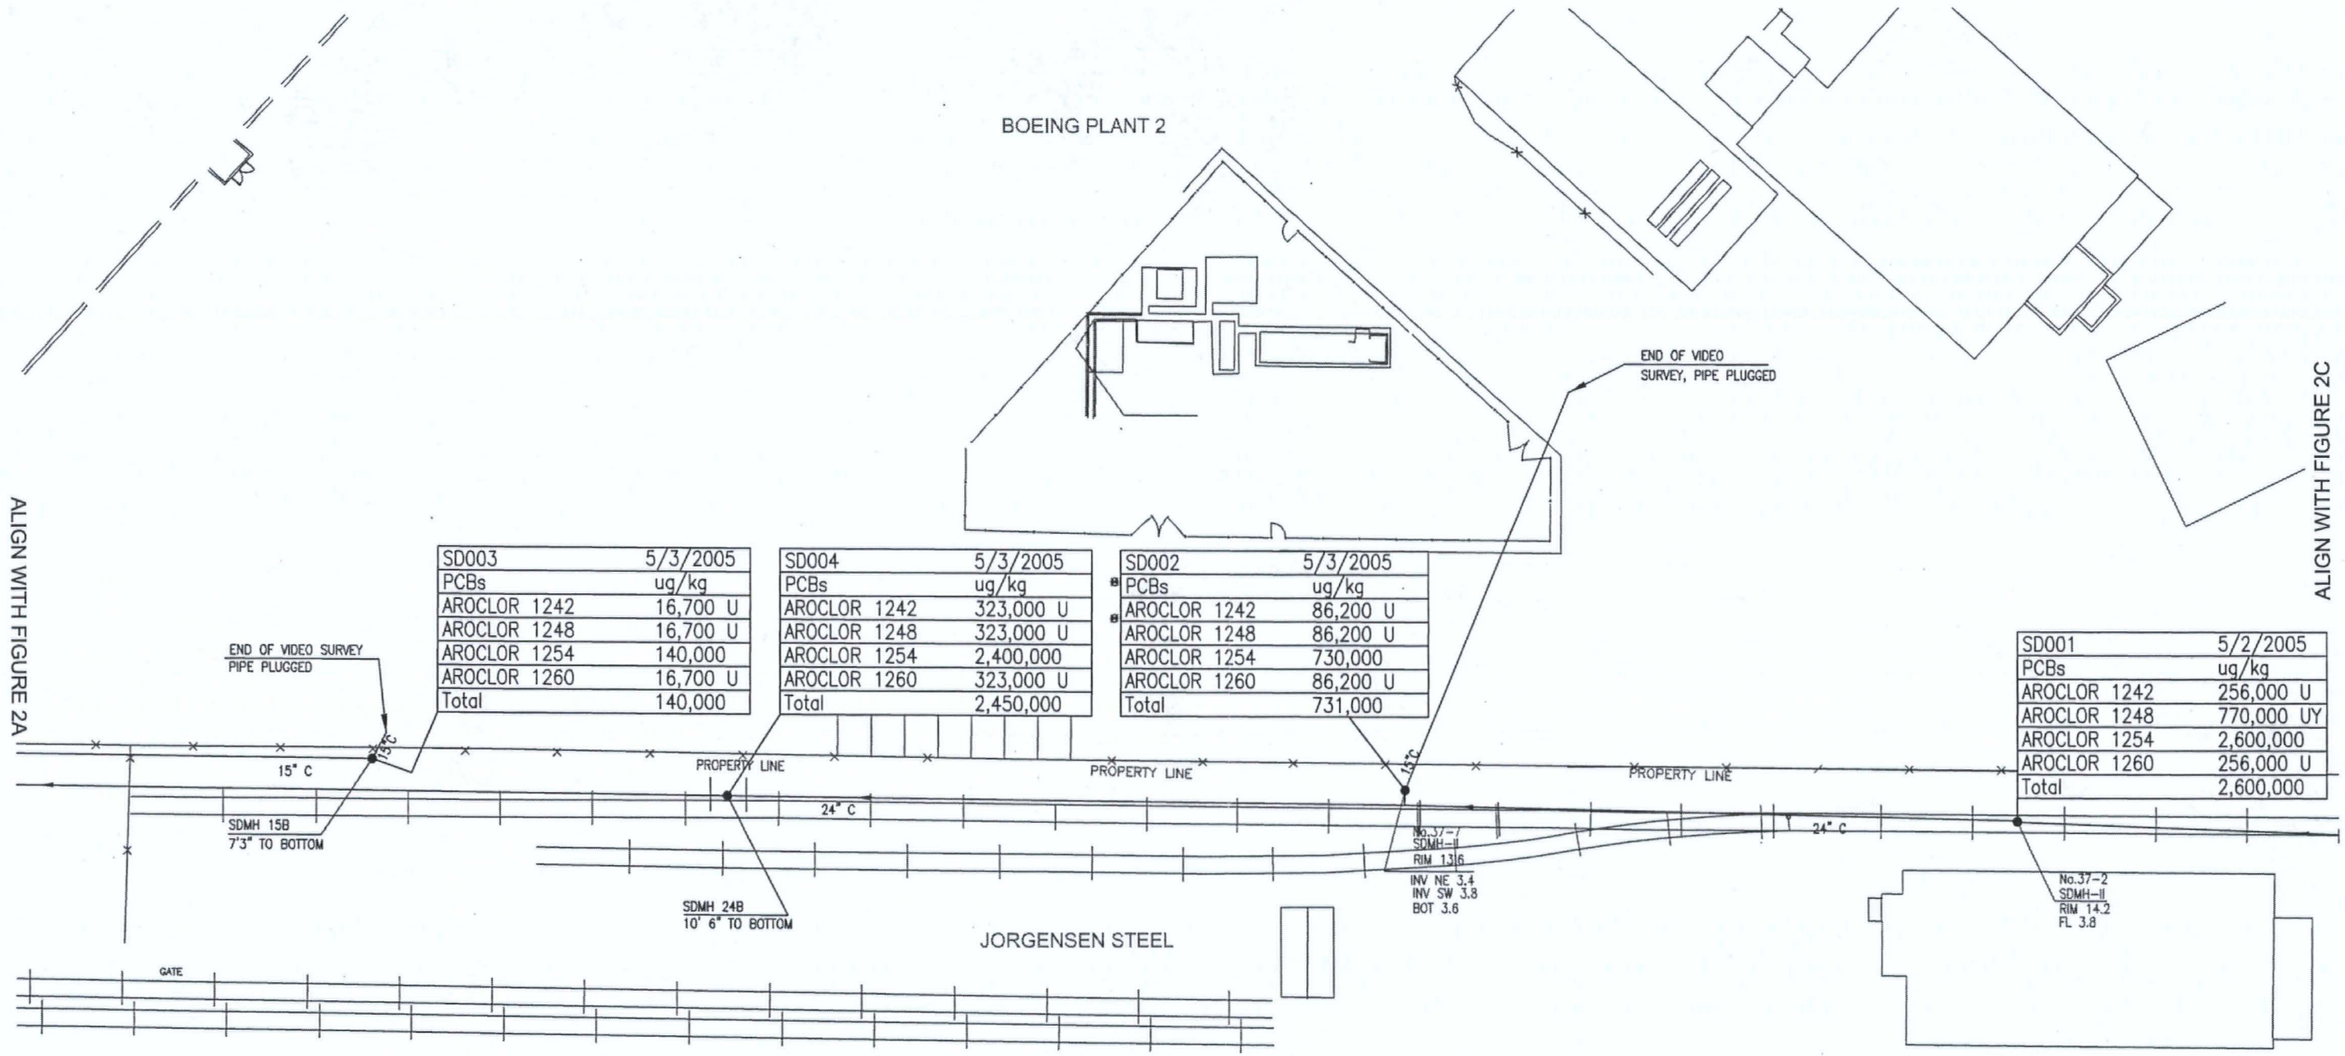
DRAWN	DATE	DWG. NO.	REV. NO.
DLD	JUNE 10, 2005	FIGURE - 2B	0
SCALE 1" = 50'	W.O. NO. 03709-034.600.0008 REF NO. 05-0031	SHT. 1 OF 1

SD003	5/3/2005
PCBs	ug/kg
AROCLOR 1242	16,700 U
AROCLOR 1248	16,700 U
AROCLOR 1254	140,000
AROCLOR 1260	16,700 U
Total	140,000

SD004	5/3/2005
PCBs	ug/kg
AROCLOR 1242	323,000 U
AROCLOR 1248	323,000 U
AROCLOR 1254	2,400,000
AROCLOR 1260	323,000 U
Total	2,450,000

SD002	5/3/2005
PCBs	ug/kg
AROCLOR 1242	86,200 U
AROCLOR 1248	86,200 U
AROCLOR 1254	730,000
AROCLOR 1260	86,200 U
Total	731,000

SD001	5/2/2005
PCBs	ug/kg
AROCLOR 1242	256,000 U
AROCLOR 1248	770,000 UY
AROCLOR 1254	2,600,000
AROCLOR 1260	256,000 U
Total	2,600,000

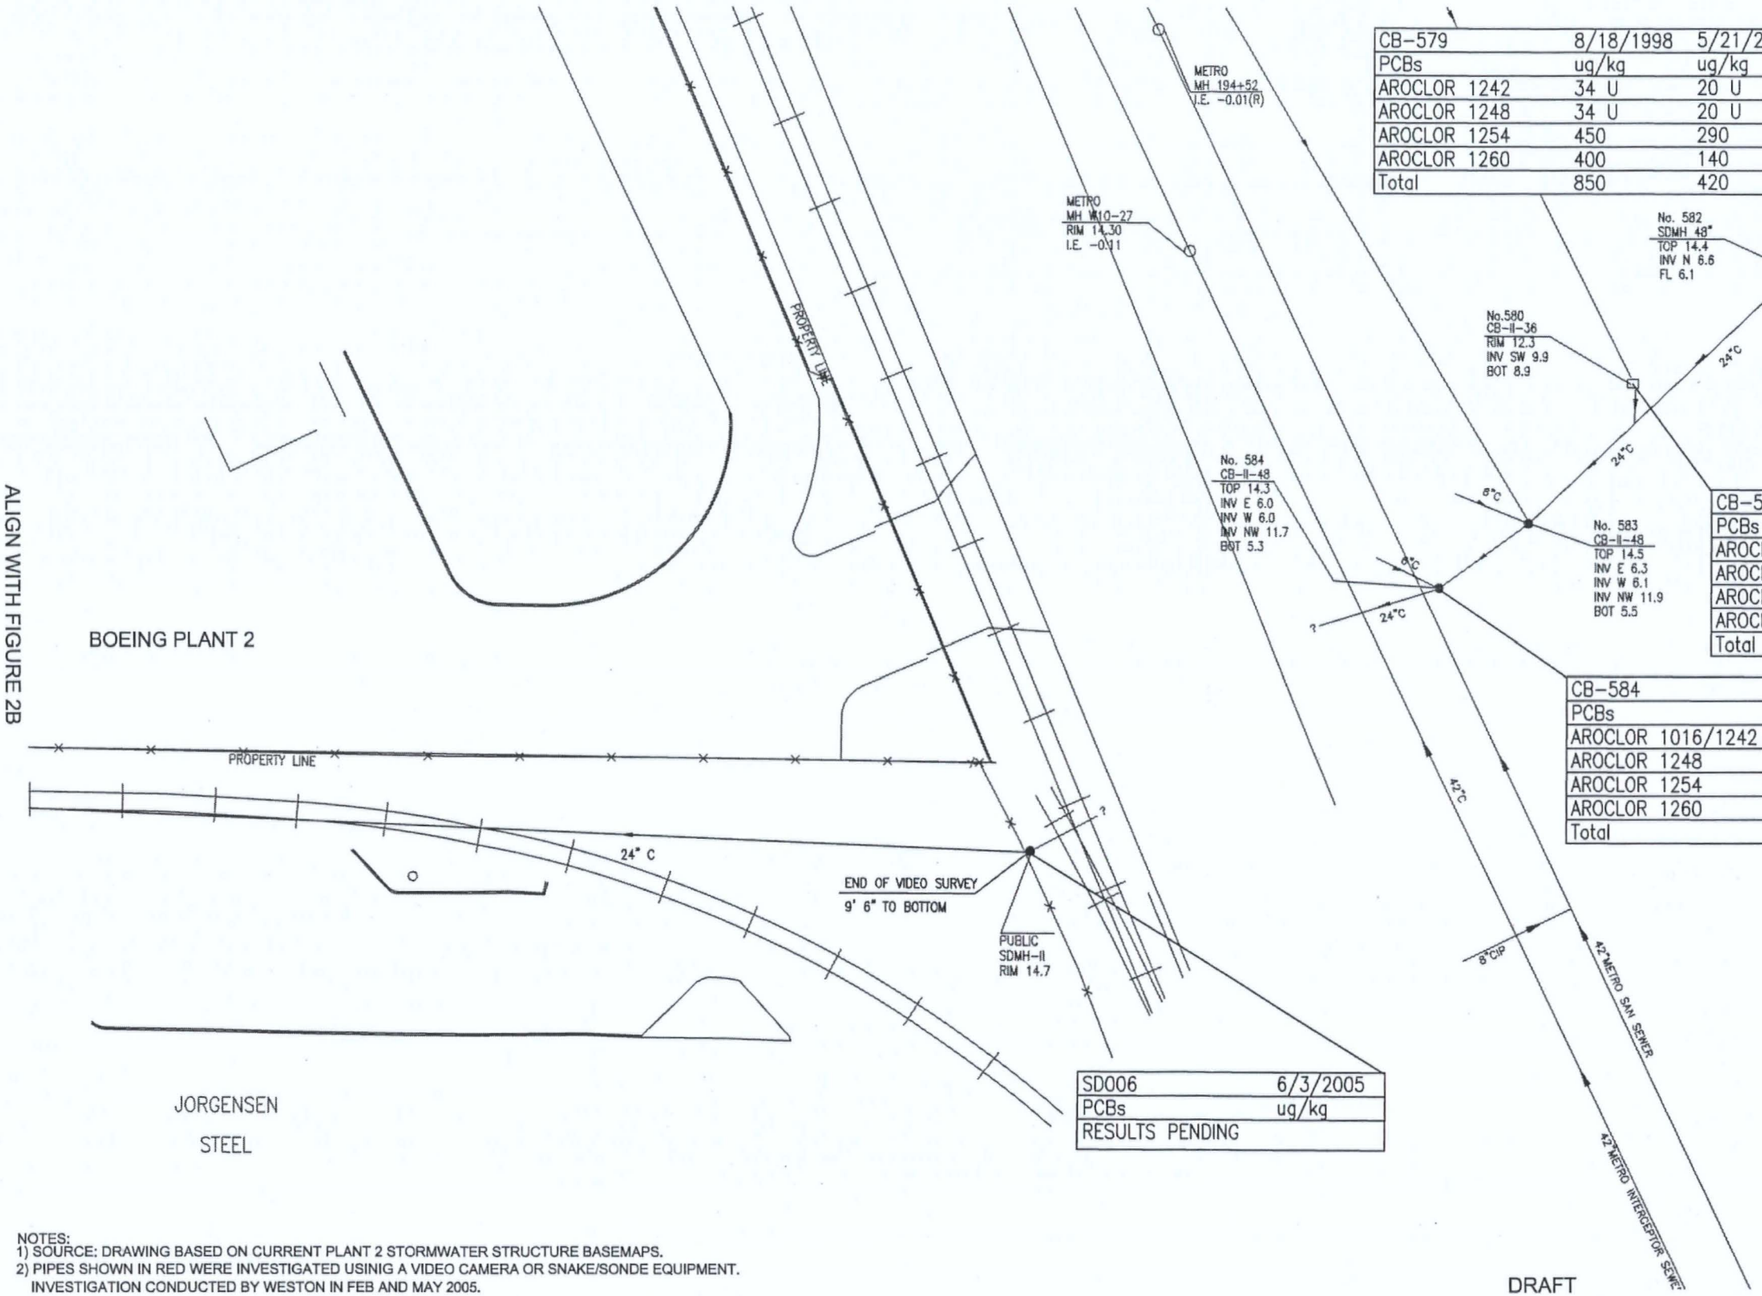
DRAWN	DATE	DWG. NO.	REV. NO.
DLD	JUNE 10, 2005	FIGURE - 2C	0
SCALE 1" = 50'	W.O. NO. 03709-034.600.0008 RFW NO. 05-0031	SHT. 1 OF 1

CB-579	8/18/1998	5/21/2000
PCBs	ug/kg	ug/kg
AROCLOR 1242	34 U	20 U
AROCLOR 1248	34 U	20 U
AROCLOR 1254	450	290
AROCLOR 1260	400	140
Total	850	420

CB-580	8/18/1998	5/21/2000
PCBs	ug/kg	ug/kg
AROCLOR 1016/1242	43 U	20 U
AROCLOR 1248	43 U	20 U
AROCLOR 1254	290	760
AROCLOR 1260	310	210
Total	600	970

CB-584	9/26/1997	8/18/1998	5/21/2000
PCBs	ug/kg	ug/kg	ug/kg
AROCLOR 1016/1242	50 U	970 U	2,310 U
AROCLOR 1248	50 U	970 U	2,310 U
AROCLOR 1254	51,000	36,000	128,000
AROCLOR 1260	50 U	970 U	85,000
Total	51,000	36,000	213,000

SD006	6/3/2005
PCBs	ug/kg
RESULTS PENDING

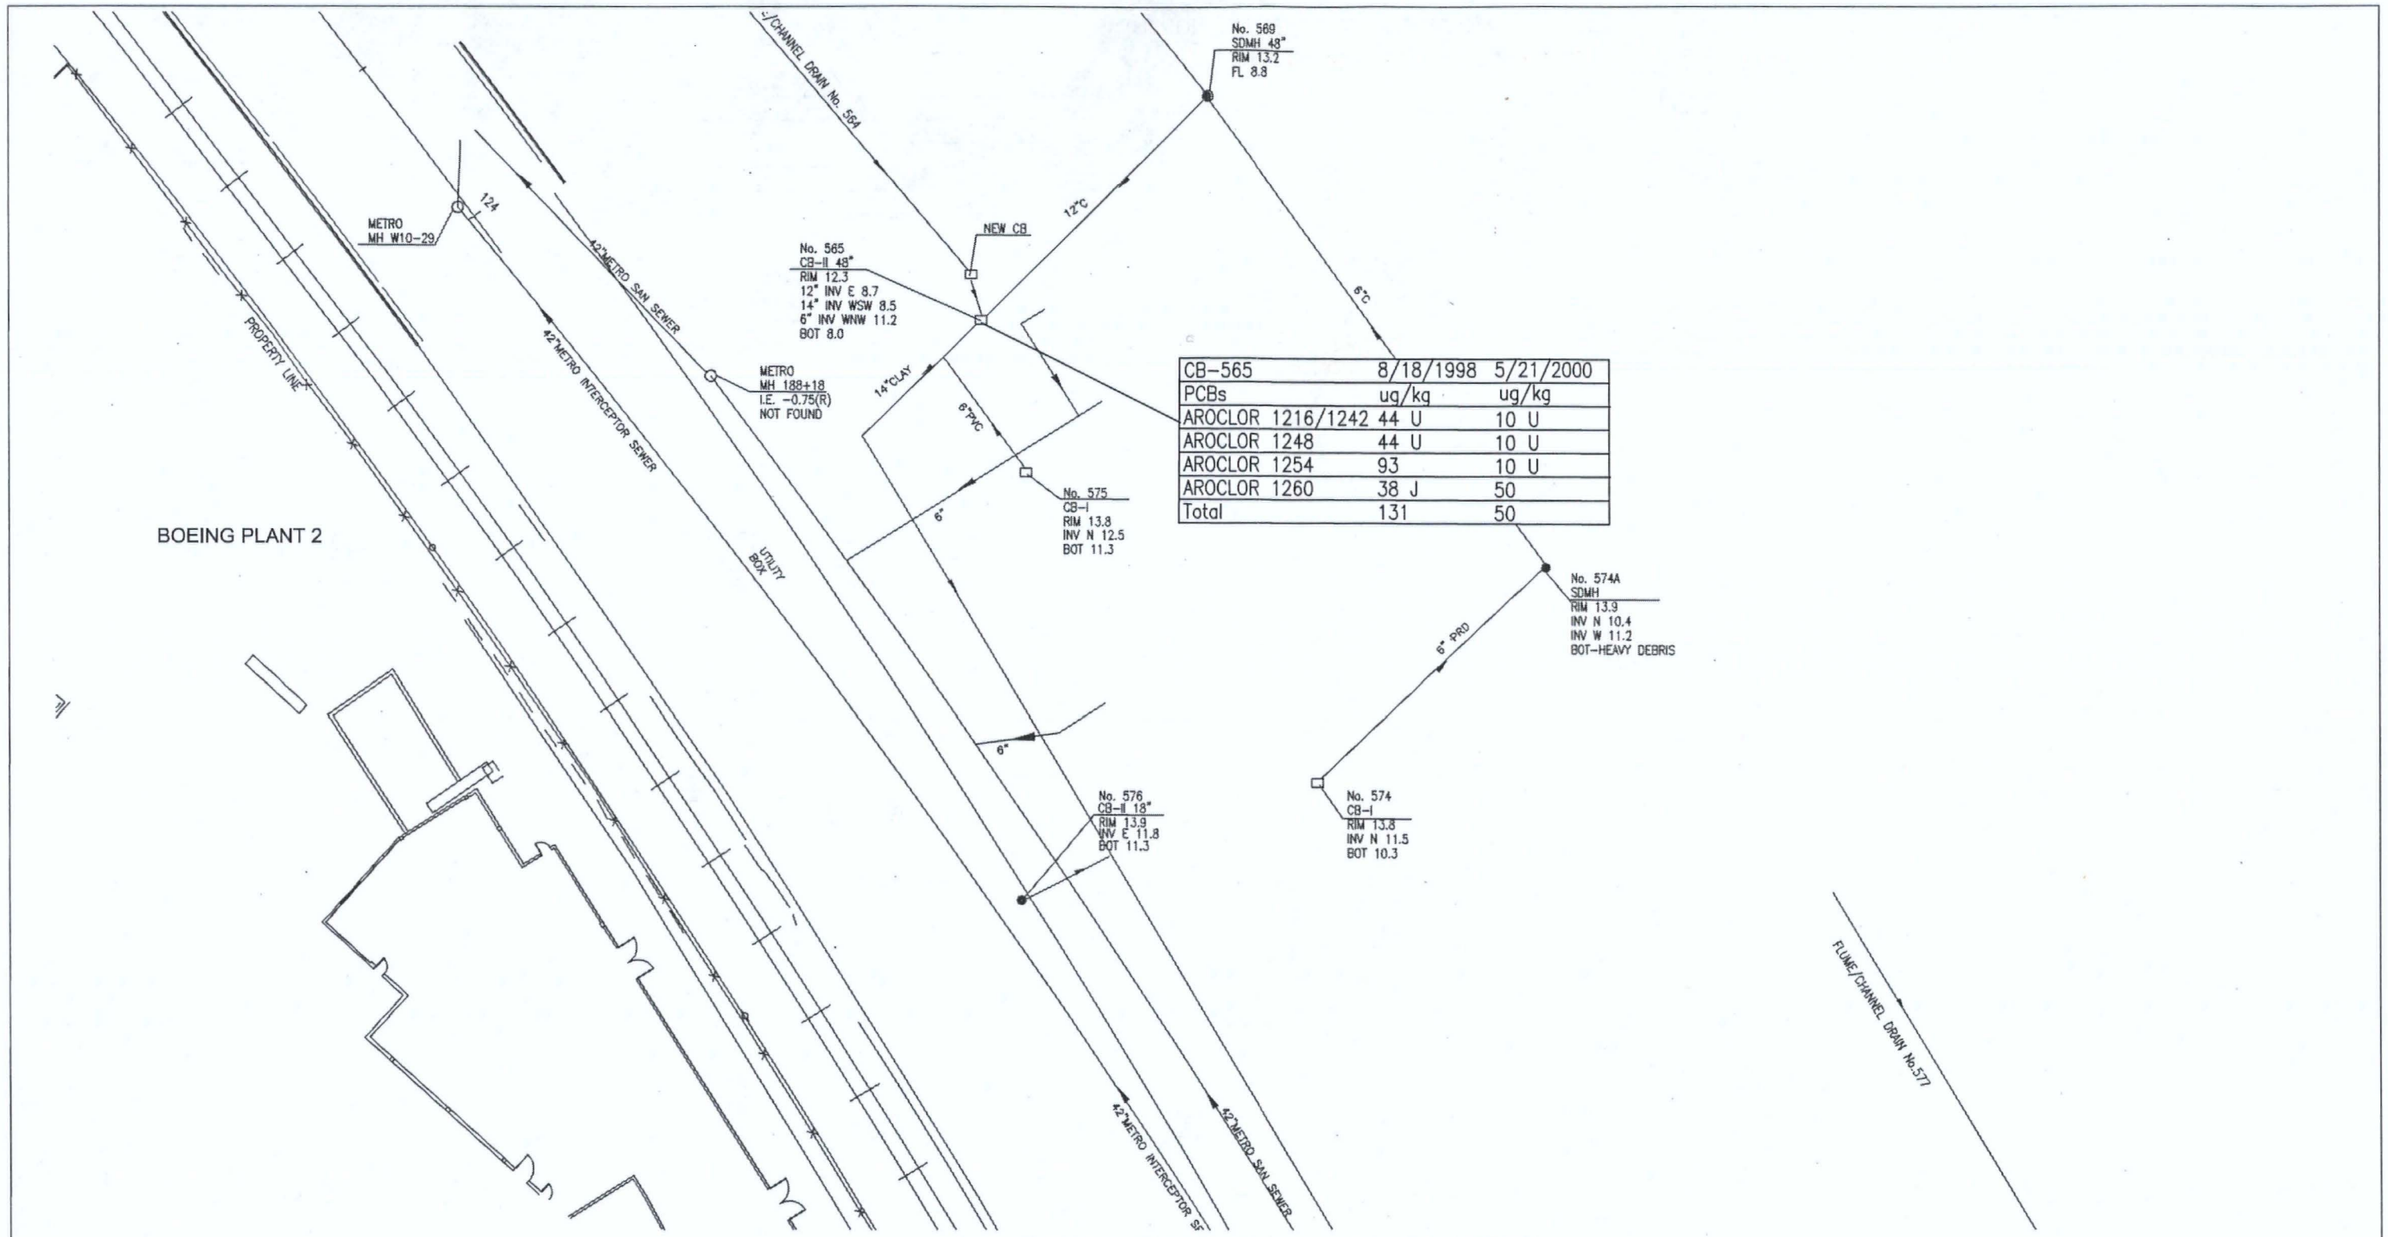
DRAWN	DATE	DWG. NO.	REV. NO.
DLD	JUNE 10, 2005	FIGURE - 2D	0
SCALE 1" = 50'	W.O. NO. 03709-034.600.0008 RFW NO. 05-0031	SHT. 1 OF 1

CB-565	8/18/1998	5/21/2000
PCBs	ug/kg	ug/kg
AROCLOR 1216/1242	44 U	10 U
AROCLOR 1248	44 U	10 U
AROCLOR 1254	93	10 U
AROCLOR 1260	38 J	50
Total	131	50
