Asbestos Abatement
Former Expansion Plant
Portland, Oregon

March 2001

URS Project No. 46347.00.00000

For REMEDIUM GROUP, INC.
A Subsidiary Of W. R. Grace & Co.

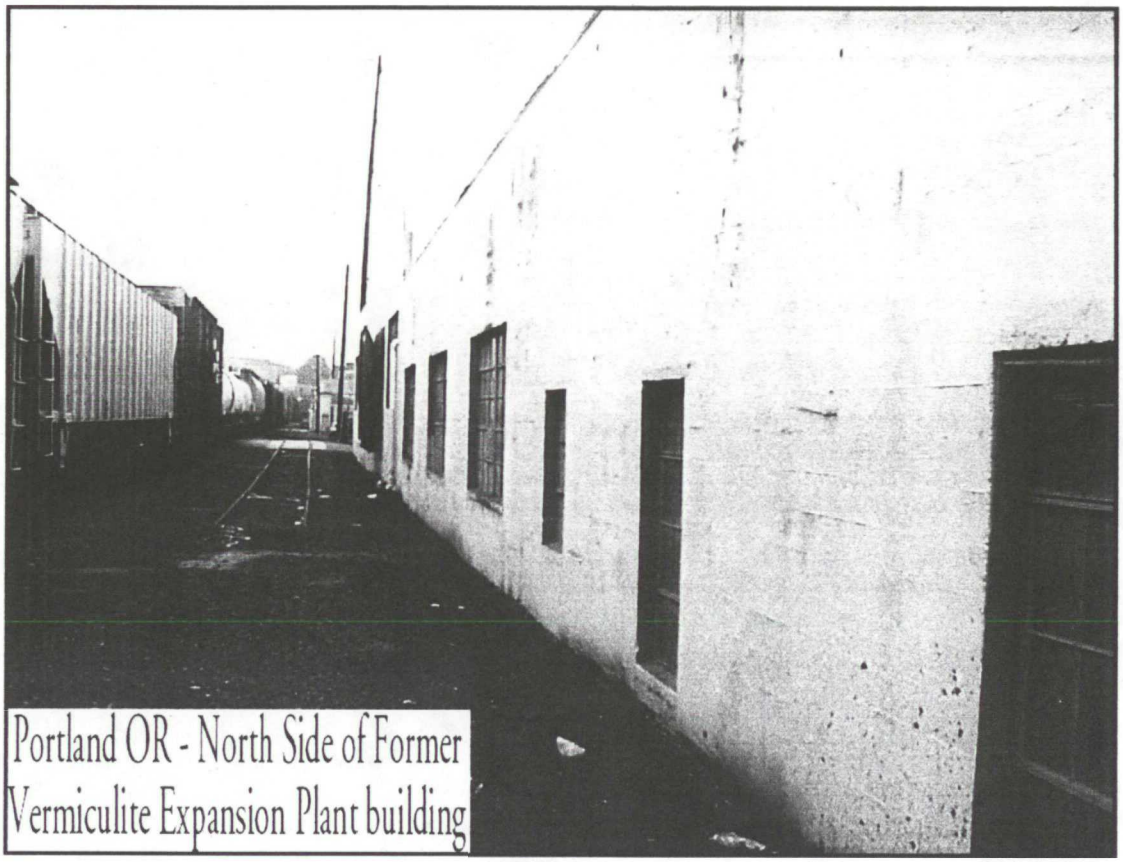
Portland OR - North Side of Former Vermiculite Expansion Plant building

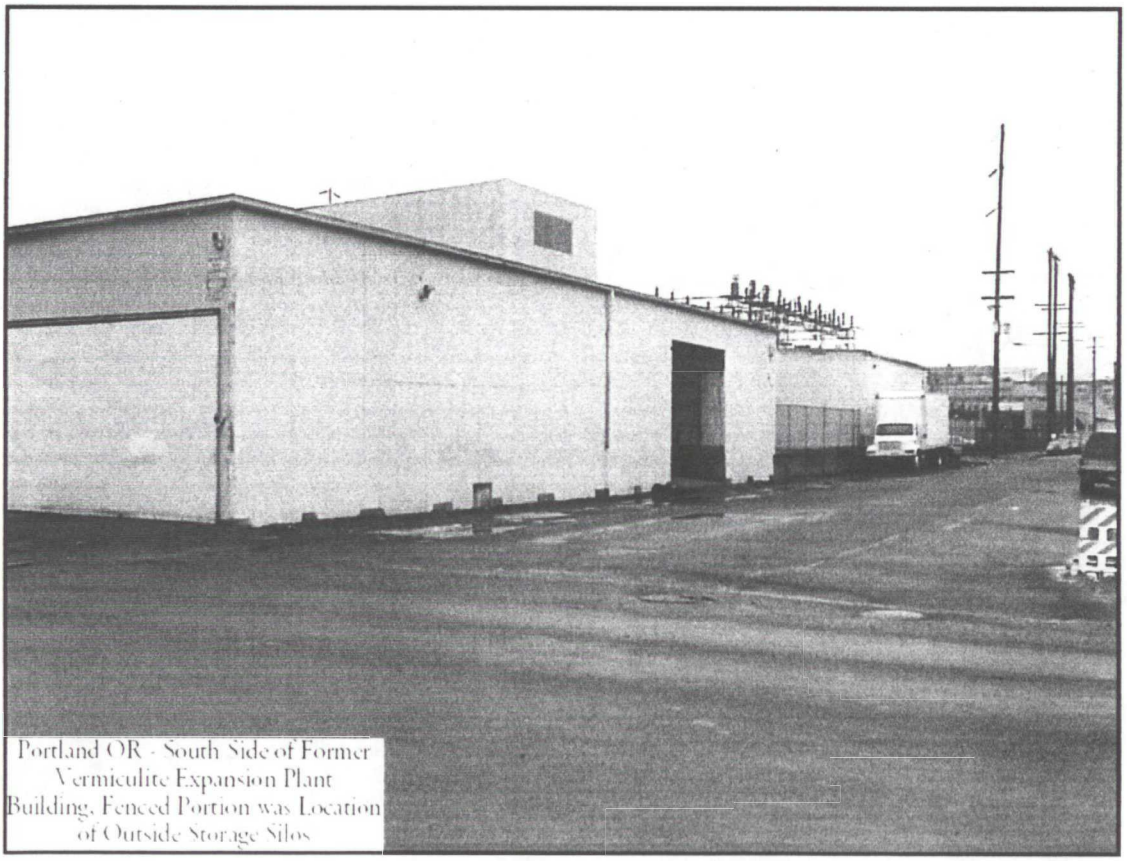
Portland OR - South Side of Former Vermiculite Expansion Plant Building, Fenced Portion was Location of Outside Storage Silos

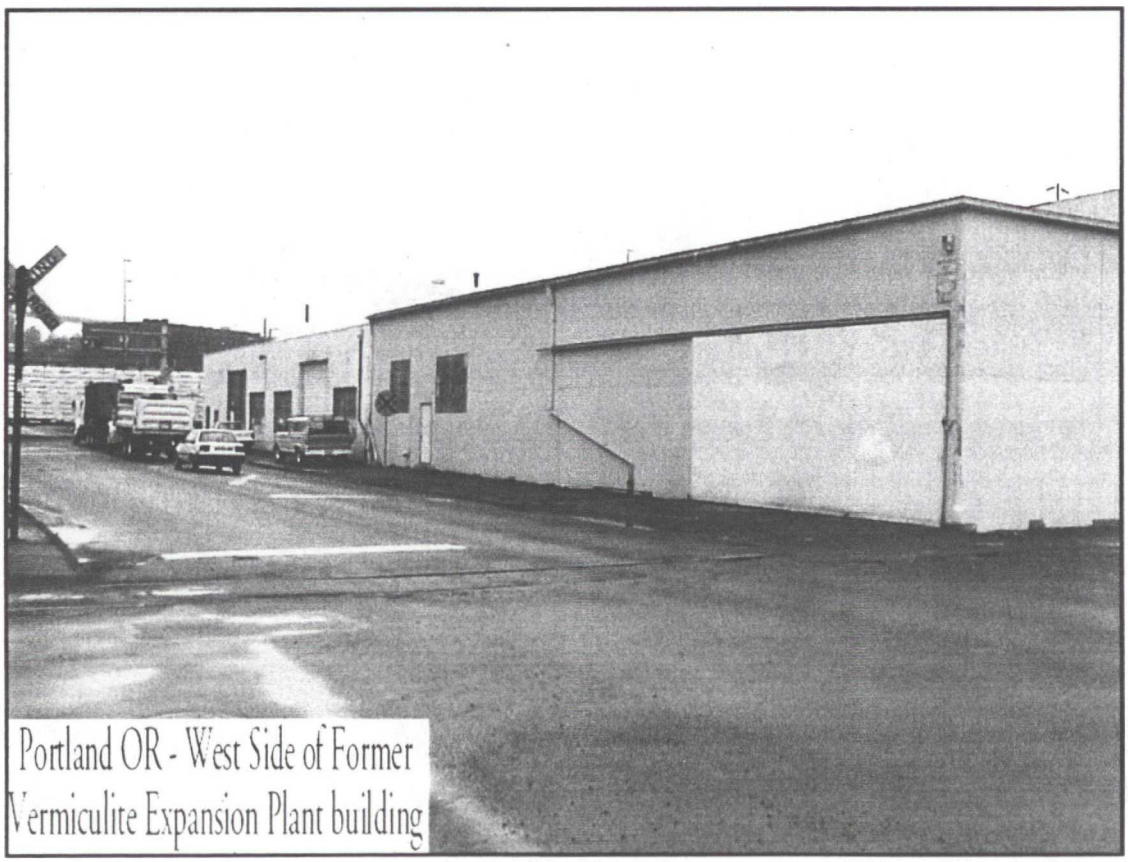
Portland OR - West Side of Former Vermiculite Expansion Plant building
