SEDIMENT SAMPLING
of Stormwater Structures
@ King County International
Airport

KCSlip4 56976

SEA423288

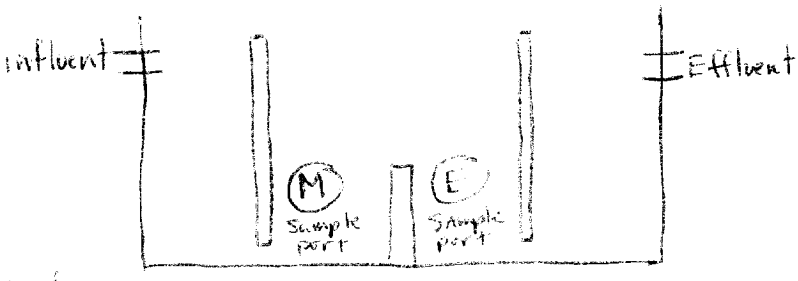
060606 SITE 1757
DLH Collected 2 Samples
& KC1A-1757-060606 (Middle)
TH + KC1A-1757-060606 (Effluent)

(M)-(middle) a little bit of orange/rust in sediment. Very little oil sheen. Dark sandy texture. (Not much sediment @ Bottom)

(E)-(Effluent) Greyish color slurry possibly asphalt/concrete slurry. Oil sheen on top of slurry. (lots of thick greyish sediment @ Bottom).
Poured a portion of (E) into a seperate container took pH reading = 6.30 @ 0935

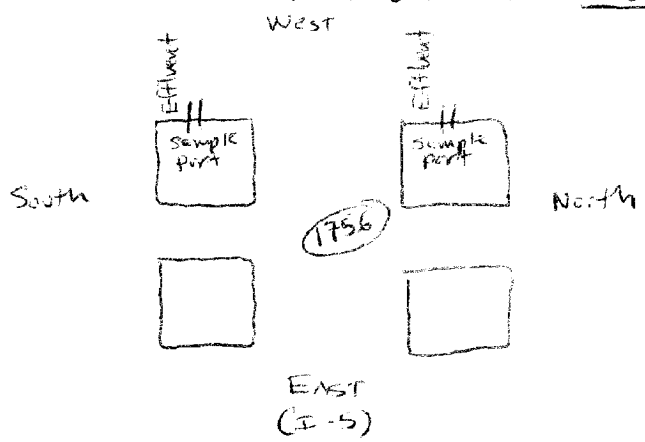
060606 SITE 1756

Collected 50% from each side - mixed in bowl.
Collected from 1ST chambers next to Effluent
The sediment is more of a sludge consistency than site # 1757.

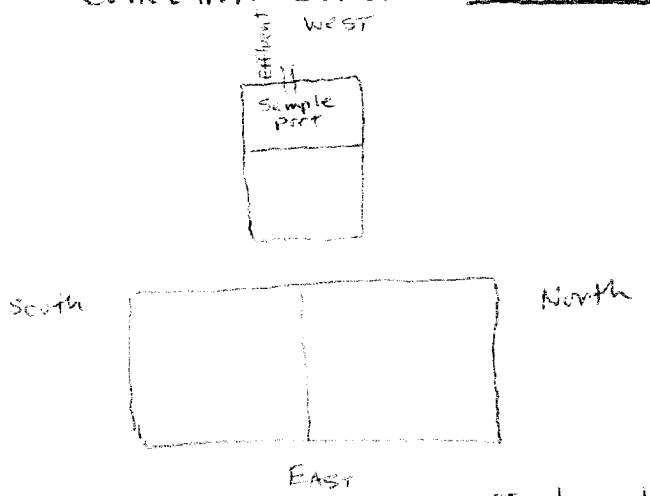
060606 Site: 1680

Notes: Sampled from 1ST chamber next to Effluent

Some orange/rust in sample possibly coming off metal baffles

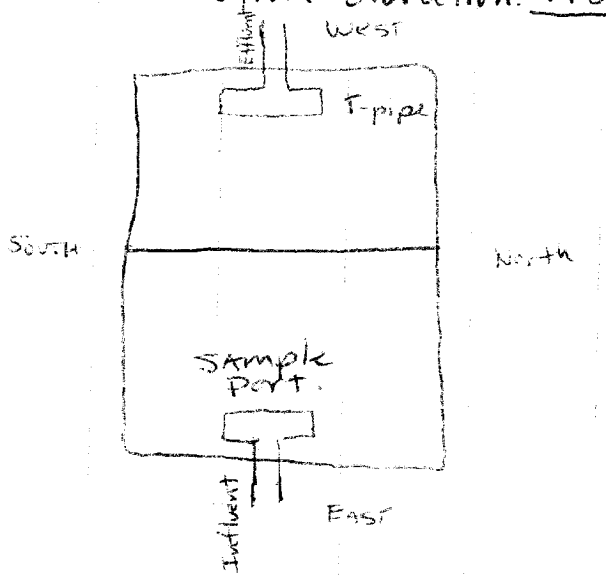
060606 SITE# 1670
DLH Collected
& KC1A-1670-060606
TH

Notes: Very little sediment.
Not enough sediment in 1st chamber (next to Effluent).
The samples were collected in 2nd chamber by Inlet T-pipe.
Note: ONLY 2 chambers in vault.

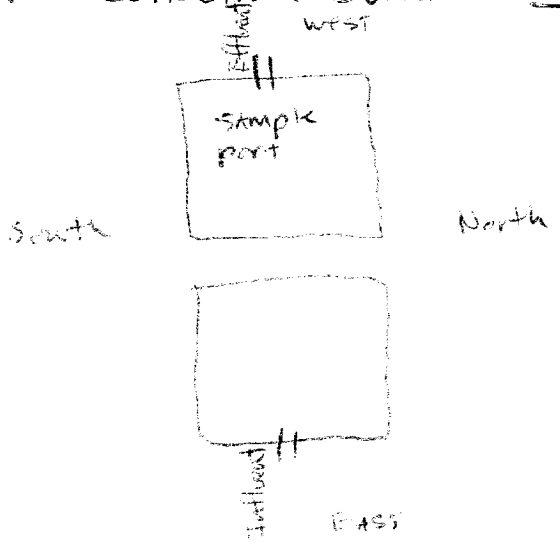
060607 Site #1650
Collected
DLH KC1A-1650-060706
&
TH Collection Duration: 10:50-11:50

Notes Oil sheen on-top of sediment
Collected samples from 1st chamber next to Effluent

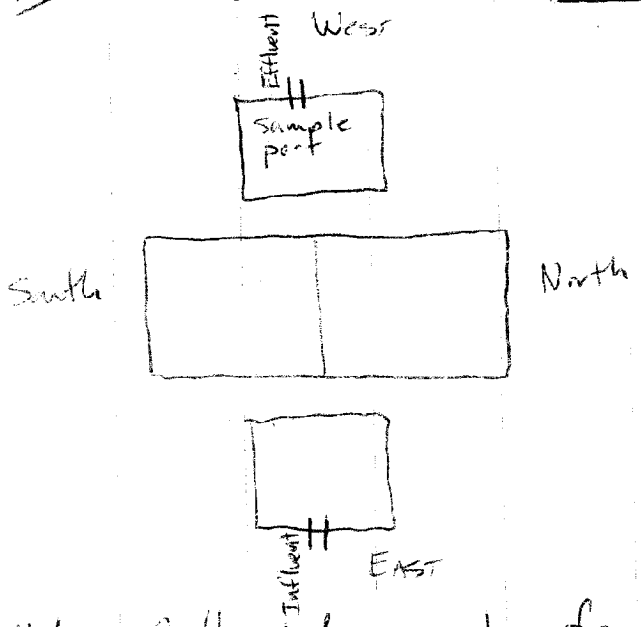
060607 Site # 1657

Notes: Collected samples from 1st chamber next to Effluent pipe.

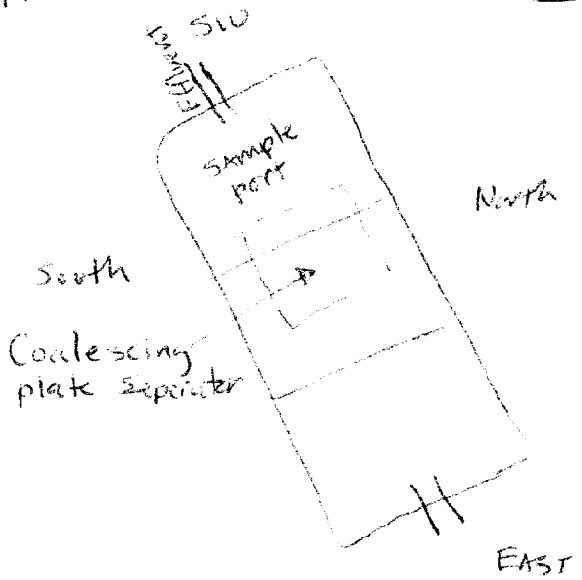
060607 SITE #1640
DLH Collected
KC1A-1640 060706
&
TH Collection duration: 14:30-15:20

Notes: Appears to have the deepest amt. of sediment
Oil sheen on-top of sediment
& Coalescing plate separator (CPS)

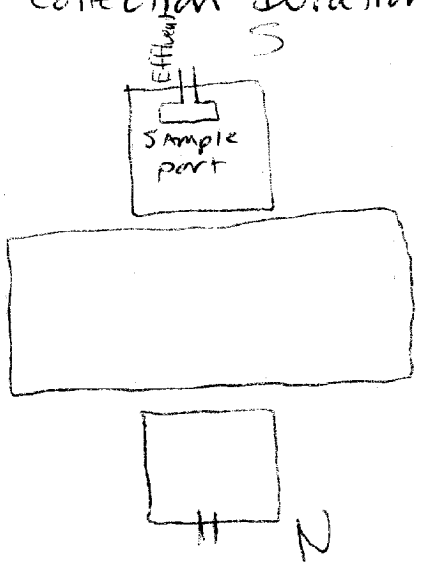
060608 Site # 1541
DLH Collected
KCIA-1541-060806
&
TH Collection Duration: 13:00-14:00

Notes: large amts of oil
stainless steel container - covered w/ oil on outside after dipping into 1st chamber (next to Effluent T-pipe)
Large amt. of sludge/sediment @ Bottom.
* took pictures of site *
