Memoranda

USEPA RCRA

PACIFIC WOOD TREATING
CORPORATION

Pacific Wood Treating Corp. 11:30 hr
111 W. Division St.
Ridgefield, WA 98642

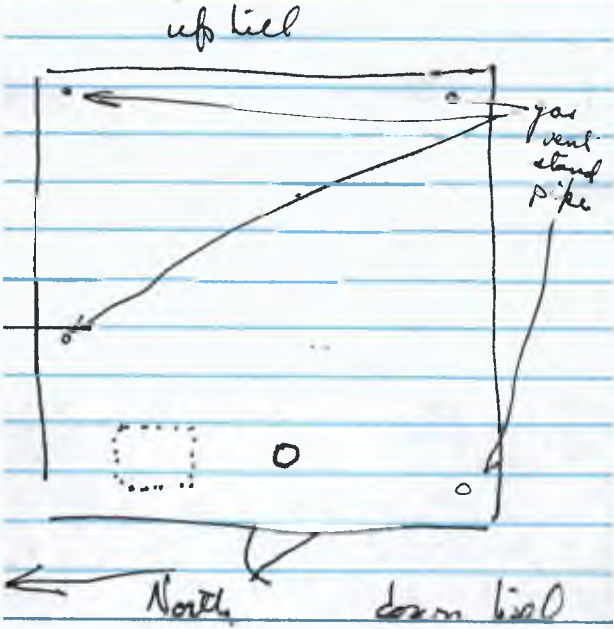
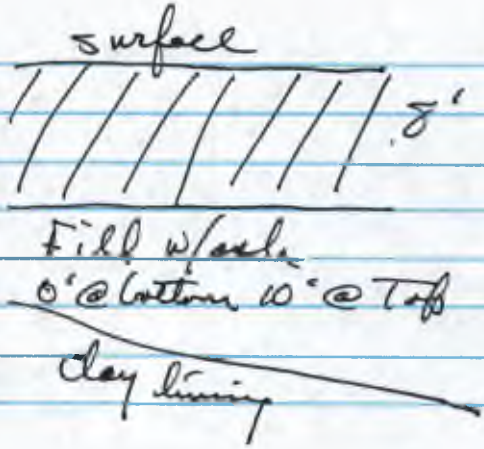
viewed old incinerators (3 in adj
7 wells

.75 acres

surface
8'
Fill w/rock
0' @ bottom 10' @ Top
clay lining
