Middle Fork Payette River GRAIP Watershed Assessment

USDA Forest Service, Boise National Forest

September 2013
Scott Bergendorf[1], Brian Anderson[1], Tom Black[2], Megan Jenkins[1], John Thornton[1] and Charles Luce[2]

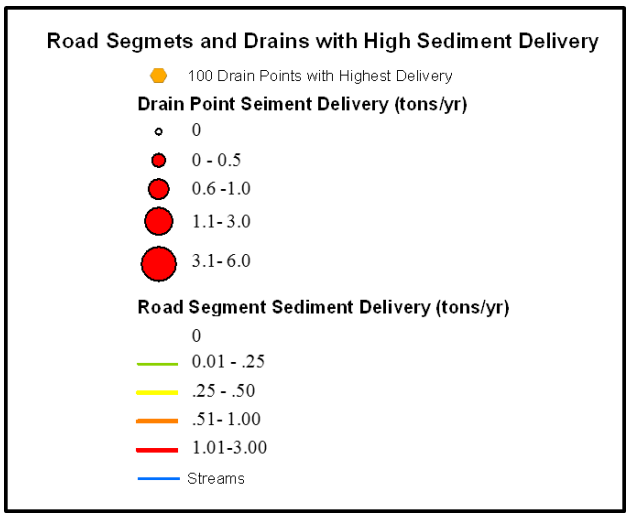
Figure 5. Maps of fine sediment delivery to channels by road segment and drain point. As indicated in the legend below, the road line is colored to indicate the predicted mass of fine sediment that is produced on the road and delivered to the channel. The size and color of the circle indicate the accumulated mass of sediment delivered through each drain point. All red circles indicate a drain point that is actively delivering sediment to streams while small white points represent a drain point not connected to the stream (see legend below). See Table 4 for length of sediment-contributing road segments and amount of fine sediment delivery for each displayed road.

A) The portions of FR 668 displayed in this graphic are found along Anderson Creek. 9 of the top 100 delivering drain points are found in this area. The delivering drain points in this graphic are contributing 4% of all road sediment delivered to the Middle Fork Payette River.

B) Portion of the FR 698 between Silver Creek and Boiling Springs. This road follows the Middle Fork Payette River. 15 of the top 100 delivering drain points are found along this stretch. The delivering drain points are contributing 10% of all road sediment delivered to the Middle Fork Payette River.
