TARGETED BROWNFIELDS ASSESSMENT (TBA)

PHASE II ENVIRONMENTAL SITE ASSESSMENT (ESA)

FORMER HOWARD COUNTY HOSPITAL BUILDING

800 West Leslie Street
NASHVILLE, HOWARD COUNTY, ARKANSAS 71852

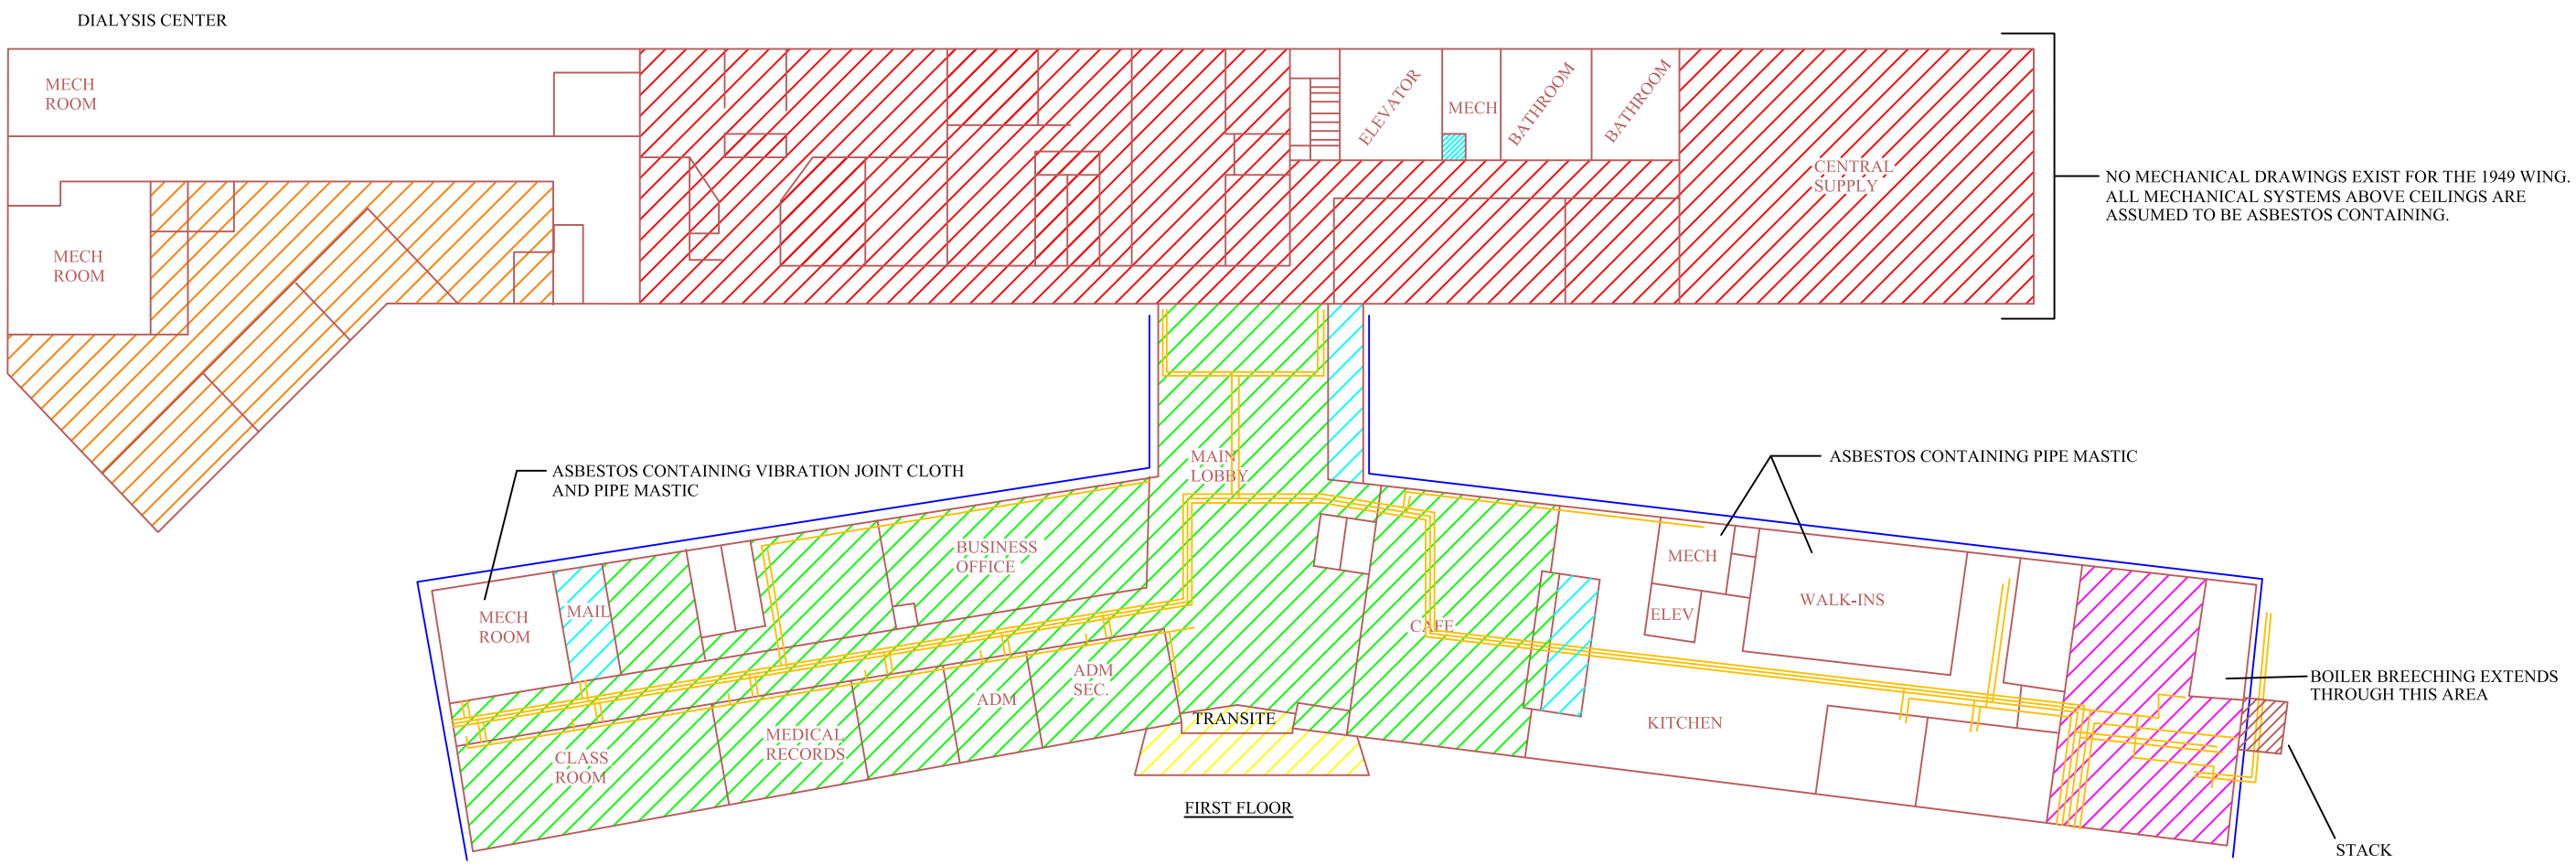
FIRST FLOOR

ASBESTOS CONTAINING BLACK MASTIC UNDER NON-ACM BLUE & BROWN 12X12 FLOOR TILE

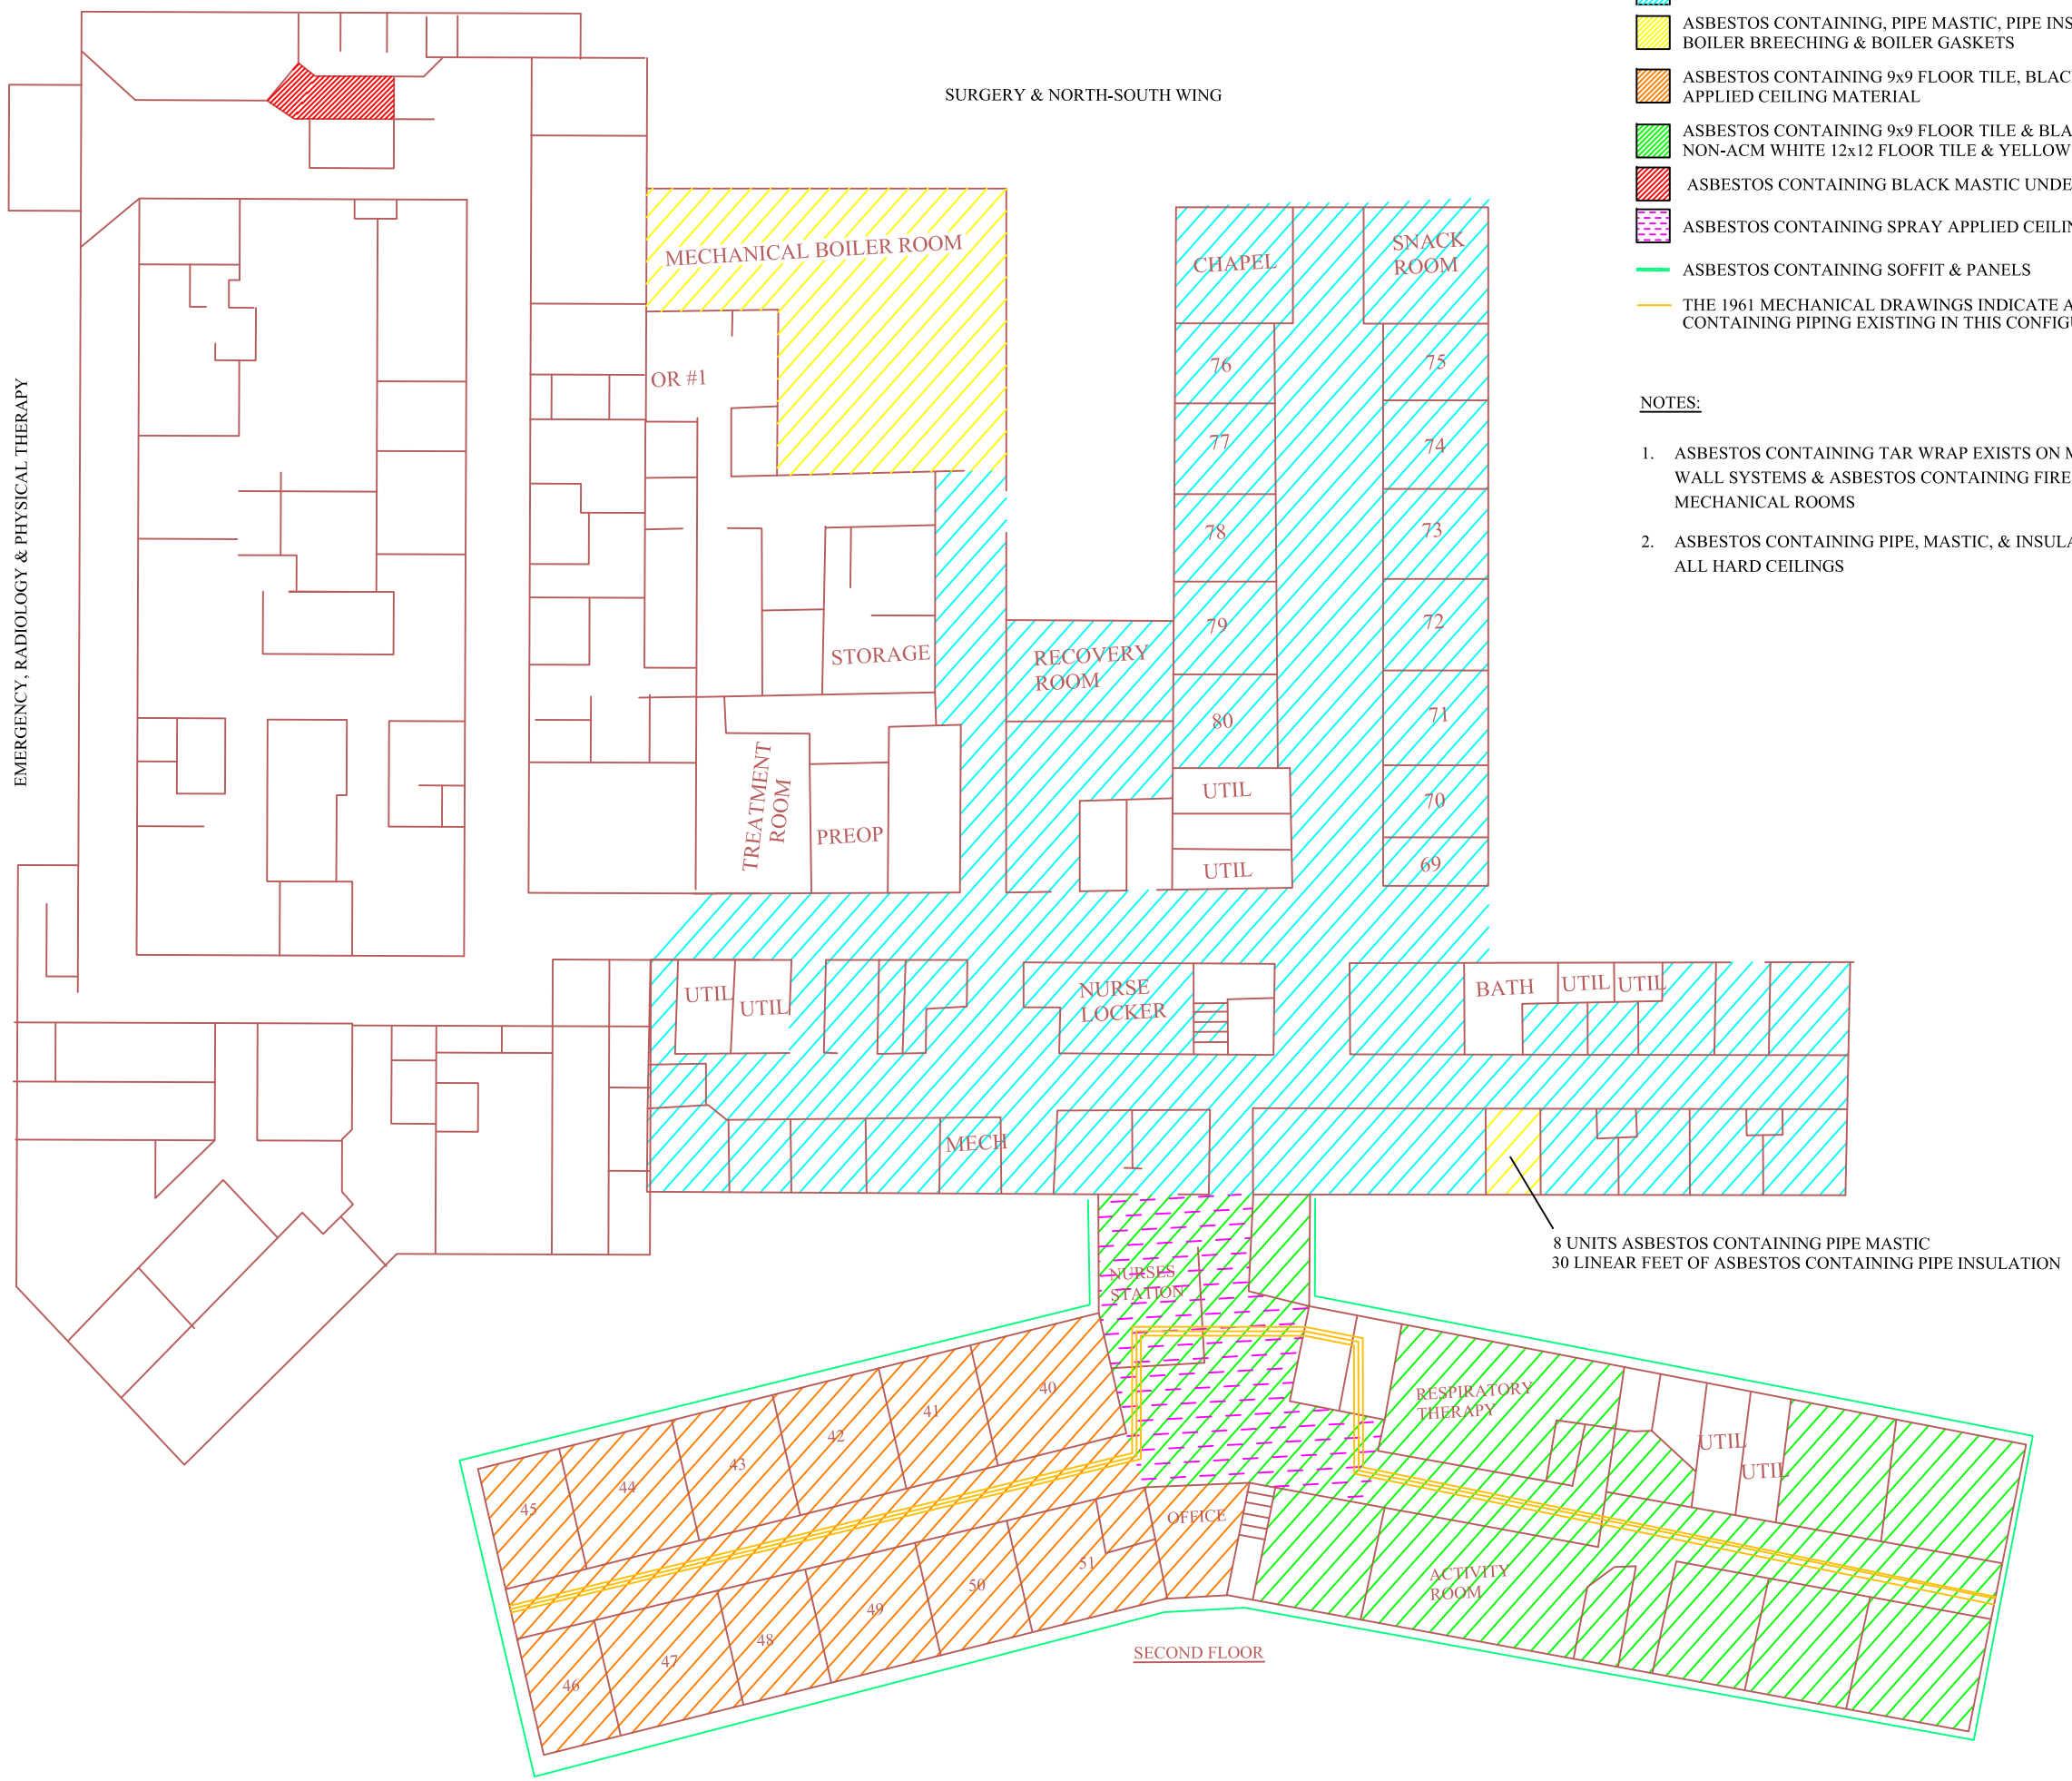
ASBESTOS CONTAINING OFF-WHITE 12x12 FLOOR TILE

ASBESTOS CONTAINING, PIPE MASTIC, PIPE INSULATION, TANK INSULATION BOILER BREECHING & BOILER GASKETS

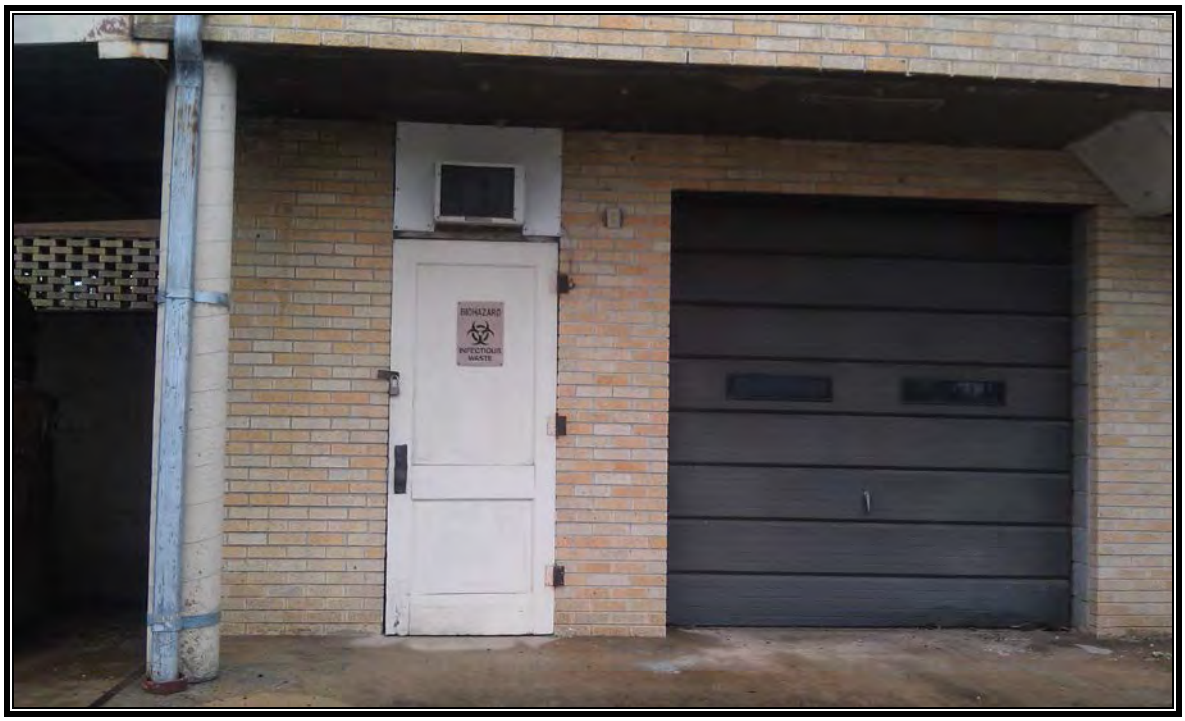
- A Biohazard room is located adjacent to the medical waste incinerator. The room may have been used to house pathogen-contaminated materials, radiological materials, special medical-use metals, or other potentially hazardous materials. No materials were stored in the room.

EEG recommends that the ACM be removed in accordance with local, state and federal regulations prior to demolition activities.

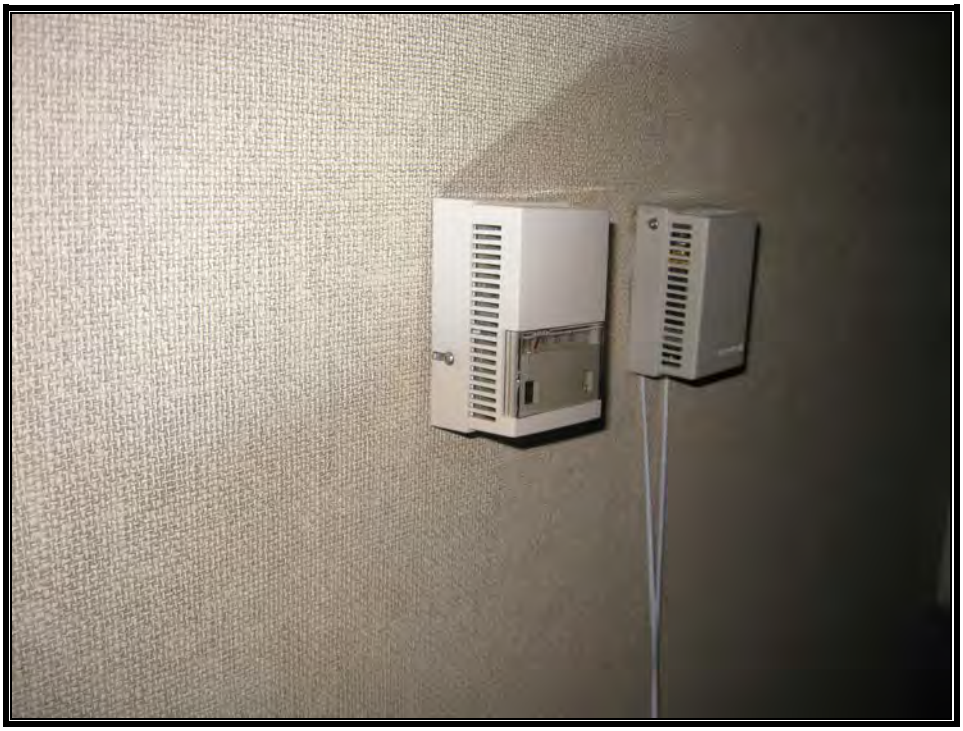
- Possible mercury-containing heating and air conditioning control thermostats were noted throughout the building. The presence of mercury-containing devices could pose a threat for an environmental impact if not removed and disposed of in accordance with regulatory standards and practices.

Material is located throughout the 1st and 2nd floors of the original 1949 building.

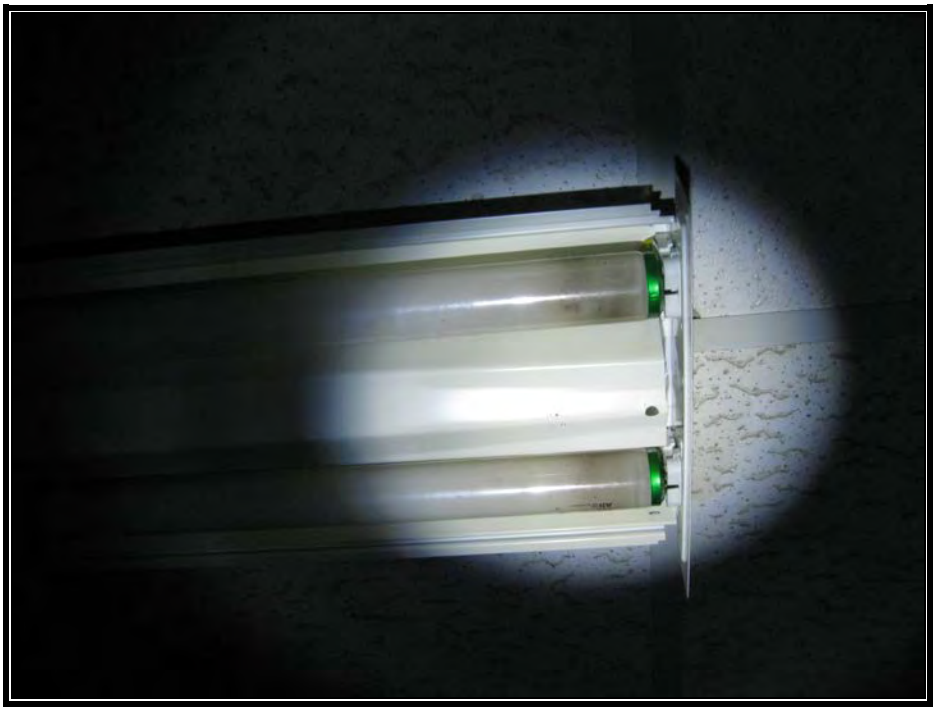
- Possible mercury-containing fluorescent lights were observed throughout the building. (See Appendix C – Photographs 9 and 10.) Possible PCB oil-containing light ballasts were also noted. The ballasts that were observed appeared to be intact and did not have signs of leakage. (See Appendix C - Photograph 11.) The light fixtures could pose a threat for environmental impact if not removed and disposed of according to current regulatory standards and practices.

HA: 27A **Material Description:** ACM Off White Pipe Mastic

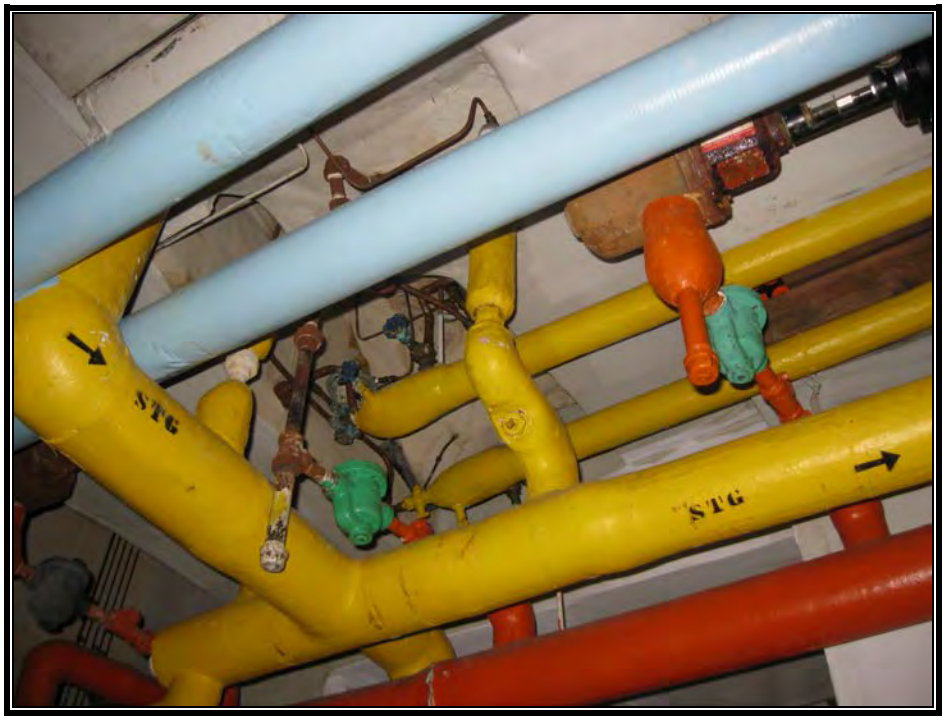
EEG recommends that the ACM be removed in accordance with local, state and federal regulations prior to demolition activities.
