Subject: Final Trip Report for the Riverside Avenue Site
Riverside Avenue, Newark, Essex County, New Jersey
EPA Contract No. EP-S7-06-01
TDD No. 0178
Document Tracking No. 1042

FINAL TRIP REPORT
RIVERSIDE AVENUE SITE
NEWARK, NJ

EPA Contract No. EP-S7-06-01

Technical Direction Document No. 0178
Document Tracking No. 1042

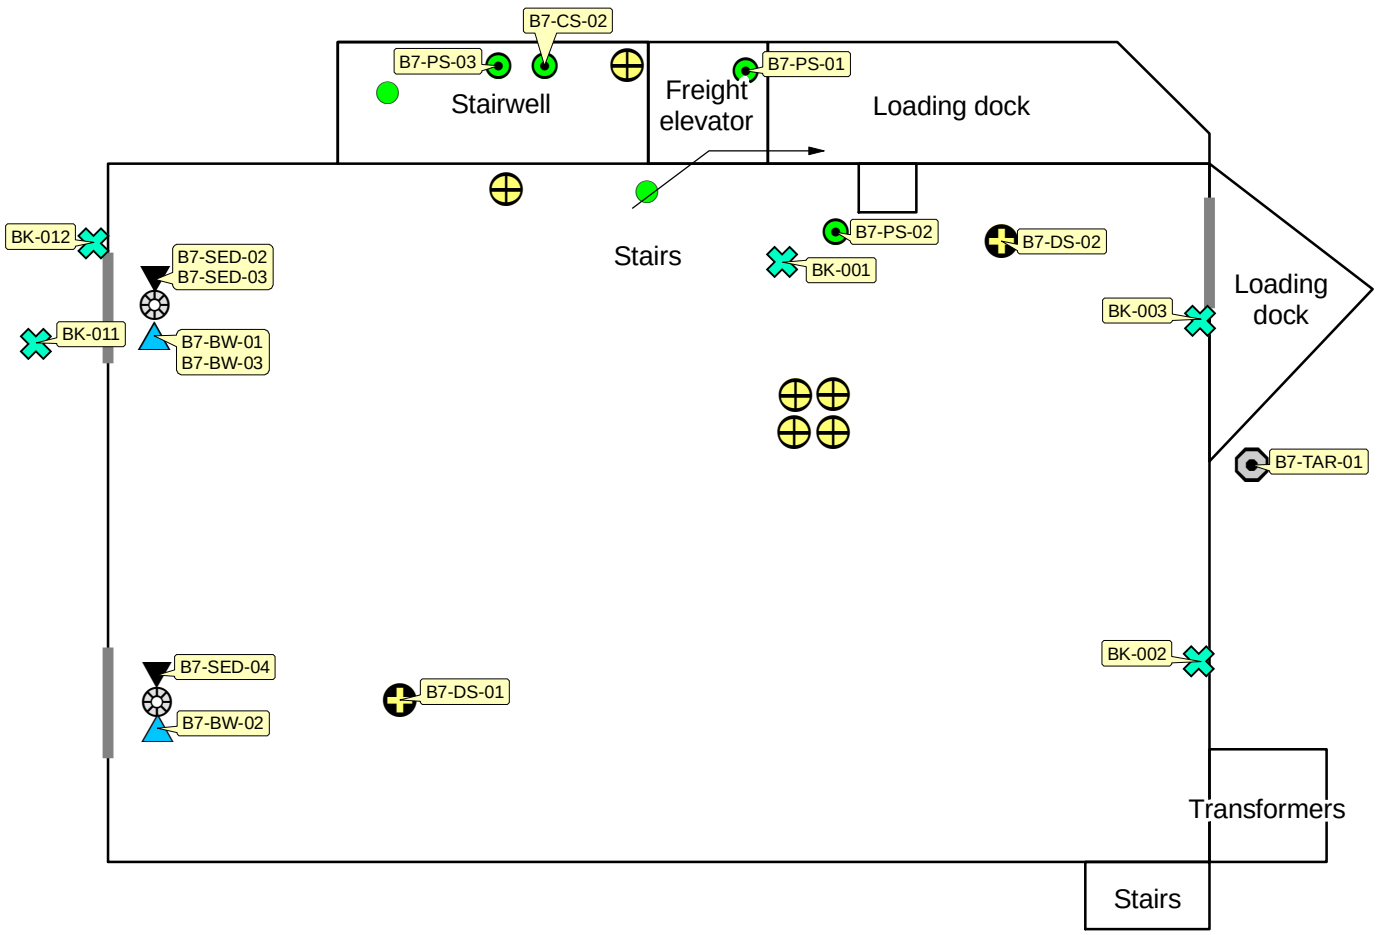
Figure 5
Sampling Location Map, Building 7, 1st Floor

As summarized in Table 4, Tetra Tech collected a total of three aqueous samples and three sediment samples from the subbasement of Building 7, including one duplicate sample and one aqueous and one sediment samples from a sump in the basement of Building # 12. Figures 5 and 7 show the locations of the aqueous and sediment samples collected from Building 7 and Building #12, respectively. At each of the aqueous sampling locations, Tetra Tech filled three certified-clean, 40-ml glass VOC vials with Teflon lined septa lids for TCL VOC and four certified-clean 32-ounce amber glass jars for TCL SVOCs, pesticides and PCBs. At each of the sediment sampling locations, Tetra Tech filled one certified-clean, 4-ounce CWM glass jars with Teflon lined septa lids for TCL VOC and four certified-clean 8-ounce CWM glass jars with Teflon lined lids for TCL SVOCs, pesticides, aroclors, TAL total metals and cyanide, and ignitibility and corrosivity analyses.

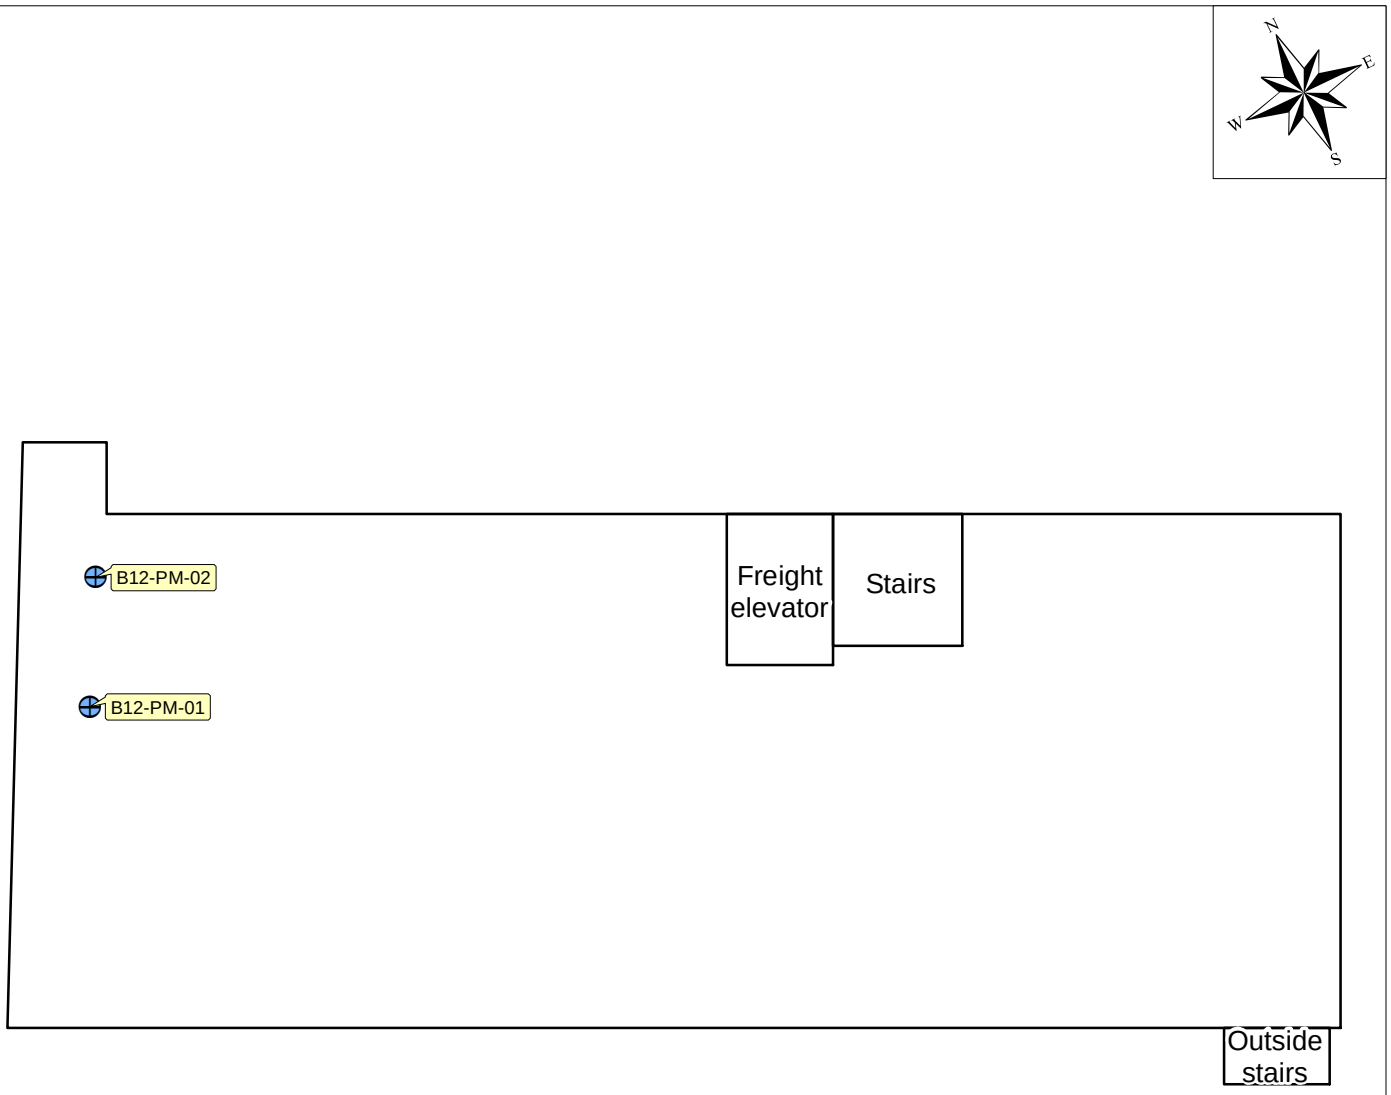
Tetra Tech collected one sample of the red-colored pigment and one sample of blue-colored pigments observed on the floors of Building #12. Figure 8 shows the locations of the pigment samples collected from Building #12. At each sampling location, Tetra Tech filled one certified-clean, 4-ounce CWM glass jar with Teflon lined septa lids for TCL VOC and three certified-clean 8-ounce CWM glass jars for TCL SVOCs, pesticides and PCBs. At each sampling location, Tetra Tech filled one certified-clean, 4-ounce CWM glass jars with Teflon lined septa lids for TCL VOCs and three certified-clean 8-ounce CWM glass jars with Teflon lined lids for TCL SVOCs, pesticides, aroclors, TAL total metals and cyanide, and ignitibility and corrosivity analyses.
